Saltstone Disposal Facility
Vault 4 Cells B and H
Drainwater Piping Anchor Bolt Inspection Summary

July 19, 2011

Prepared by: Savannah River Remediation LLC
Closure & Waste Disposal Authority
Aiken, SC 29808

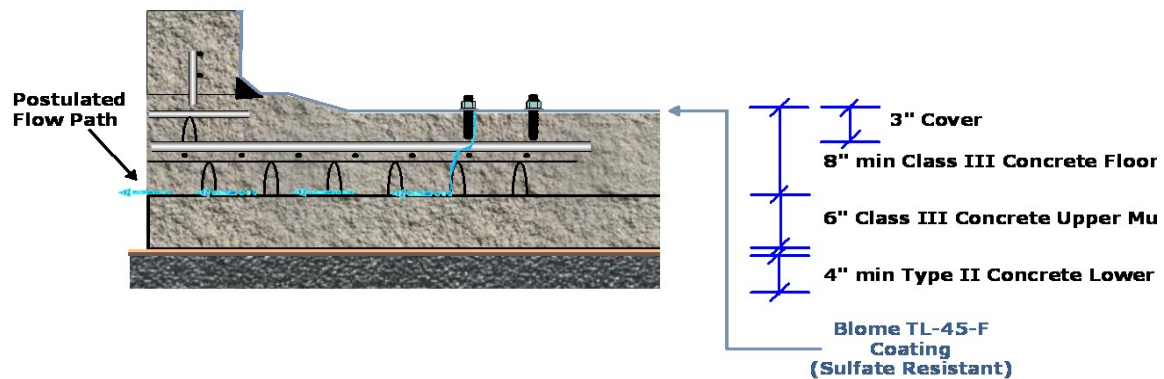
Figure 1.1-1 below depicts the DU2 interior section along with a postulated fast flow path resulting from these imperfections. Figure 1.1-2 represents details of the postulated condition on the floor of DU2 occurring at the anchor bolt penetration.

Figure 1.1-1: DU2 Interior Section Postulated Fast Flow Path

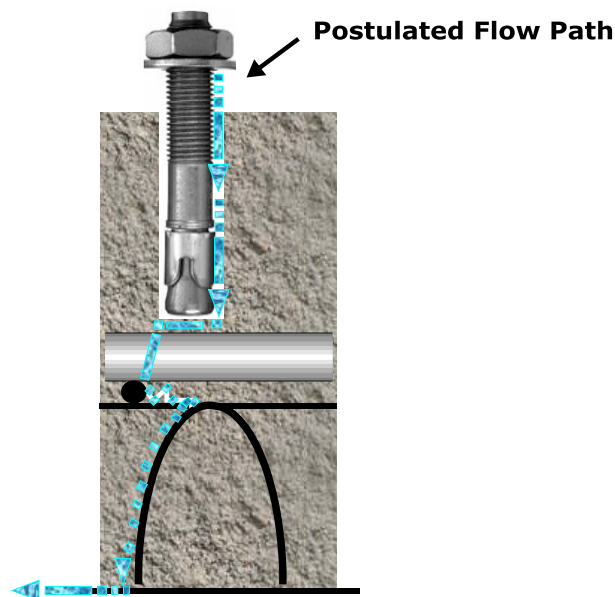
Figure 1.1-2: DU2 Interior Details Postulated Fast Flow Path

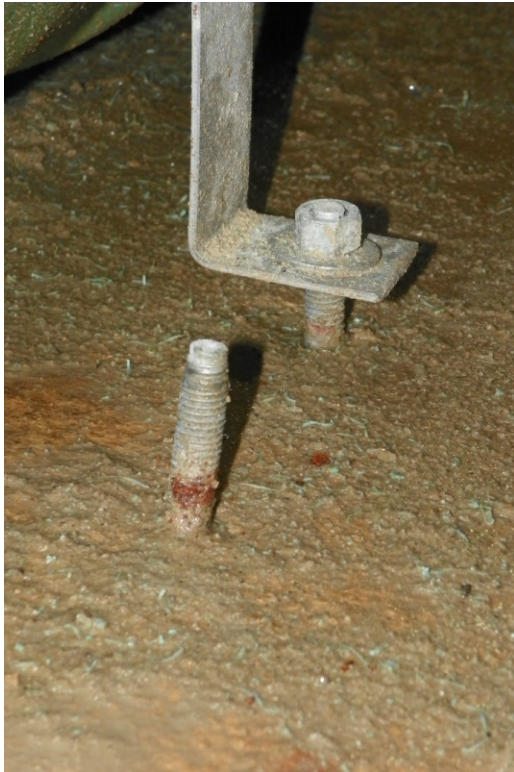
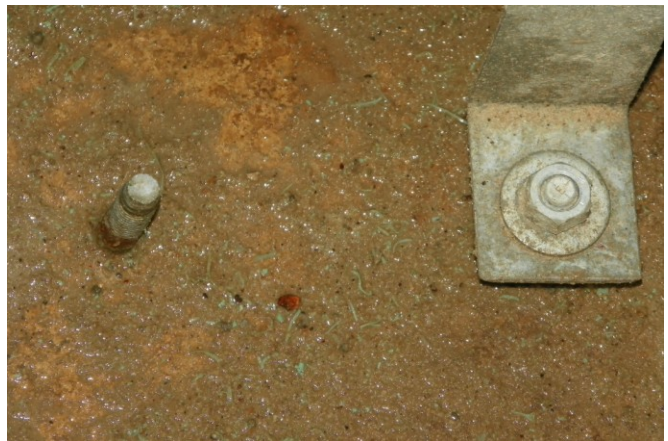
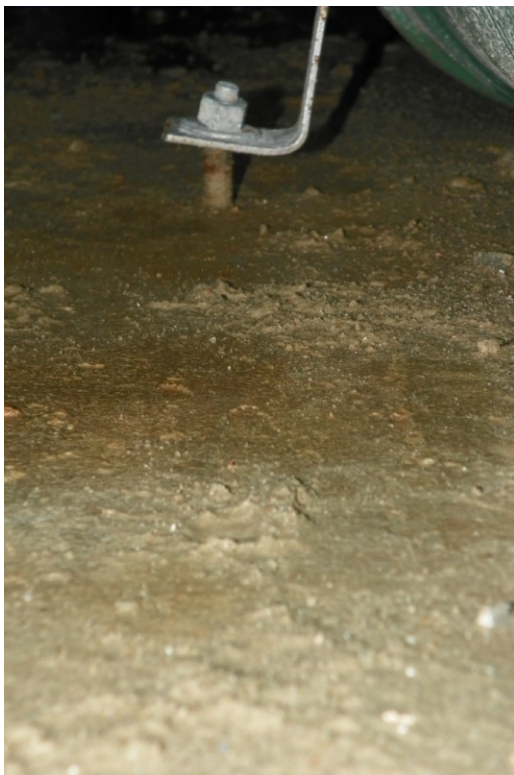
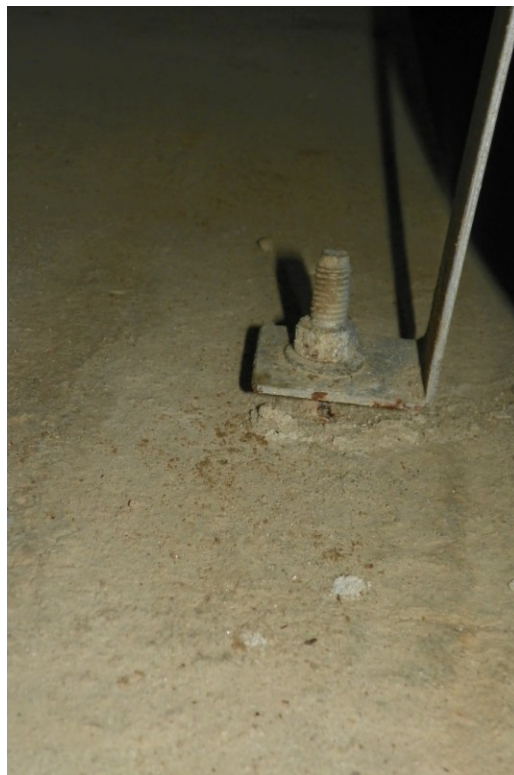
Approximately 20% (48) of the total anchor bolts (approximately 240 per cell) could be inspected and/or clearly photographed. Inspections of the visible anchor bolts in Vault 4 Cells B and H revealed no visible means for immediate leakage of liquids, via either cracks or voids. Several typical locations are shown in Figures 1.5-1 through 1.5-4 (e.g., Figure 1.5-1 shows both used and not used bolt installations). Figure 1.5-2 shows a concrete fragment under a strap that is excess from construction activities and was not dislodged from the anchor bolt location. One location at the southwest corner of Cell B contained freestanding water approximately 10 feet x 10 feet x 1 inch deep (Figure 1.5-4). Several straps and anchor bolts were located in this section. The presence of freestanding water over these anchor bolts supports the conclusion that anchor bolts installed in Vault 4 do not result in fast flow paths.

Figure 1.5-1: Typical Vault 4 Anchor Bolt Installations – Used and Unused

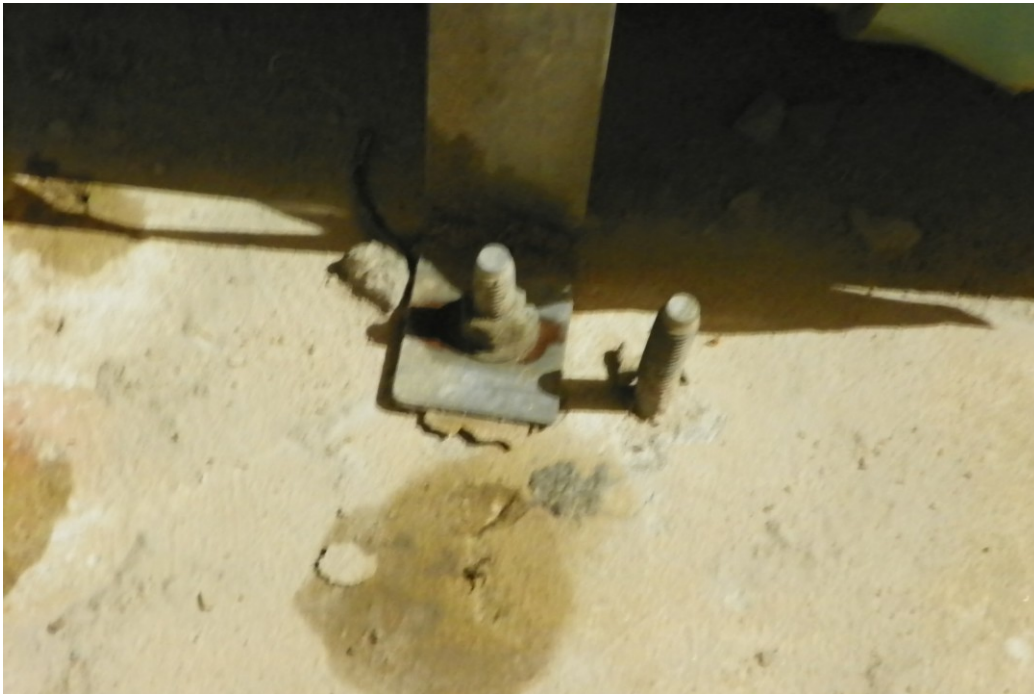
Figure 1.5-2: Typical Vault 4 Anchor Bolt Installation – Excess Construction Concrete Fragment

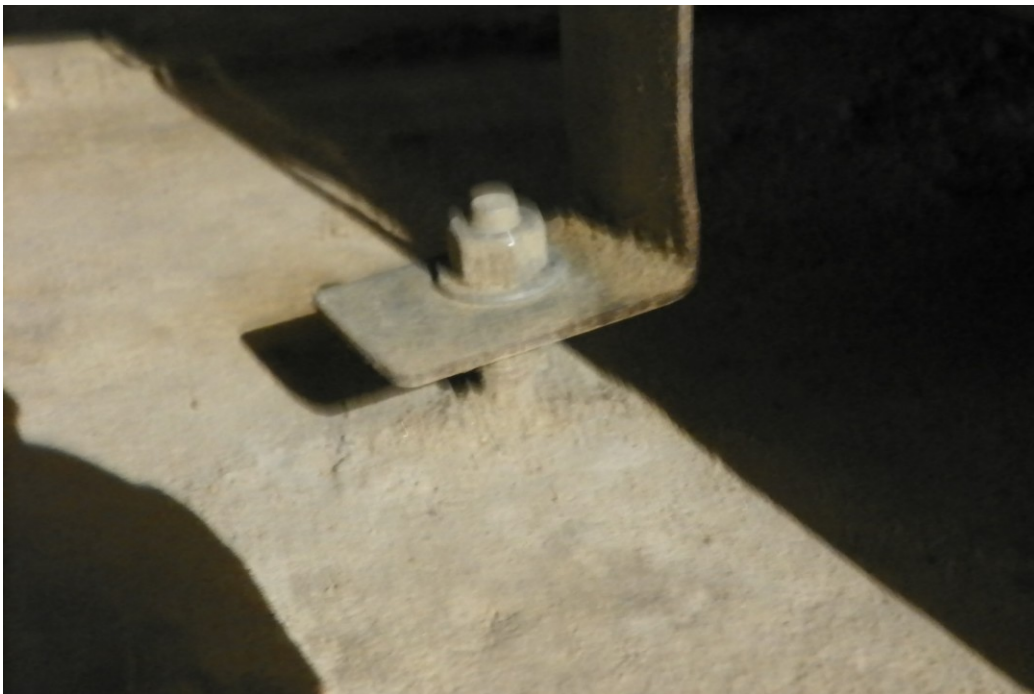
Figure 1.5-3: Typical Vault 4 Anchor Bolt Installation – No Cracking or Voids

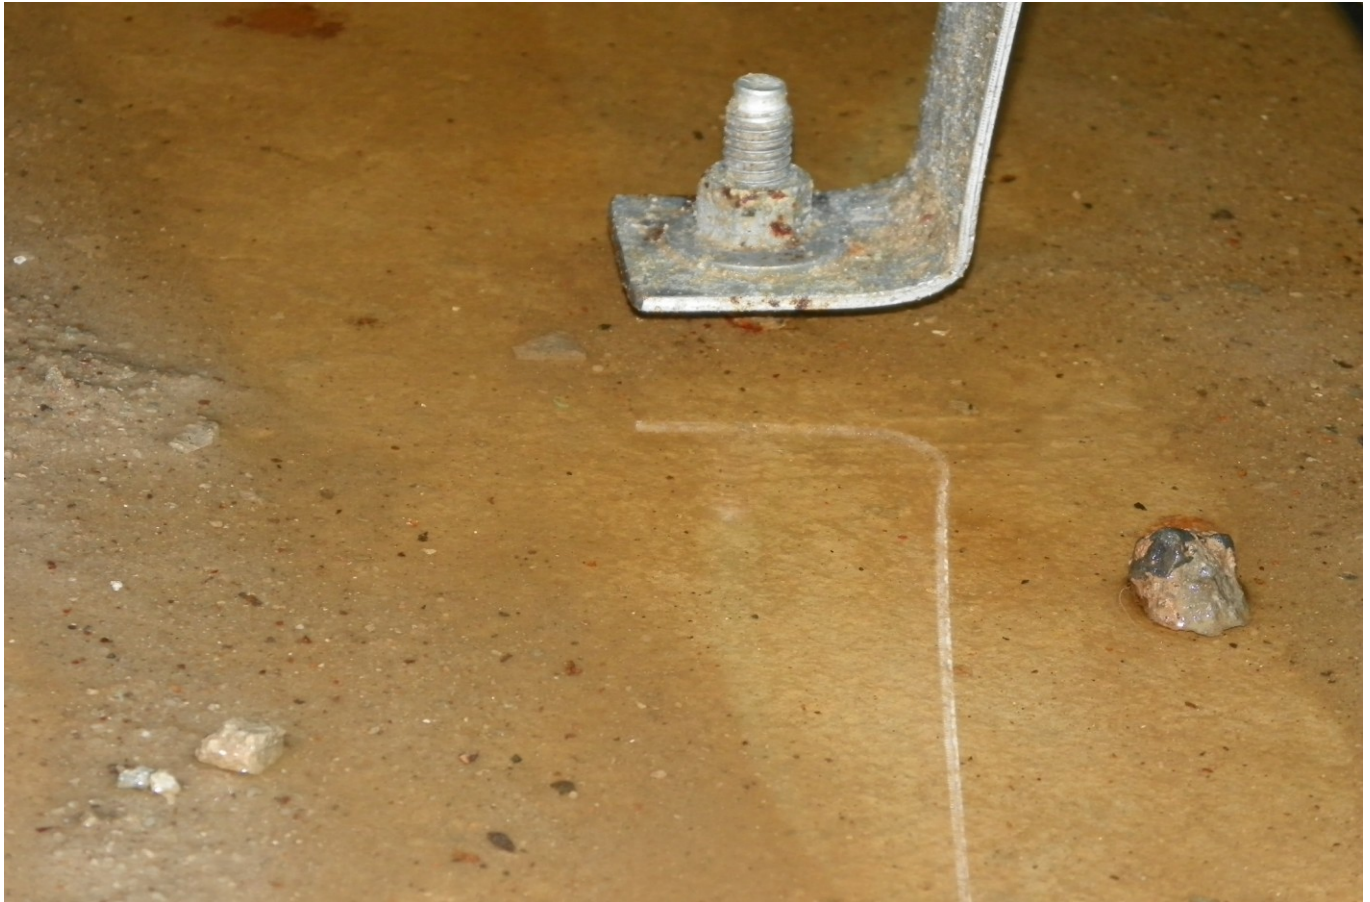
Figure 1.5-4: Typical Vault 4 Anchor Bolt Installation – In Freestanding Water

The objective of the Vault 4, Cells B and H entry was to address questions related to anchor bolt penetrations in the floor concrete of Saltstone DU2 (their potential to facilitate fast flow paths in the unit) raised by the NRC during their July 2010 Onsite Observation. Specifically, do the anchor bolt penetrations in Vault 4 display evidence of cracking or voids around the bolt threads that would allow liquid to bypass the cementitious materials to move into the environment. Visual indications from entry into Cells B and H indicate that the concrete remains continuous and free of cracking around the visible bolt locations. In addition, there is no visual evidence of voids around the bolt threads. Finally, standing water in the area of anchor bolts suggests that water does not flow through cracks or voids around the threads, nor through any other pathway.
