# **Saltstone Disposal Facility**

## **Vault 4 Video Inspection Summary**

**July 2011**

Prepared by: Savannah River Remediation LLC  
Closure & Waste Disposal Authority  
Aiken, SC 29808

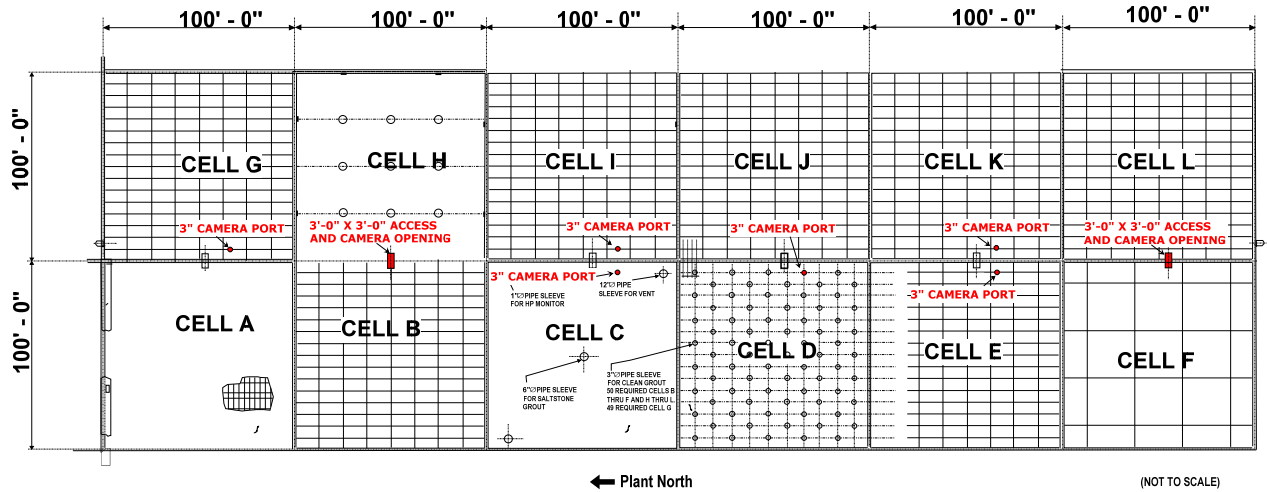
Figure 2.1-1: Vault 4 Camera Locations

As previously discussed, the process cameras are mounted near the inside edge of Cells F and L, making the camera in Cell F on the eastern edge of the cell, and the camera in Cell L on the western edge of the cell. The I&M videos of Cells C, D, E, G, I, and K were taken via a camera inserted through 3-inch ports on the vault roof. These ports all fall along the centerline of Vault 4, with the ports for Cells C, D, and E on the eastern edge of the cell, and the ports for Cells G, I, and K on the western edge of the cell. Figure 2.1-1 presents the camera location in each cell.

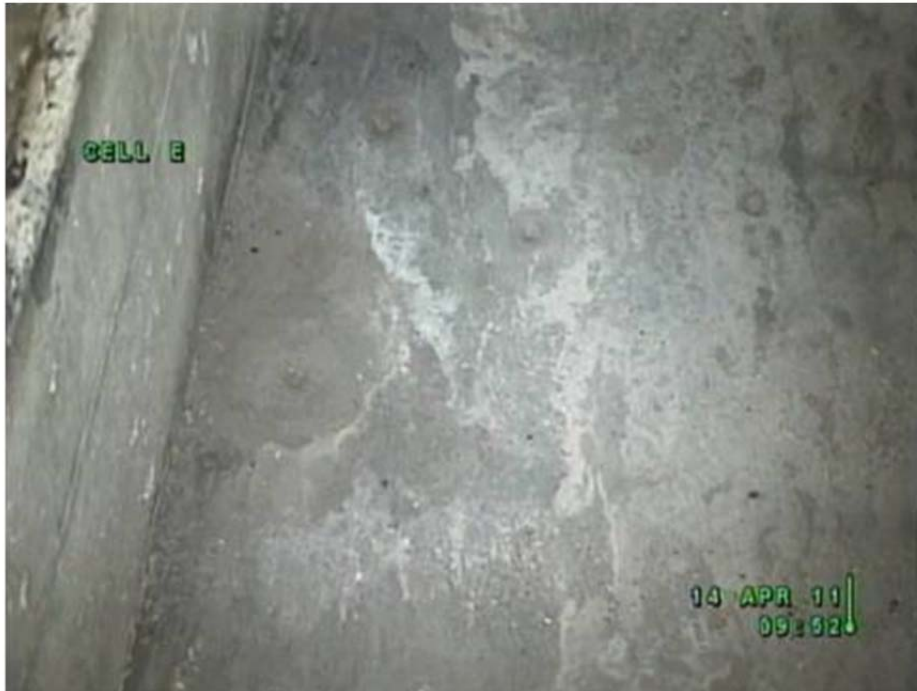
Figure 3.1-1: Cell E, East Wall Interface

Shrinkage of the saltstone monolith from the vault walls and columns could provide fast-flow paths for water in the long-term predictions made by the PA. Such shrinkage was not observed in Cells C, D, E, F, G, I, or K. Figure 3.1-1 shows a representative grout-wall interface, in this case one from Cell E.

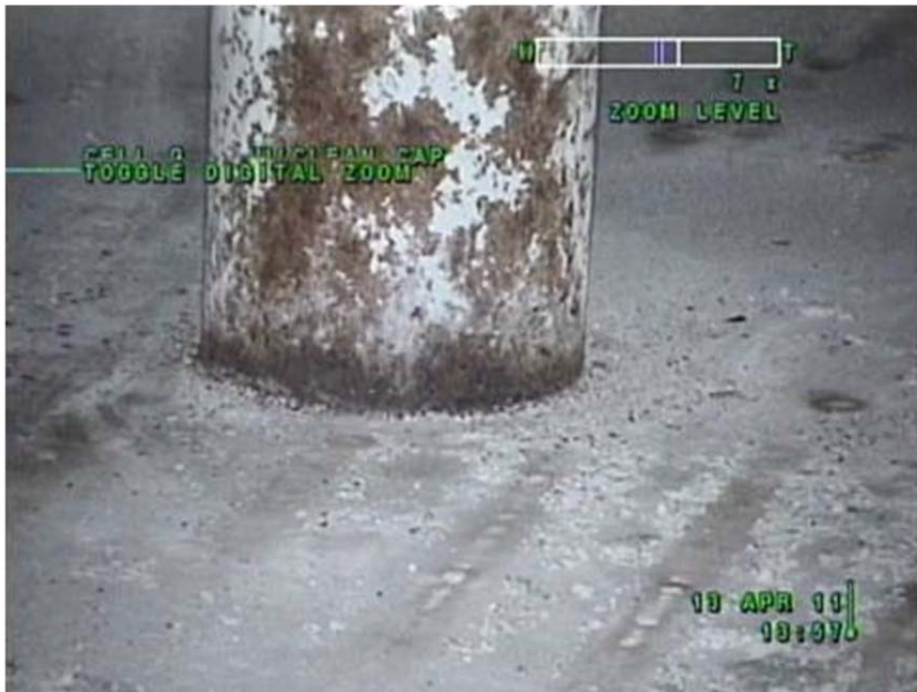
Figure 3.1-2: Cell G, Column-Grout Interface

Similar results were seen for the column-grout interfaces, shown in Figure 3.1-2 for a column in Cell G.

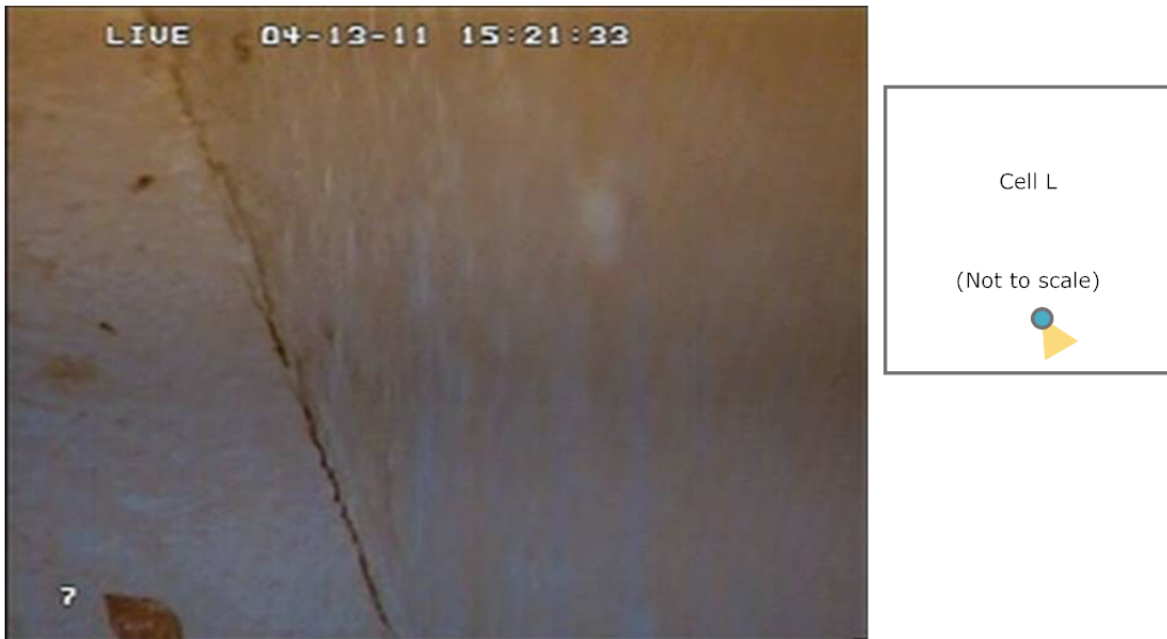
**Figure 3.1-3: Cell L, West Wall Interface**

The only observed instance of shrinkage was in Cell L, which evidenced a small void space between the saltstone monolith and a section of the cell wall. Figure 3.1-3 shows a video still of the observed shrinkage in Cell L. The depth and width of this void space is not known. The observed length of the shrinkage between the wall and grout was approximately 10-feet.

Despite the fact that the surveyed cells evidenced small cracks in the surface, the overall saltstone monolith seems to be intact. The surface cracks observed did not seem to penetrate deeply, some of them only appearing as thin white lines. The shrinkage appearing in Cell L seems to be localized to a single area. The overall grout level seems very even, spreading out well over the entire cell except for the dip in Cell I produced beneath the port where grout was introduced to the cell.

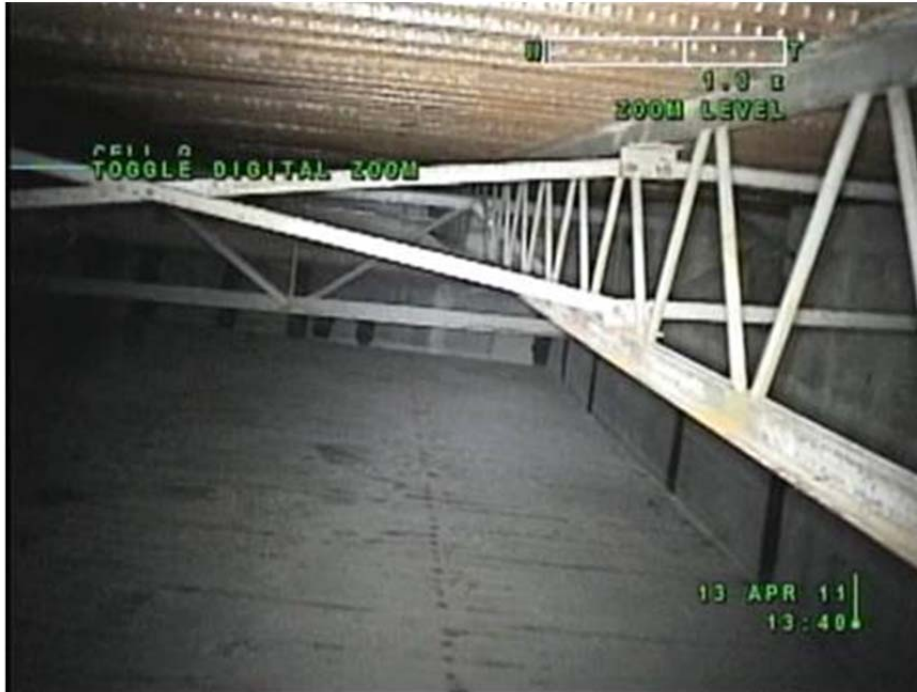
Figure 3.2-1: Cell G, Wide Angle View

Degradation of the saltstone monolith is a matter of importance for PA modeling efforts. Improved understanding of degradation mechanisms, including cracking, provides insights that will inform PA modeling assumptions. This inspection could only inspect for surface cracking. Cells E, F, and G showed no evidence of surface cracking in this inspection. Cell F was the only inspected cell without an operational layer of clean grout covering the saltstone. Figure 3.2-1 shows a wide-angle view of Cell G.

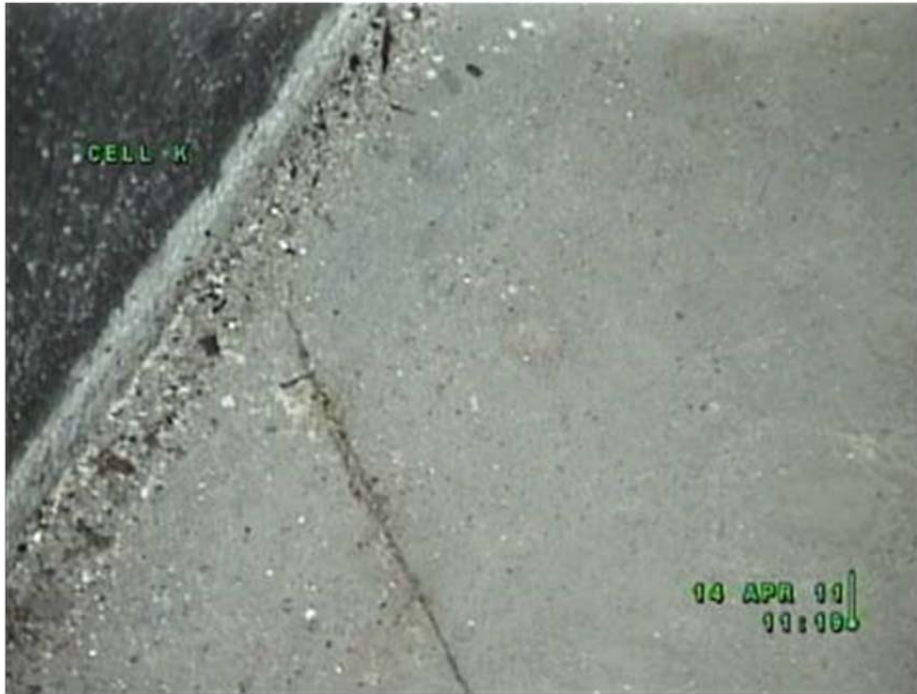
Figure 3.2-2: Cell K, West Wall Interface

Cells C, D, I, K, and L all show varying evidence and degrees of surface cracking, with Cell K being the most apparent and Cells C, D, I, and L merely evidencing a few white lines on the surface of the grout. All surface cracks observed were in the operational clean layer of grout covering the saltstone surface. The depth and thickness of these cracks is not known. Figures 3.2-2 through 3.2-4 show the cracks observed in Cell K.

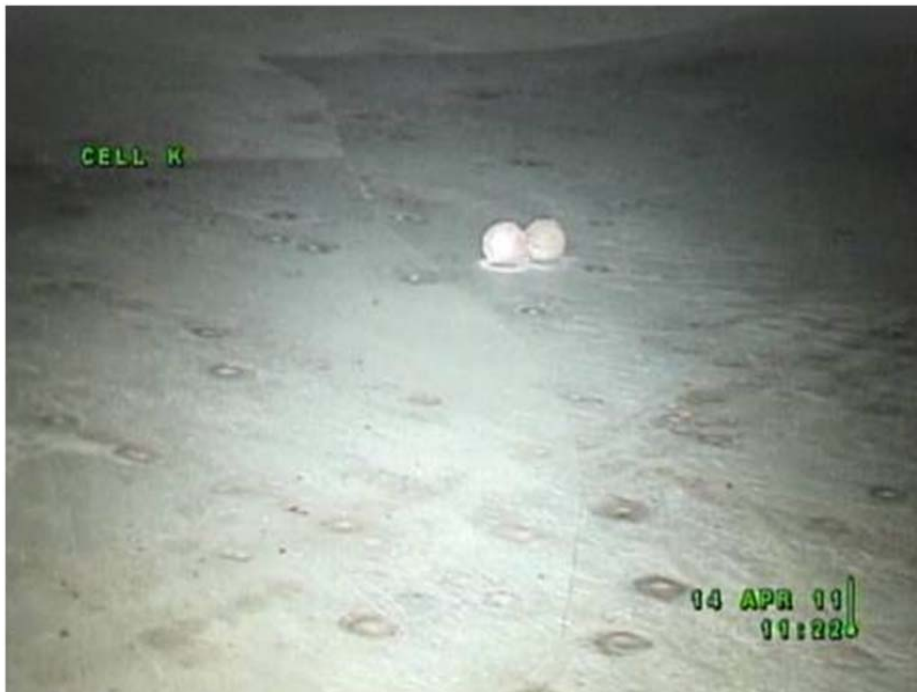
Figure 3.2-3: Cell K, Grout Surface

Figure 3.2-3 shows two “pigs” used to remove grout from transfer lines during processing. Each pig is approximately 3 inches in diameter.

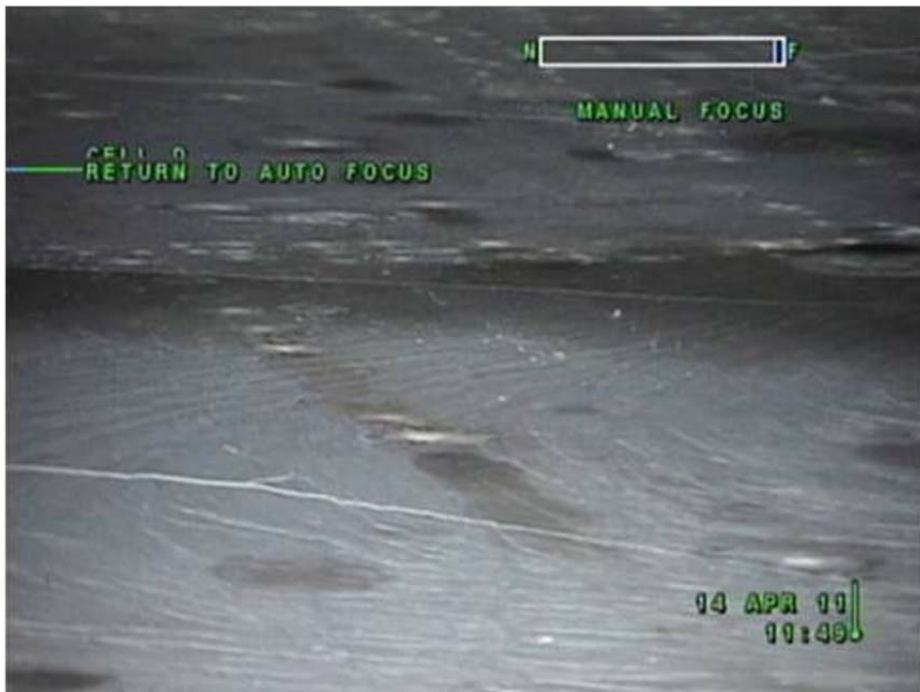
Figure 3.2-5: Cell D, Grout Surface

Cell D also evidenced some minor indications of surface cracking, as shown in Figure 3.2-5. Evidence of surface cracking in Cell D was much less pronounced than observed in Cell K.

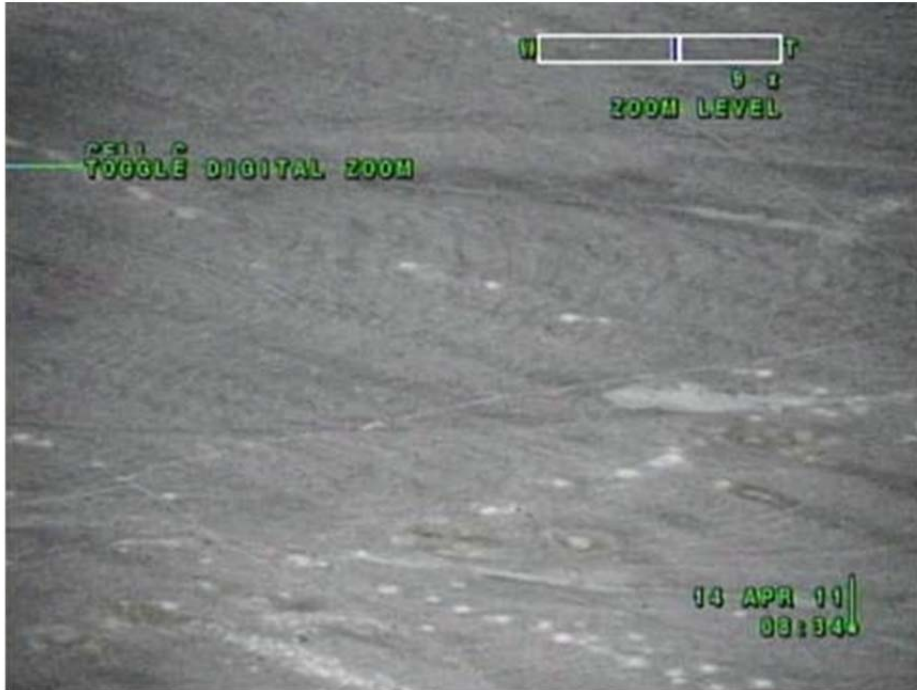
**Figure 3.2-6: Cell C, Grout Surface**

Cells C, I, and L were less conclusive in evidence of surface cracking than Cells D or K. Cells C, I, and L all show thin white lines in the grout, but video limitations such as resolution and focus made precise characterization difficult. Video stills showing this evidence from Cells C, I, and L are shown in Figure 3.2-6 through Figure 3.2-8.

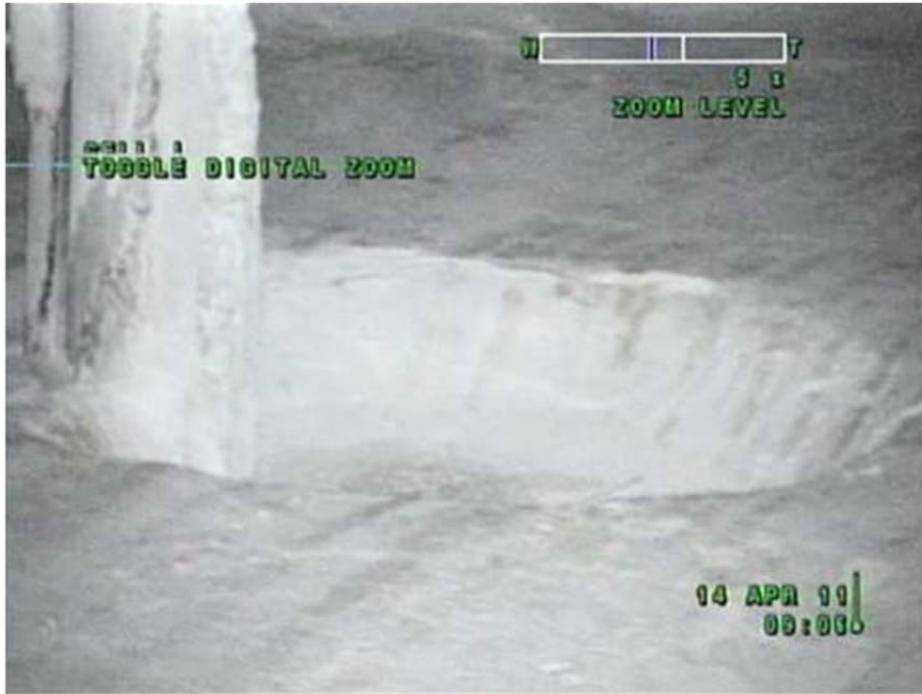
Figure 3.3-1: Cell I, Grout Surface Variation

The grout surface was relatively uniform overall. Variations of less than 3 inches in shallow “bumps” and “dips” were common, but only one larger variation was visible. This dip appears in Cell I, and seems to be below the port where the grout was added to the vault, which would account for the level variation. Figure 3.3-1 is a video still from Cell I, showing the dip at the base of a column. The column shown is 10 inches in diameter, which corresponds to an estimated height variation of approximately 10 inches and a diameter of approximately 2.5 feet.

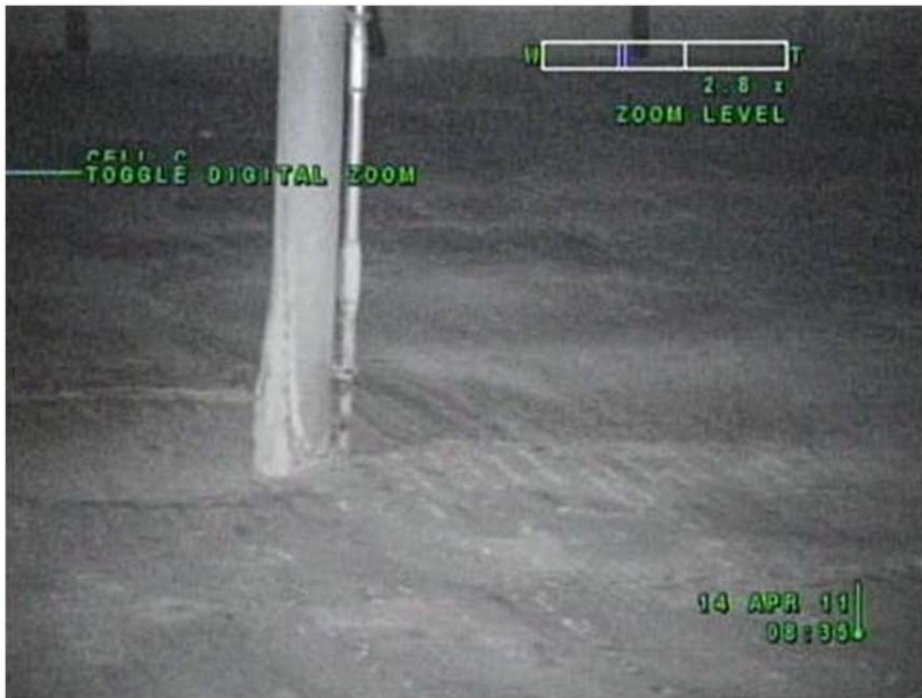
Figure 3.3-2: Cell C, Grout Surface Level

Figures 3.3-2 through 3.3-4 show examples of wide-angle views from Cells C, E, and G, which show only minor variation and provide representative examples of the other cells.
