**UNITED STATES
NUCLEAR REGULATORY COMMISSION**
REGION III
2443 WARRENVILLE ROAD, SUITE 210
LISLE, IL 60532-4352

EA-11-243

**SUBJECT: PALISADES NUCLEAR PLANT - NRC SPECIAL INSPECTION TEAM (SIT)
REPORT 05000255/2011014 PRELIMINARY YELLOW FINDING**

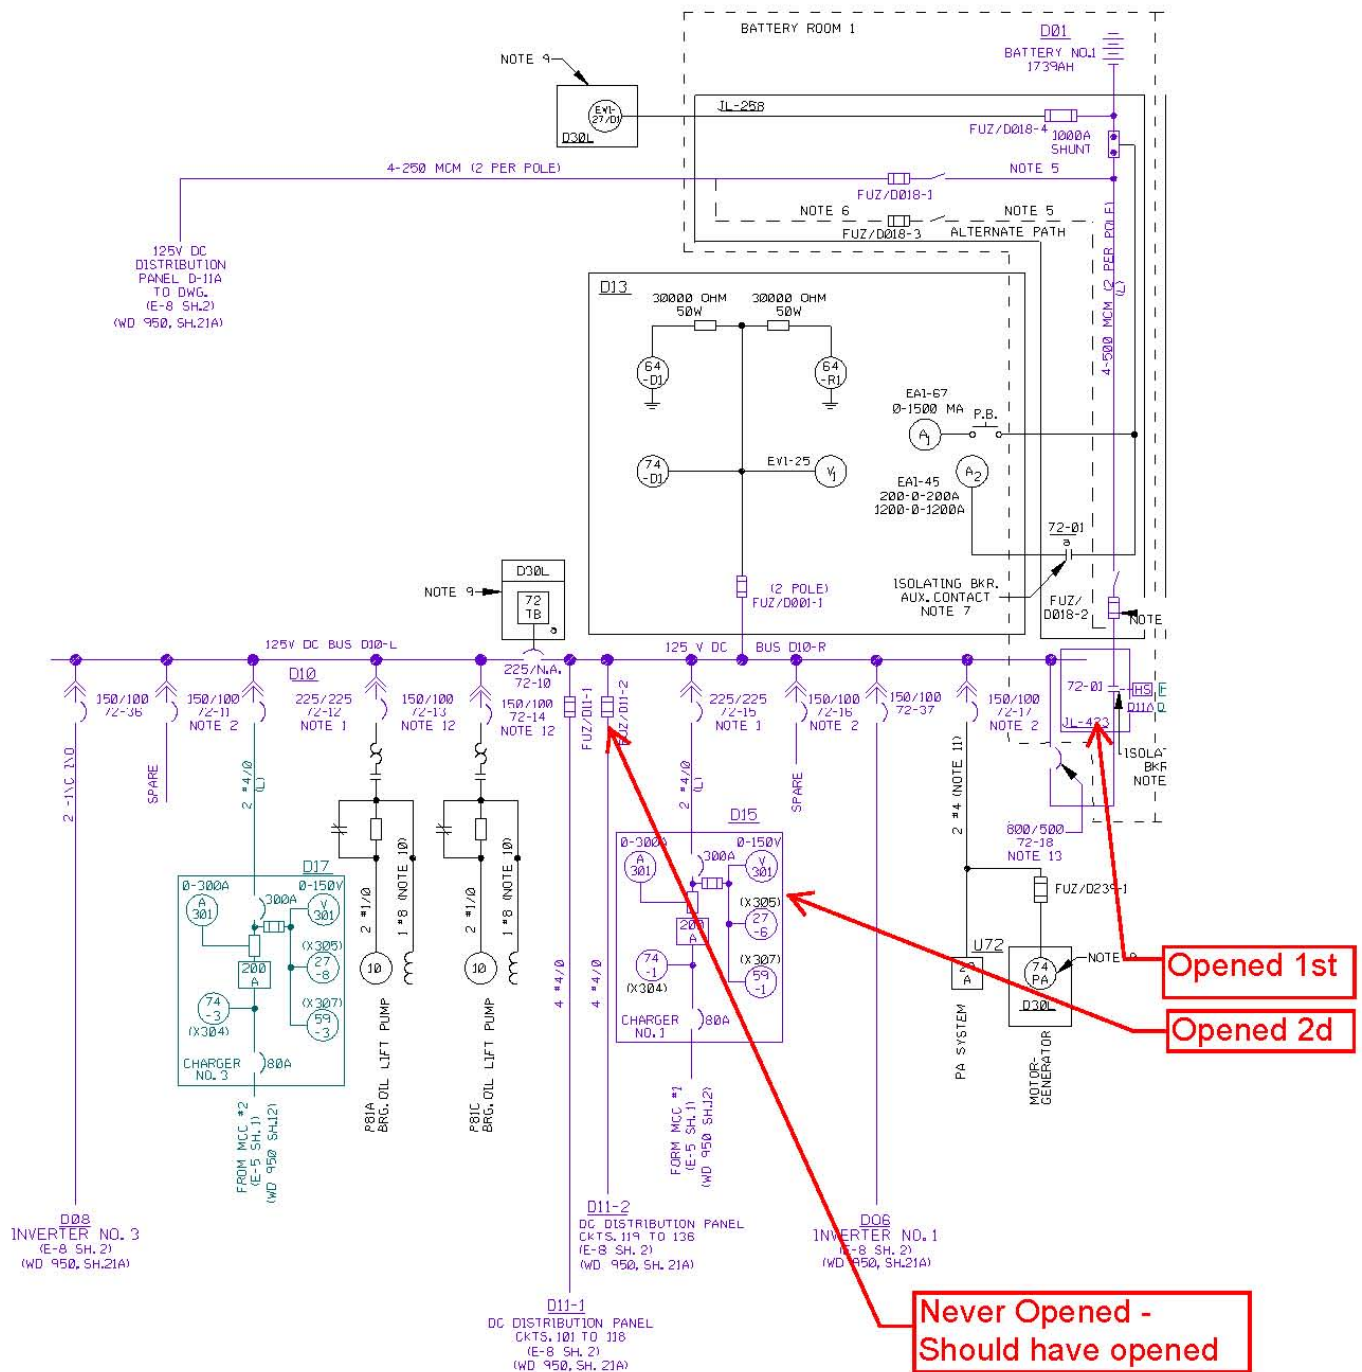
FIGURE 2 - SIMPLIFIED DIAGRAM OF LEFT TRAIN 125-VOLT DC BUS DE-ENERGIZED DURING EVENT

An electrical fault occurred from this contact between the positive and negative bus bars. This fault revealed a latent design deficiency of the installed shunt trip Breaker 72-01, in that, the installed breaker had thermal and instantaneous trip settings actuate due to the fault. The installed thermal and instantaneous trip settings on the shunt trip breaker were not listed as a characteristic of the breaker in the plant's updated final safety analysis report (UFSAR), drawings, or calculations. The design and licensing basis documentation described the shunt trip breakers as only a non-automatic, manually-operated breaker without any thermal or instantaneous protection devices. Per the system design, the transient, that occurred due to the electrical fault, should have only resulted in the loss of Panel D11-2, due to the actuation of fuse FUZ-D11-2 (which should have isolated the fault from the rest of the loads on the bus). However, because the shunt trip Breaker 72-01, which was installed in 1981 for both the left and right trains of 125-Volt DC busses, had thermal and instantaneous protection for overcurrent, the breaker tripped free on an overcurrent setting when the electrical fault on Panel D11-2 occurred and the entire left train 125-Volt DC bus was lost (reference Figure 2 of Attachment 4).

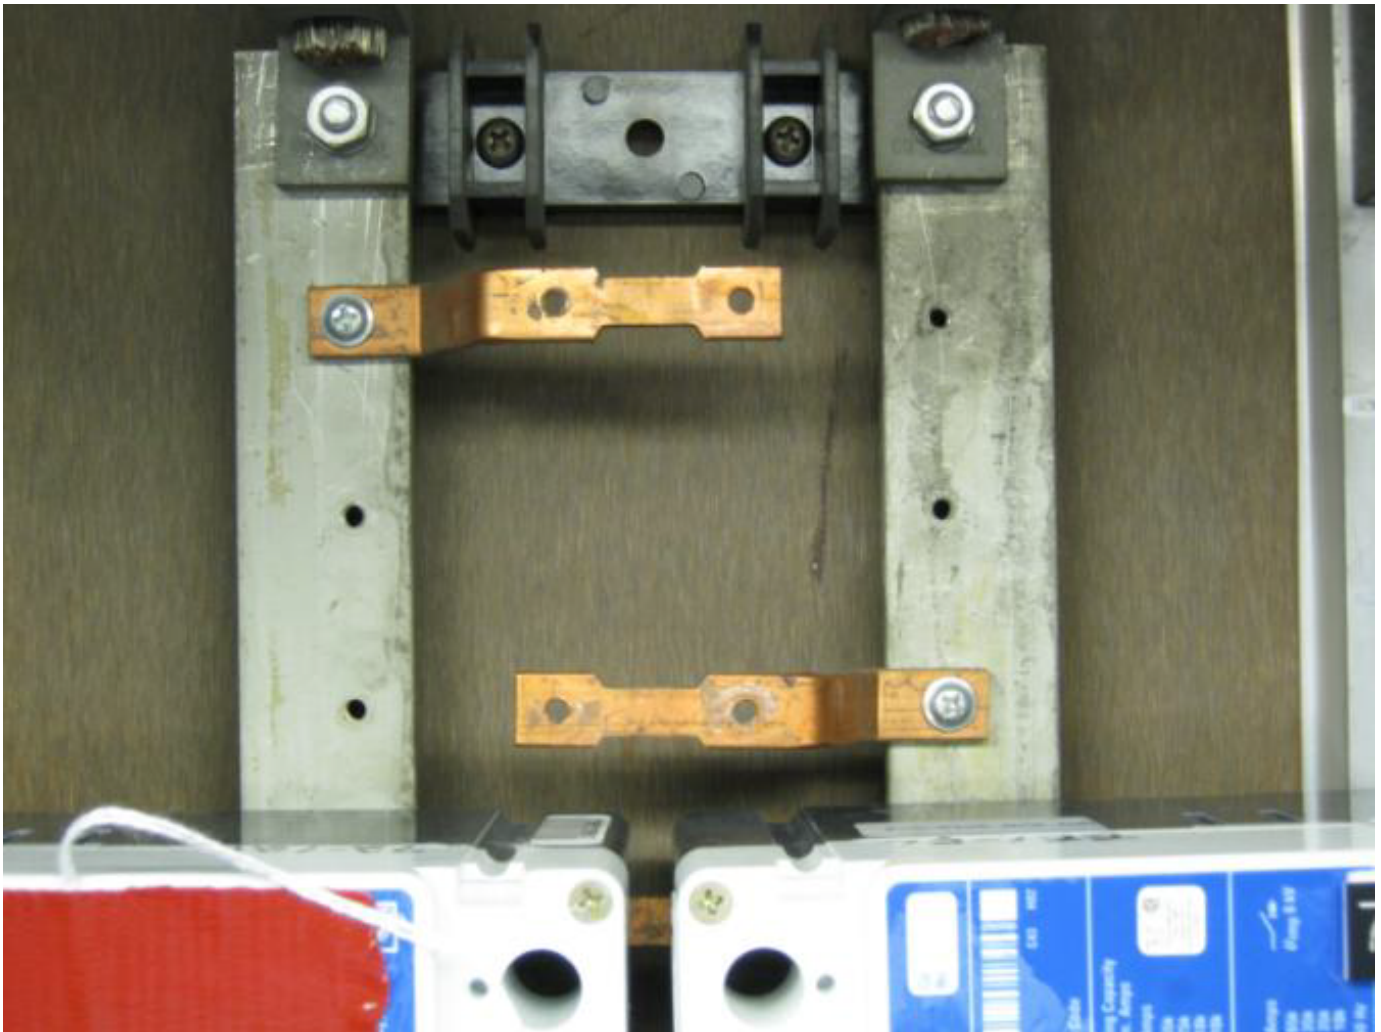
FIGURE 4 - DC DISTRIBUTION PANEL D11-2 WITH BREAKERS 72-119 AND 72-120 REMOVED

Following the removal of the fourth breaker and after the observers inspected Panel D11-2, the electricians began removal of the first positive horizontal bus stab located in the upper left-hand corner of the bus (reference Figure 4 in Attachment 5). The workers were concerned that the single screw holding the horizontal bus stab would fall into the bus cubicle, so they devised a plan to hold onto the horizontal bus stab with one hand, loosen the screw with the other hand, and slowly back out the screw. At the time, the workers believed they met the intent of a note in the WO package to insulate the bus stab because the electrician performing the work was wearing insulated gloves. The electrician felt positive control was maintained by holding the bus bar.

(Note that with both breakers removed the positive horizontal bus bar (top left copper stab) and the negative horizontal bus bar (right copper stab) were not insulated.)

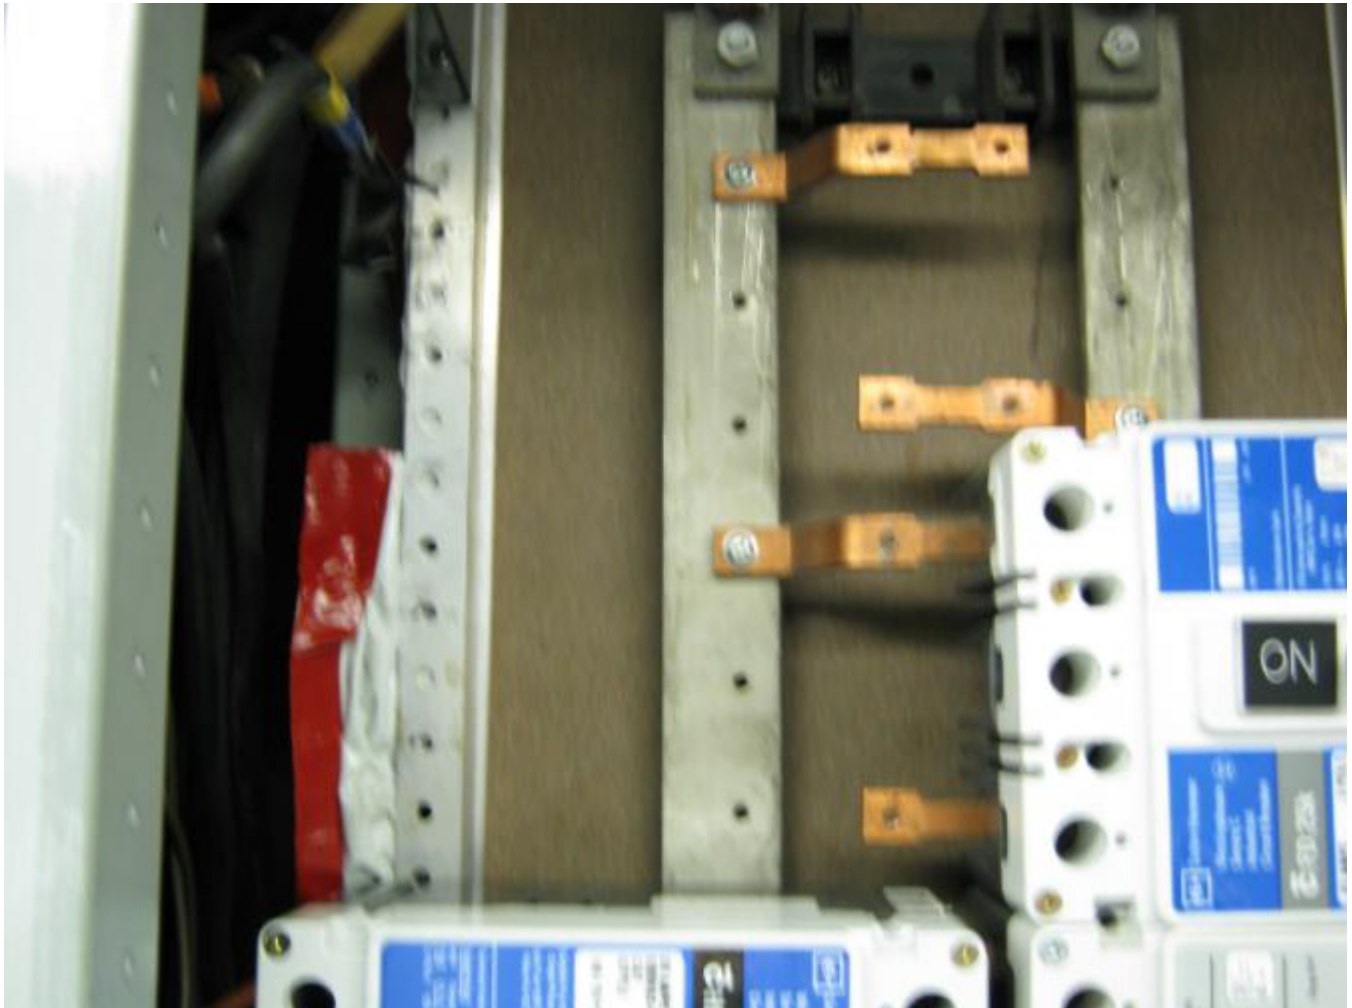
**FIGURE 5 - DC DISTRIBUTION PANEL D11-2 WITH BREAKERS 72-119, 72-120
AND 72-121 REMOVED**

(Note that with three breakers removed the positive horizontal bus bar (top left copper stab) and the negative horizontal bus bar (upper right copper stab) were not insulated.)

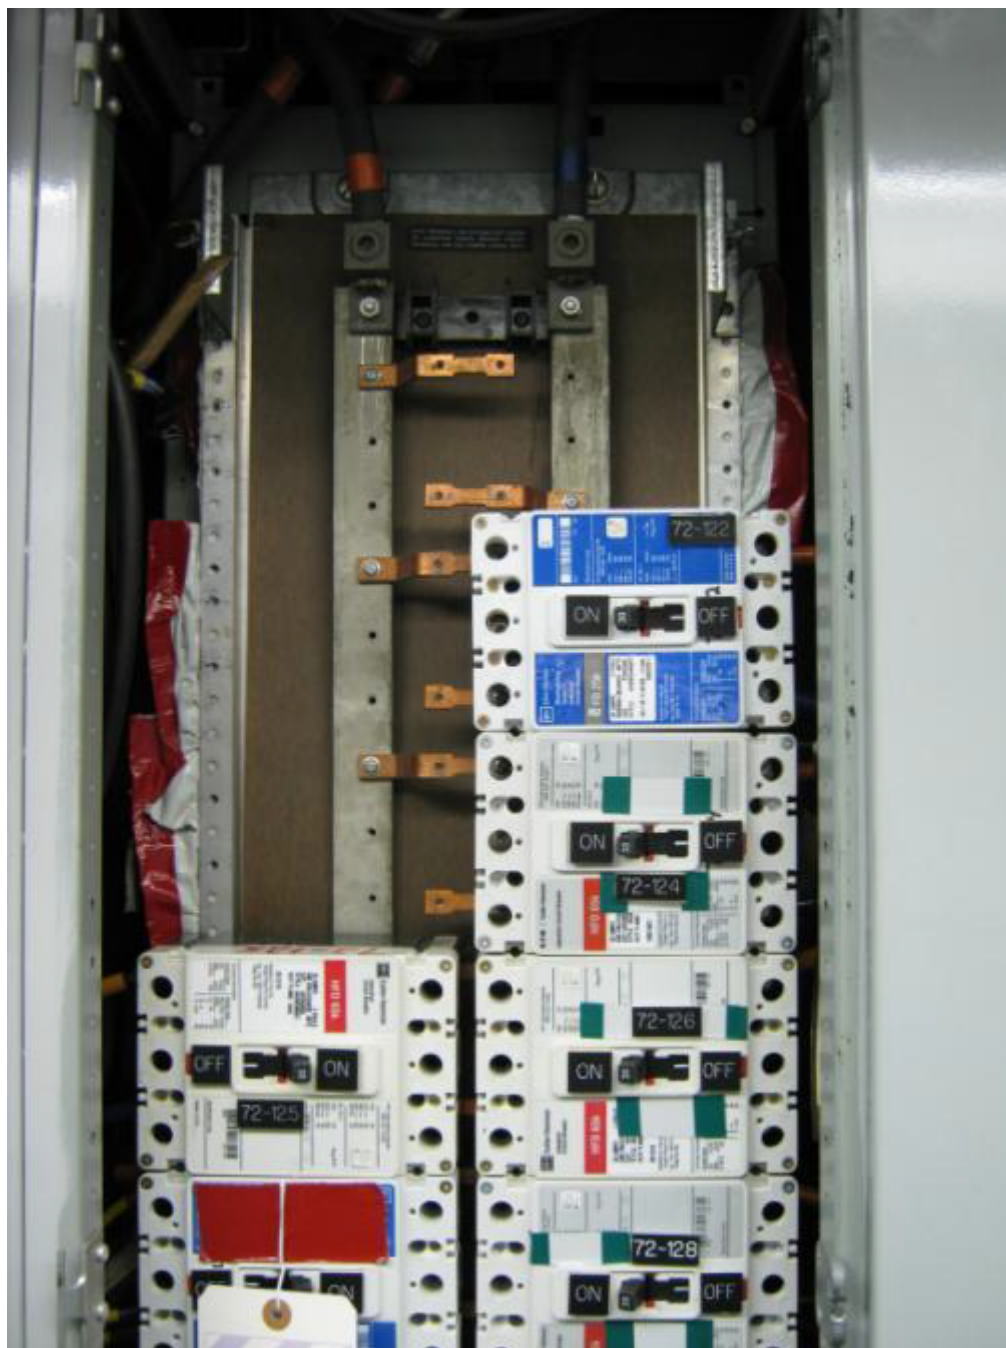
FIGURE 6

DC DISTRIBUTION PANEL D11-2 WITH BREAKERS 72-119, 72-120, 72-121 AND 72-123 REMOVED

(Note that with all 4 breakers removed the positive horizontal bus bar (top left copper stab) and the negative horizontal bus bar (right copper stab) were not insulated.)

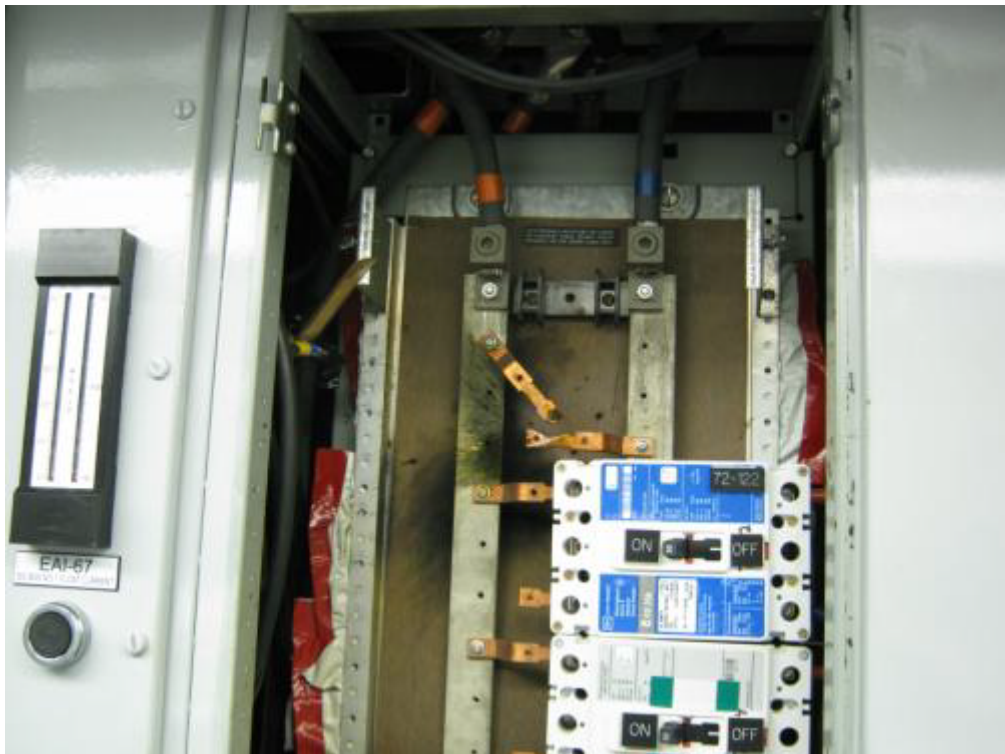
FIGURE 7 - DC DISTRIBUTION PANEL D11-2 IMMEDIATELY FOLLOWING THE ELECTRICAL FAULT

During the maintenance activities, a horizontal bus bar slipped out of an electrician's hand, causing an electrical fault and the loss of one of the two trains of DC power distribution (reference Figure 7 in Attachment 5 of the Enclosure). Each train was comprised of a set of batteries, two chargers, instrumentation, and two inverters (reference Figure 1 in Attachment 4 of the Enclosure). The inverters provided AC power to the preferred AC busses, which in turn provided power to approximately 50 percent of the control room indications and controls.

At approximately 3:06 p.m. on September 25, after initially loosening the screw for the horizontal bus bar, the worker saw a flash from the area of the screw. Upon seeing a flash, the worker's hands instinctively recoiled from the work area for personal protection, thereby letting go of the horizontal positive bus bar. The horizontal positive bus bar was loosened enough so that it rotated downward and contacted the negative bus bar causing a significant arc and melting of the bus bars (reference Figure 7 of Attachment 5). The worker was not injured during the incident because the appropriate protective clothing was worn.

(Note that when the positive bus bar, top left copper stab, was loosened and the electrician let go of it, the bus bar rotated down contacting the negative bus bar, which initiated the electrical fault on the left train 125-Volt DC system.)
