**Subject: November 2011 Inspection Report
Cameco Resources, Permits 603 & 633**

**PERMITS 603 & 633 INSPECTION REPORT
NOVEMBER 2011
DISTRICT 1/LAND QUALITY DIVISION**

COMPANY: Cameco Resources Incorporated

LOCATION: North of Glenrock, Converse County (Smith-Highland Ranch Uranium Project)

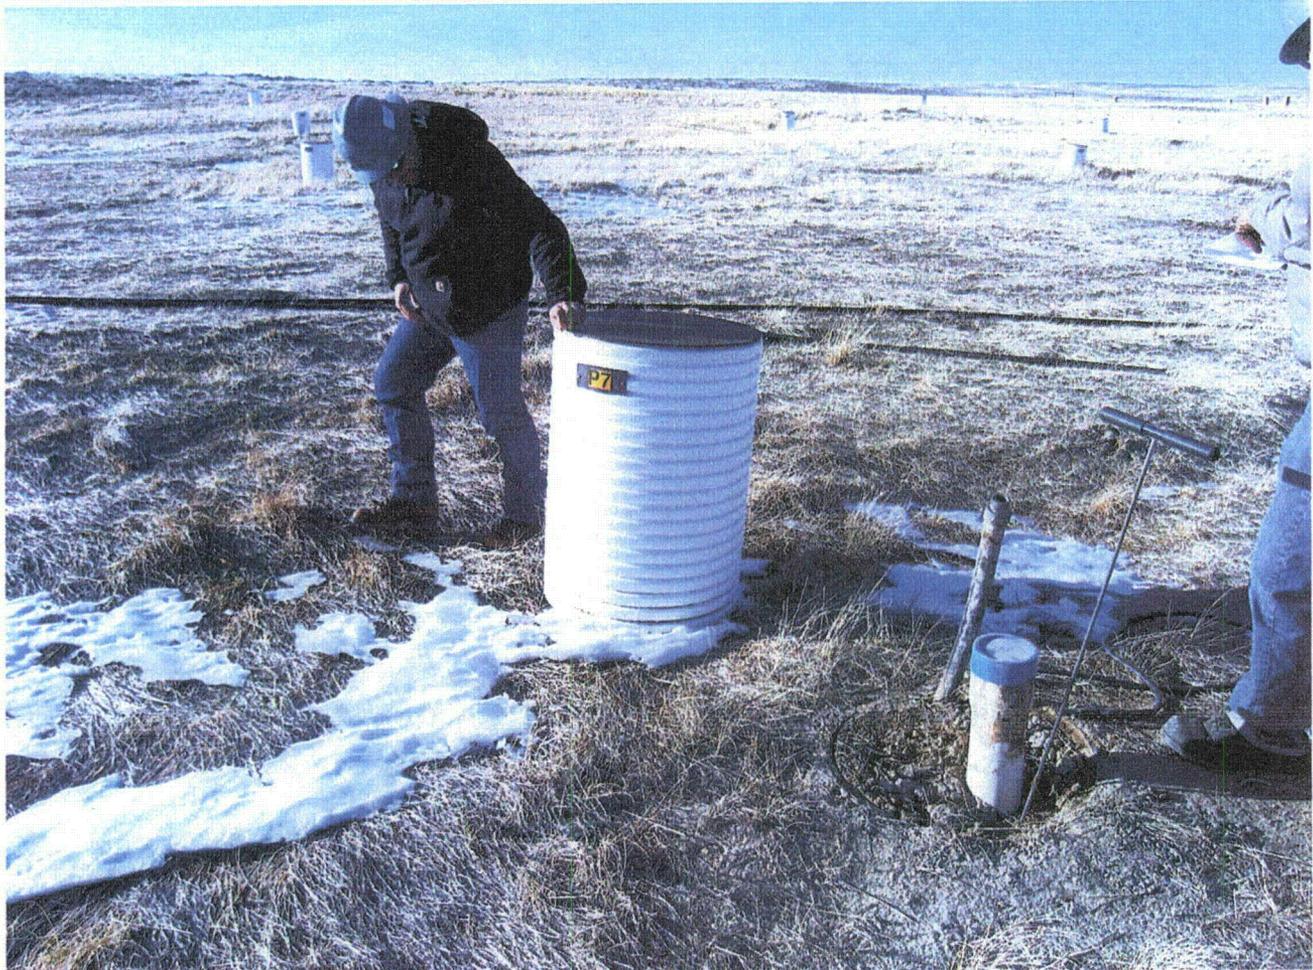
CR repaired seven wells in MU-K and provided notification to LQD with a letter received on October 7, 2011. According to Chapter 11, Section 8 (c), a repaired well must be retested within 120 days of the repair. A review of the MIT retest records was conducted and a site inspection of the repaired wells was completed. The records review indicated the failed MITs were the result of calcification in the well joints leading to damaged and/or failed casing. The repaired wells were noted to have the casing cemented to the surface (**Figure 1**).

Figure 1 Soil probe inserted and stopped at depth (approximately 3") to concrete seal at repaired well in MU-K

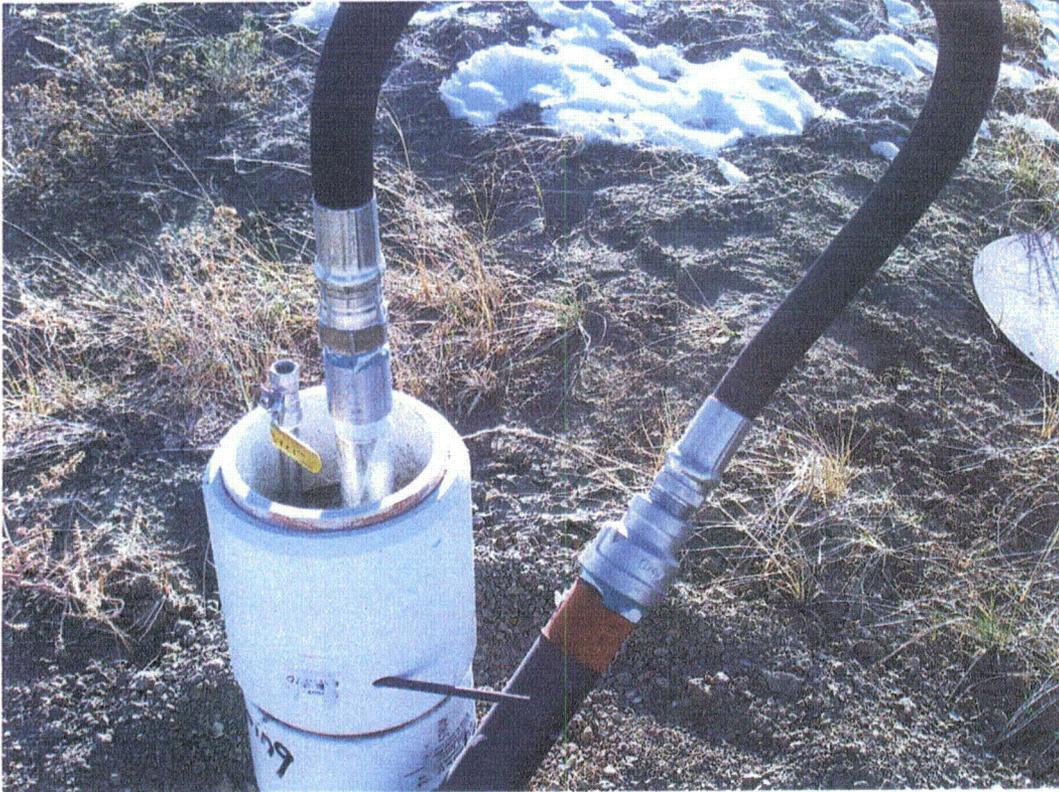
The wells were not in use at the time of the inspection as CR was waiting for LQD authorization. The coupling had been replaced on well EI-287A (**Figure 2**). CR will be abandoning holes in multiple wellfields that had not been previously abandoned. Surety coverage was added for all wells installed at the HUP and SR mines to cover wells previously thought to have been adequately abandoned. The surety increase for MU-E abandoned wells is included in the recently approved 2009-2010 Annual Report surety increase. The instrument was provided to LQD on October 20, 2011.

Figure 2 Replaced cracked coupling at EI-287A

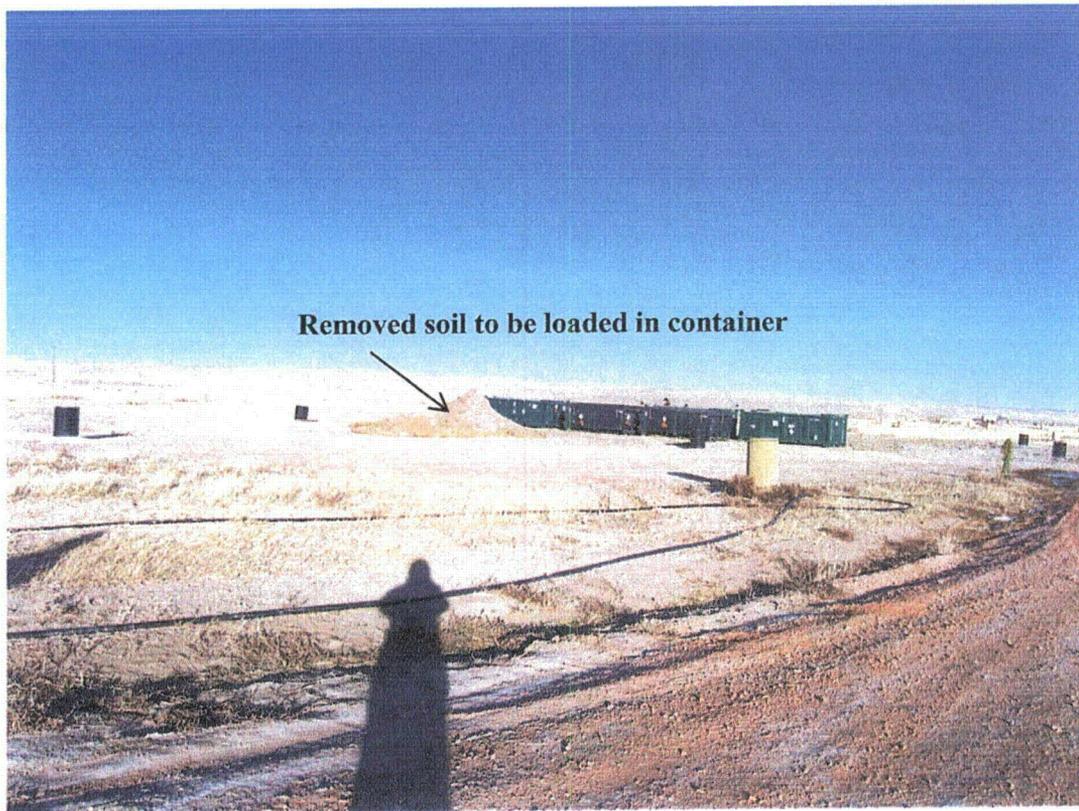
The clean-up of the spill has progressed with the removal of a maximum depth of 4 inches of contaminated soil so far. The contaminated soils are stripped and loaded into steel freight containers and hauled to a facility in Utah that accepts 11e2 bi-product waste material. There have been approximately 17 containers filled with 10 hauled away (**Figure 3**). An additional 12 to 15 containers are estimated to be needed for additional soil removal. The turn-around time for hauling the material appears to be causing minor delays in the project. It is not anticipated that the stripping depth will need to go much further.

Figure 3 Soil cleanup at HH-15-20

There are no compliance items that require immediate action. Please notify the LQD when the soil clean-up is complete and prior to re-seeding the Mine Unit 15, Header House 20 spill area. LQD would like to evaluate the clean-up using CRs equipment (scintilometer) and the condition of the soils for revegetation.

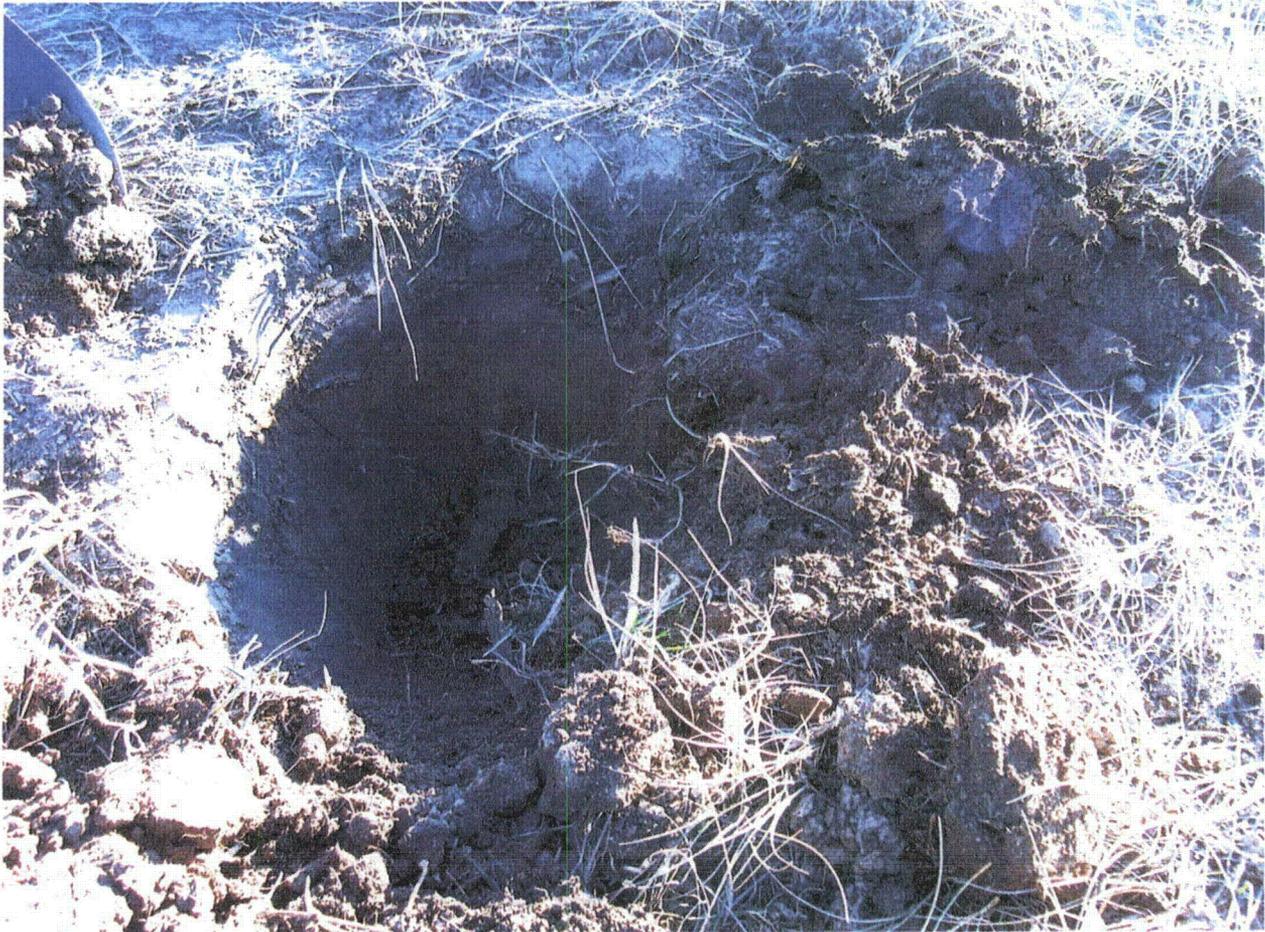
A shallow hole was dug to expose the soil profile to approximately six inches (**Figure 4**). Good organics were noted in the top one to two inches followed by a sandy loam below.

Figure 4 Excavation of soil in the clean-up area of HH-15-20
