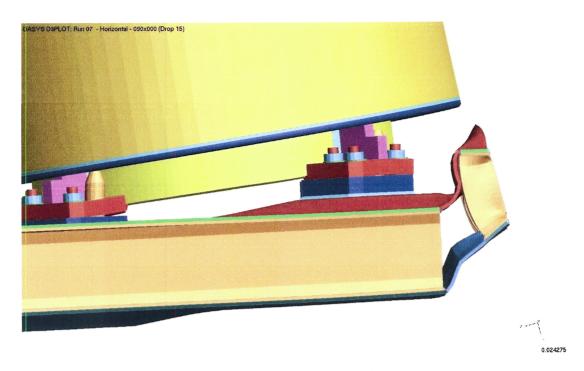
Figure 21: Pallet after 9m side drop (modelled)

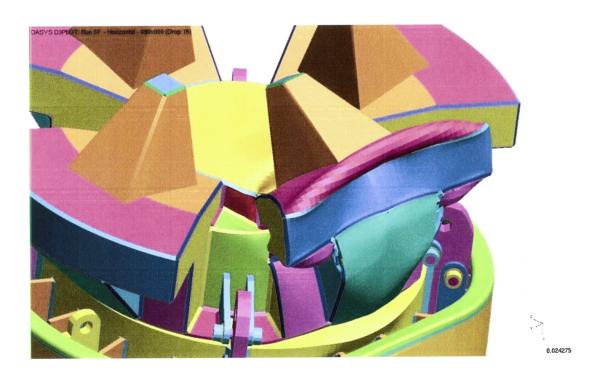
Figure 22: Top shield after 9m side drop (modelled)

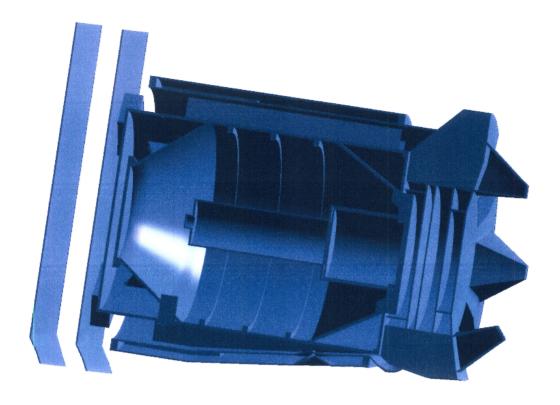
Figure 23: Thermal model (half section) showing 9m side drop damage

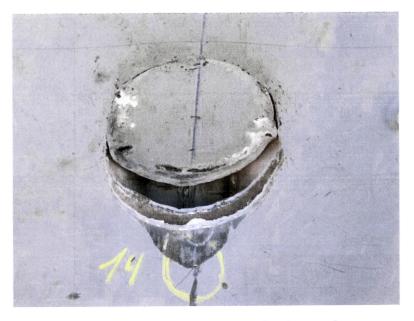
Punch damage (see Figs 24-27) consisted primarily of partial penetration of both jacket plates on a 150mm diameter (see RTR 248 & IR 0675). The new jacket design incorporates reinforcement in the area around the drain plug to prevent penetration so the damage was therefore modelled in an unreinforced area where it could still affect the drain plug, i.e. in the same fin channel and still aimed at the centre gravity but angled 25 degrees above the horizontal instead of 25 degrees below it. The actual deformation was modelled as realistically as possible (Fig 28).

Figure 24: Partial penetration of jacket after 1m punch

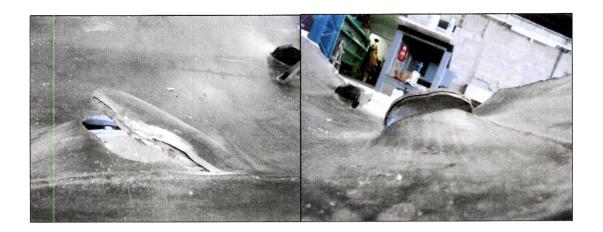
Figure 25: Shearing of jacket outer and inner skins from angled side punch

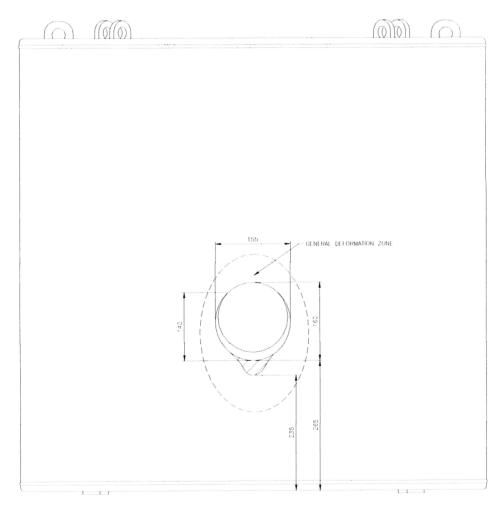
Figure 26: Punch penetration
