UNITED STATES
NUCLEAR REGULATORY COMMISSION
REGION IV
612 EAST LAMAR BLVD, SUITE 400
ARLINGTON, TEXAS 76011-4125

Subject: COLUMBIA GENERATING STATION - NRC SPECIAL INSPECTION REPORT
05000397/2011008

Enclosure:
NRC Inspection Report 05000397/2011008
w/ Attachment: Supplemental Information

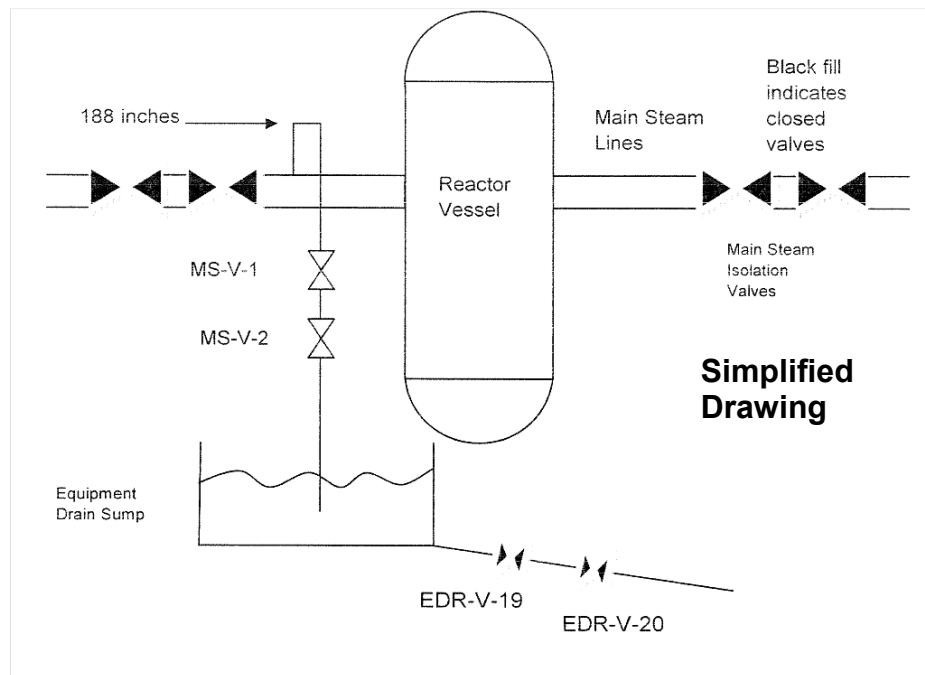
1. **April 11, loss of 4000 gallons through two main-steam drain valves during vessel fill:**

From May 5 to 6, 2007, operators were filling the reactor vessel to prepare to remove the reactor vessel head. Operators failed to close main steam line drain valves MS-V-1 and MS-V-2 during the fill evolution. The failure to take effective corrective measures for this event led to the subsequent loss of inventory event described below. Both events were discussed previously in NRC Inspection Report 05000397/2011003. An inadequate procedure contributed to both events.

During this inspection, the team asked a senior reactor operator about the configuration control of valves MS-V-1 and MS-V-2 during past outages. Since the same procedure was used during those outages, it was unclear why the same loss of inventory did not occur during each outage. The operator stated that more experienced operators were in the control room during prior outages and knew that they needed to close the two valves prior to exceeding a certain level. The operators did not write condition reports to document the deficient procedure. This was a missed opportunity to correct the problem earlier. The failure to correct the procedure before proceeding was inconsistent with Procedure OI-9, Step 13.2.4.

1. April 11 event – operators inadvertently drained 4000 gallons of reactor coolant inventory through valves MS-V-1 and MS-V-2 to the equipment drain sump. Operators failed to follow OI-9 Steps 11.1 and 13.2.4, in that: 1) operators failed to know the status of plant equipment at all times; and 2) during prior outages, operators had failed to resolve procedure problems prior to commencing similar work.

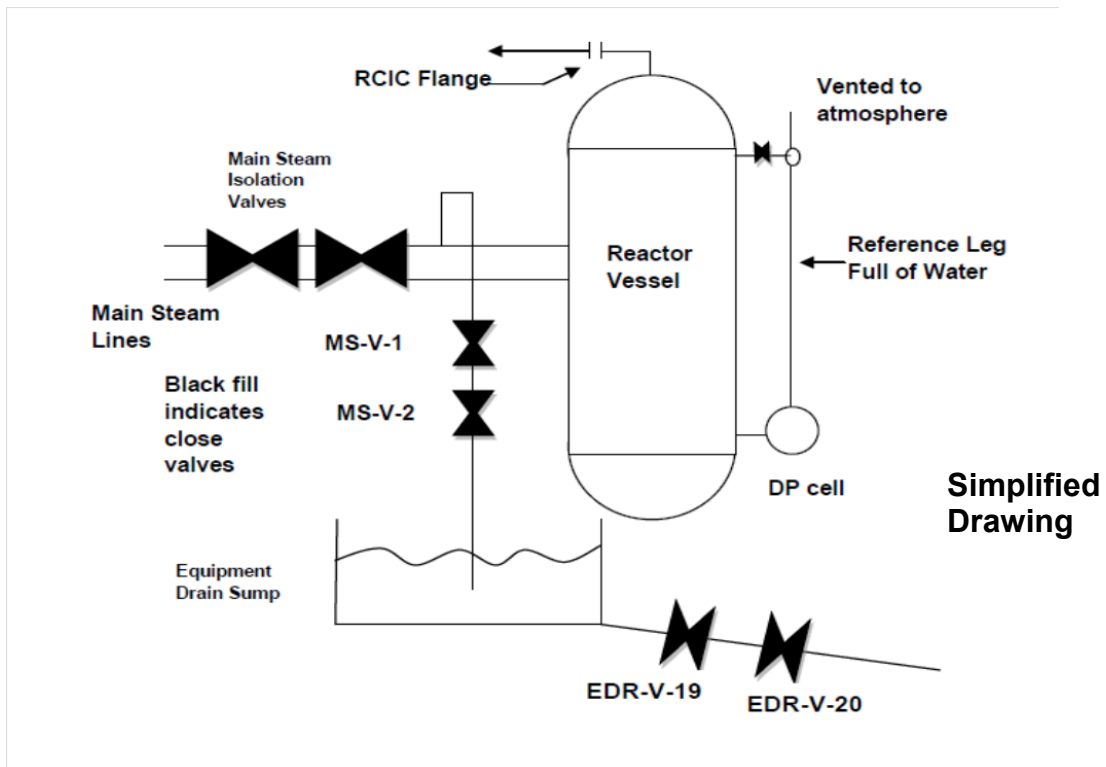
2. **July 28-30. loss of accurate reactor pressure vessel level indication for approximately 40 hours:**

- 3:15 p.m. While maintaining reactor vessel level constant, operators identified a flow mismatch between the control rod drive system and the reactor water cleanup system. As part of normal control rod drive operations, water will enter the reactor vessel. To maintain reactor vessel level constant, operators must drain water out of the reactor vessel through the reactor water cleanup system. The in-flow and out-flow should have been the same, but operators noted that less water was flowing through the reactor water cleanup letdown path. Operators suspected that water was leaking out through valves MS-V-1 and MS-V-2 to the equipment drain sump.

- 10:36 a.m. MS-V-1 was closed. Reactor vessel level indication started to slowly increase.
- 10:38 a.m. Operators noted that flow from the equipment drain sump decreased from approximately 30 gallons per minute to less than 1 gallon per minute. Operators had confirmed that water was leaking from the reactor vessel to the equipment drain sump through valves MS-V-1 and MS-V-2.

2. July 28 to 30 event - reactor vessel level instruments were inaccurate and operators inadvertently drained approximately 4300 gallons of water from the reactor vessel. Operators failed to follow OI-9 Steps 4.2.2, 11.1, 11.2.1, and 13.2.5 because 1) operators did not understand the task and were not aware of the expected results prior to proceeding; 2) operators did not know the status of plant equipment at all times; 3) operators used verbal instructions to control work, versus procedures, work orders or tags; and 4) operators failed to stop the activity when the procedure was found to be inadequate or unclear and failed to correct the procedure prior to proceeding. In addition, during past outages, operators had worked around the deficient procedure and had failed to get it changed.

1. Revision of the noted procedures to provide appropriate direction. The procedures were revised to require that an alternate vent path be provided prior to closing the reactor core isolation cooling system head flange.
 2. Create a new system operating procedure for reactor shutdown level control strategies.
- “Loss of Reactor Protection System Channel B and Automatic Isolation of Shutdown Cooling,” dated 10/31/2011
 1. Columbia Generating Station did not take a proactive approach to replacing the older style logic boards.

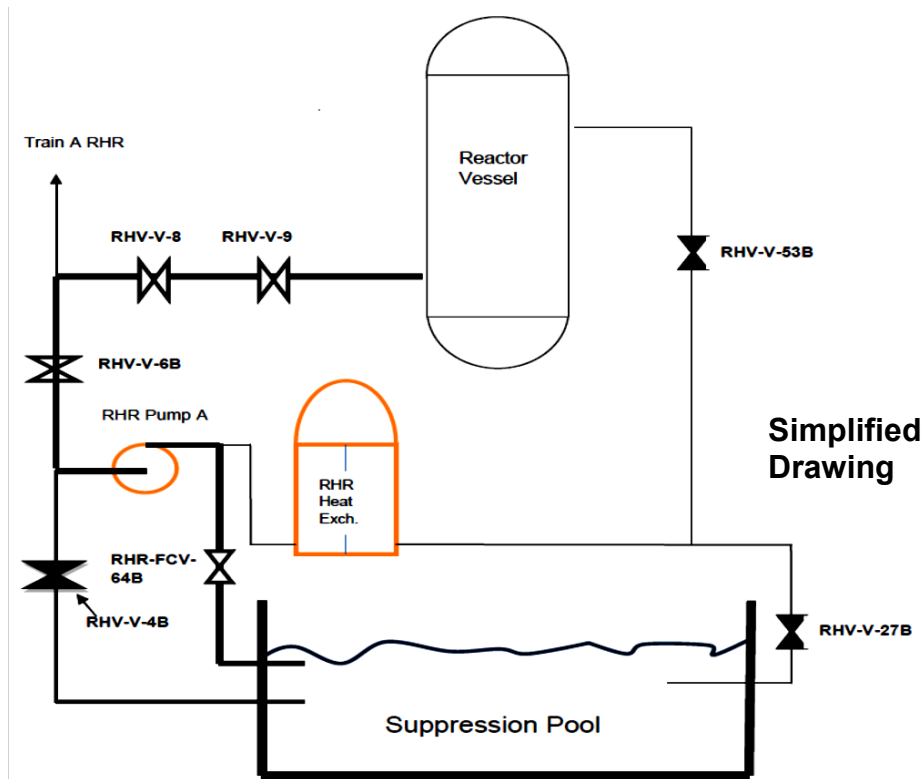
3. September 10, loss of reactor pressure vessel inventory to the suppression pool through the residual heat removal minimum flow valve:

The operator failed to implement Procedure SOP-RHR-STBY, Step 5.2.1, which specified, in part:

3. September 10 event - operators failed to follow procedures and drained reactor coolant to the suppression pool. Operators failed to follow OI-9 Step 18.2.9.c and Section 14, in that: 1) operators started work prior to conducting a pre-job brief; and 2) the peer check for the evolution did not perform an adequate peer check.

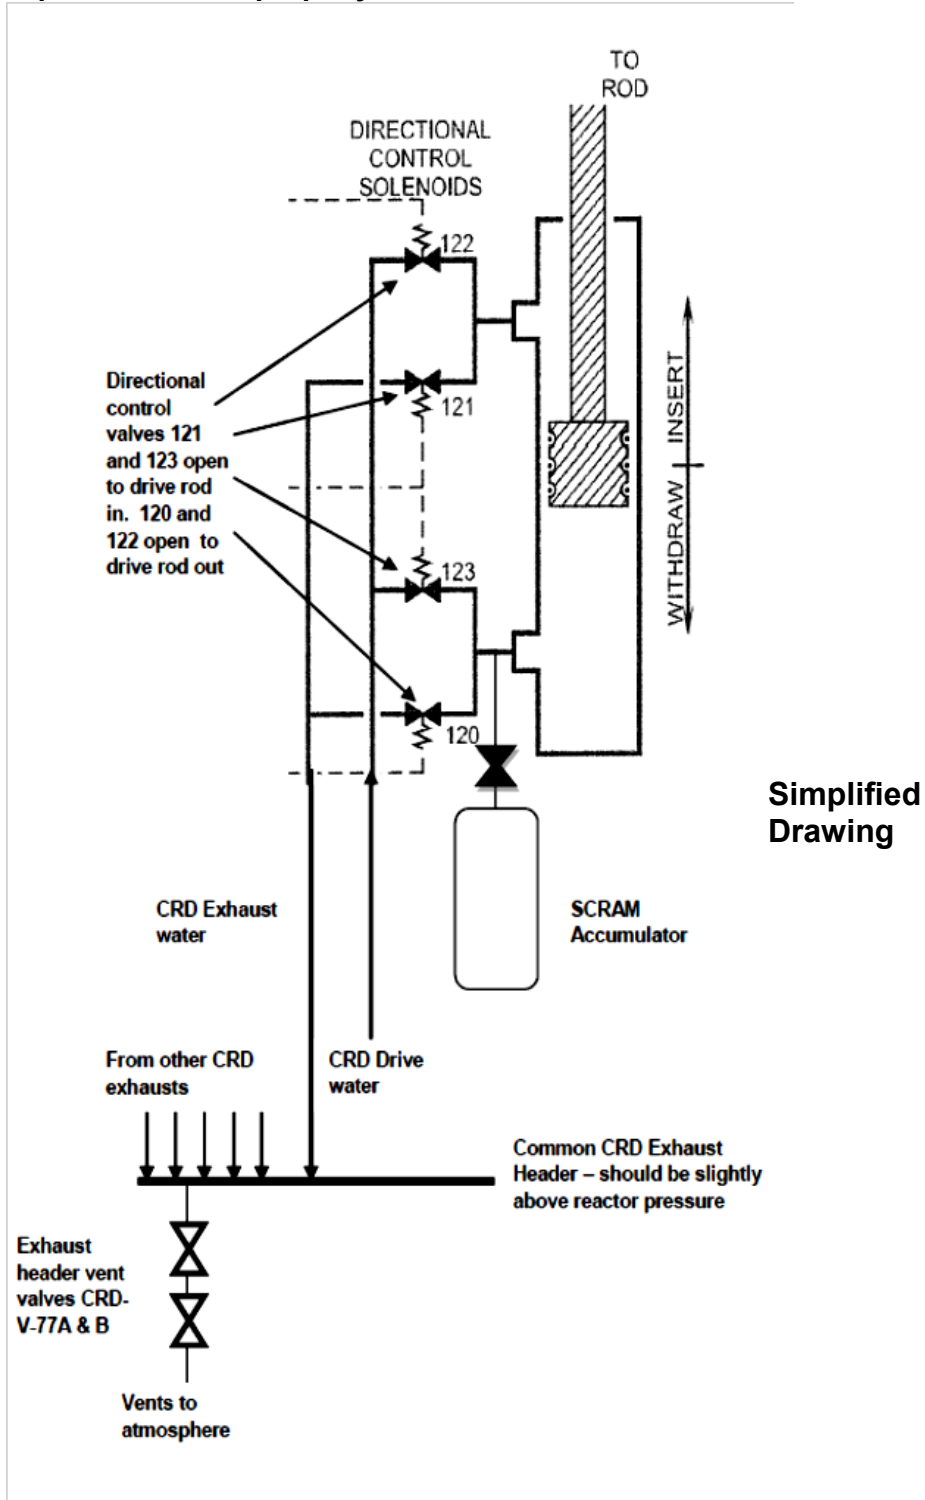
4. Sept 15, failure to properly coordinate control rod drive surveillances:

This step was initiated by a reactor operator as complete. Contrary to this requirement, the operator did not adequately review the open surveillance log or the clearance order log for potential conflicts. Operators had improperly assumed that, because they were performing a reactor hydrostatic test, the control rod drive system had been restored to its normal valve lineup.

Note: The NRC team determined that, at the time of the control rod malfunction, postmaintenance testing on control rod drive 14-51 was already satisfactorily completed. Based on this, it was not reasonable for the operators to have assumed that the control rod malfunction was caused by the directional control valve maintenance. Further, no directional control valve problem could have caused this control rod to insert rapidly into the core in response to a manual insert signal.

In response to the control rod 18-51 malfunctions, operators determined that a potentially generic problem existed and they started to look for the problem. Operators then discovered that the valves to the control rod drive exhaust header were in the improper configuration.
