UNITED STATES
NUCLEAR REGULATORY COMMISSION
REGION IV
612 EAST LAMAR BLVD, SUITE 400
ARLINGTON, TEXAS 76011-4125

Subject: COLUMBIA GENERATING STATION - NRC SPECIAL INSPECTION REPORT
05000397/2011008

Docket: 50-397
License: NPF-21

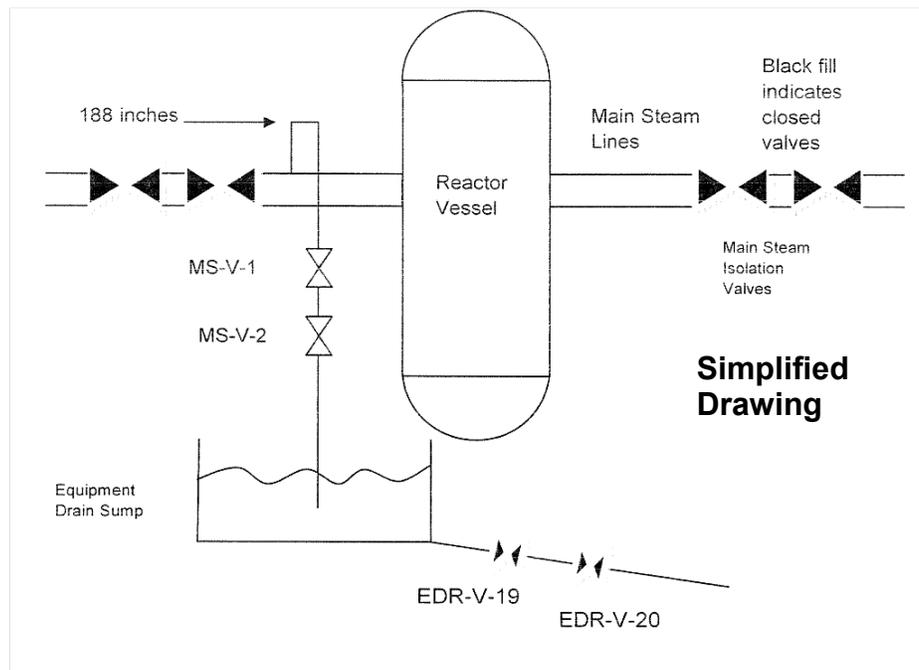
1. **April 11, loss of 4000 gallons through two main-steam drain valves during vessel fill:**

Background: Reactor vessel level instruments are provided in the control room. During shutdown conditions, operators typically monitor the shutdown range level instruments as well as temporary refueling outage level instruments. The zero reference point is approximately 168 inches above the top of active fuel. During power operations, the normal vessel level is approximately +36 inches (204 inches above the top of reactor fuel). If main steam valves MS-V-1 and MS-V-2 are open, water can start to flow to the equipment drain sump when reactor vessel level is at +188 inches or higher.

From May 5 to 6, 2007, operators were filling the reactor vessel to prepare to remove the reactor vessel head. Operators failed to close main steam line drain valves MS-V-1 and MS-V-2 during the fill evolution. The failure to take effective corrective measures for this event led to the subsequent loss of inventory event described below. Both events were discussed previously in NRC Inspection Report 05000397/2011003. An inadequate procedure contributed to both events.

1. April 11 event – operators inadvertently drained 4000 gallons of reactor coolant inventory through valves MS-V-1 and MS-V-2 to the equipment drain sump. Operators failed to follow OI-9 Steps 11.1 and 13.2.4, in that: 1) operators failed to know the status of plant equipment at all times; and 2) during prior outages, operators had failed to resolve procedure problems prior to commencing similar work.

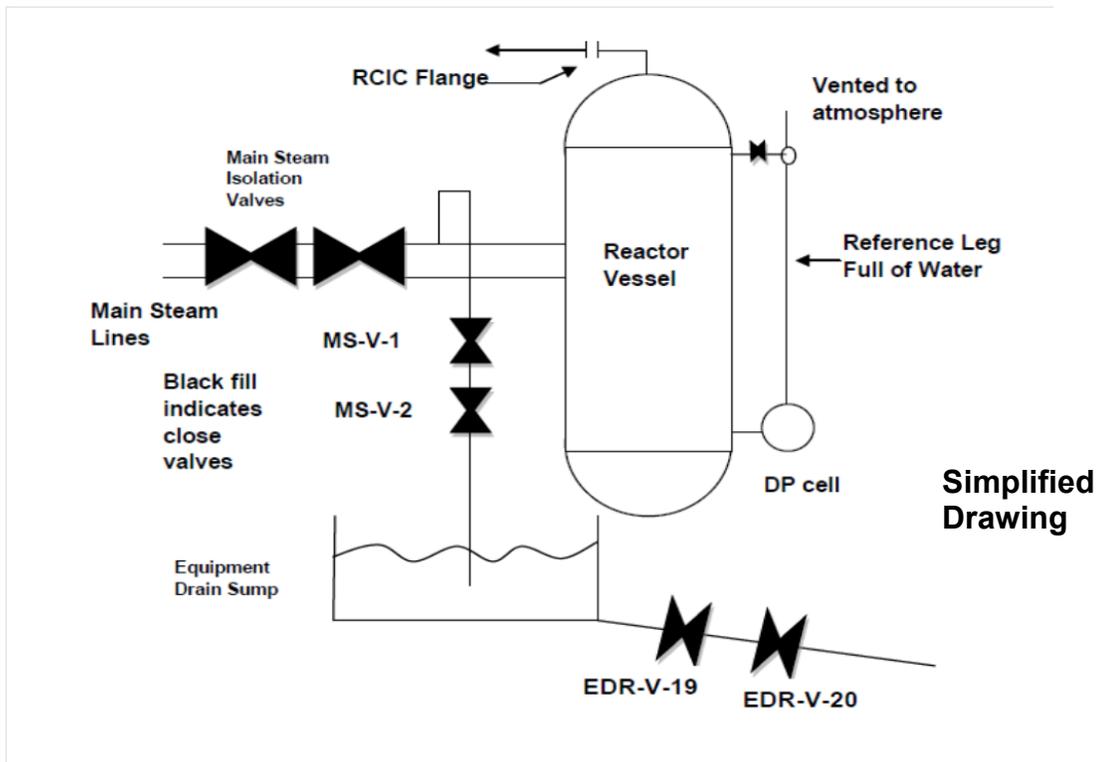
2. **July 28-30. loss of accurate reactor pressure vessel level indication for approximately 40 hours:**

Background: Reactor vessel level instruments include a reference leg (filled with water at all times), a variable leg (the water in the reactor vessel), a differential pressure

sensor that measures the pressure difference between the two legs, and level indicators in the control room.

- 3:15 p.m. While maintaining reactor vessel level constant, operators identified a flow mismatch between the control rod drive system and the reactor water cleanup system. As part of normal control rod drive operations, water will enter the reactor vessel. To maintain reactor vessel level constant, operators must drain water out of the reactor vessel through the reactor water cleanup system. The in-flow and out-flow should have been the same, but operators noted that less water was flowing through the reactor water cleanup letdown path. Operators suspected that water was leaking out through valves MS-V-1 and MS-V-2 to the equipment drain sump.

- 10:36 a.m. MS-V-1 was closed. Reactor vessel level indication started to slowly increase.
- 10:38 a.m. Operators noted that flow from the equipment drain sump decreased from approximately 30 gallons per minute to less than 1 gallon per minute. Operators had confirmed that water was leaking from the reactor vessel to the equipment drain sump through valves MS-V-1 and MS-V-2.

2. July 28 to 30 event - reactor vessel level instruments were inaccurate and operators inadvertently drained approximately 4300 gallons of water from the reactor vessel. Operators failed to follow OI-9 Steps 4.2.2, 11.1, 11.2.1, and 13.2.5 because 1) operators did not understand the task and were not aware of the expected results prior to proceeding; 2) operators did not know the status of plant equipment at all times; 3) operators used verbal instructions to control work, versus procedures, work orders or tags; and 4) operators failed to stop the activity when the procedure was found to be inadequate or unclear and failed to correct the procedure prior to proceeding. In addition, during past outages, operators had worked around the deficient procedure and had failed to get it changed.

1. Revision of the noted procedures to provide appropriate direction. The procedures were revised to require that an alternate vent path be provided prior to closing the reactor core isolation cooling system head flange.
 2. Create a new system operating procedure for reactor shutdown level control strategies.
- “Loss of Reactor Protection System Channel B and Automatic Isolation of Shutdown Cooling,” dated 10/31/2011
 1. Columbia Generating Station did not take a proactive approach to replacing the older style logic boards.

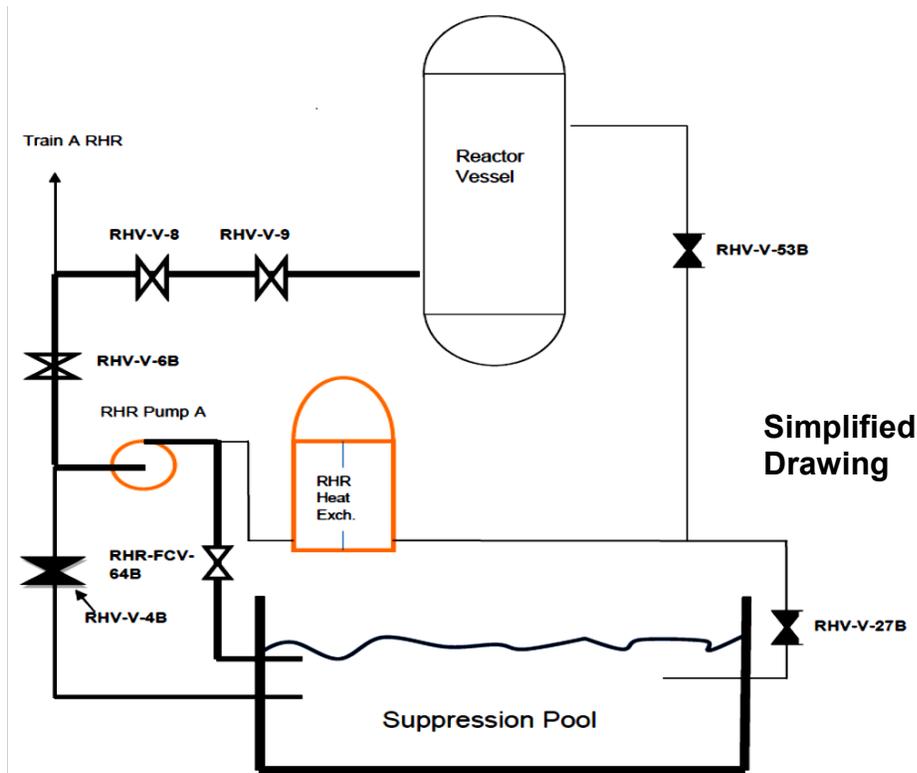
3. September 10, loss of reactor pressure vessel inventory to the suppression pool through the residual heat removal minimum flow valve:

- 8:45 a.m. The shift supervisor briefed the control room crew on swapping trains of shutdown cooling from train B to train A.
- 9:21 a.m. Operators completed the shutdown cooling train swap.

The operator failed to implement Procedure SOP-RHR-STBY, Step 5.2.1, which specified, in part:

3. September 10 event - operators failed to follow procedures and drained reactor coolant to the suppression pool. Operators failed to follow OI-9 Step 18.2.9.c and Section 14, in that: 1) operators started work prior to conducting a pre-job brief; and 2) the peer check for the evolution did not perform an adequate peer check.

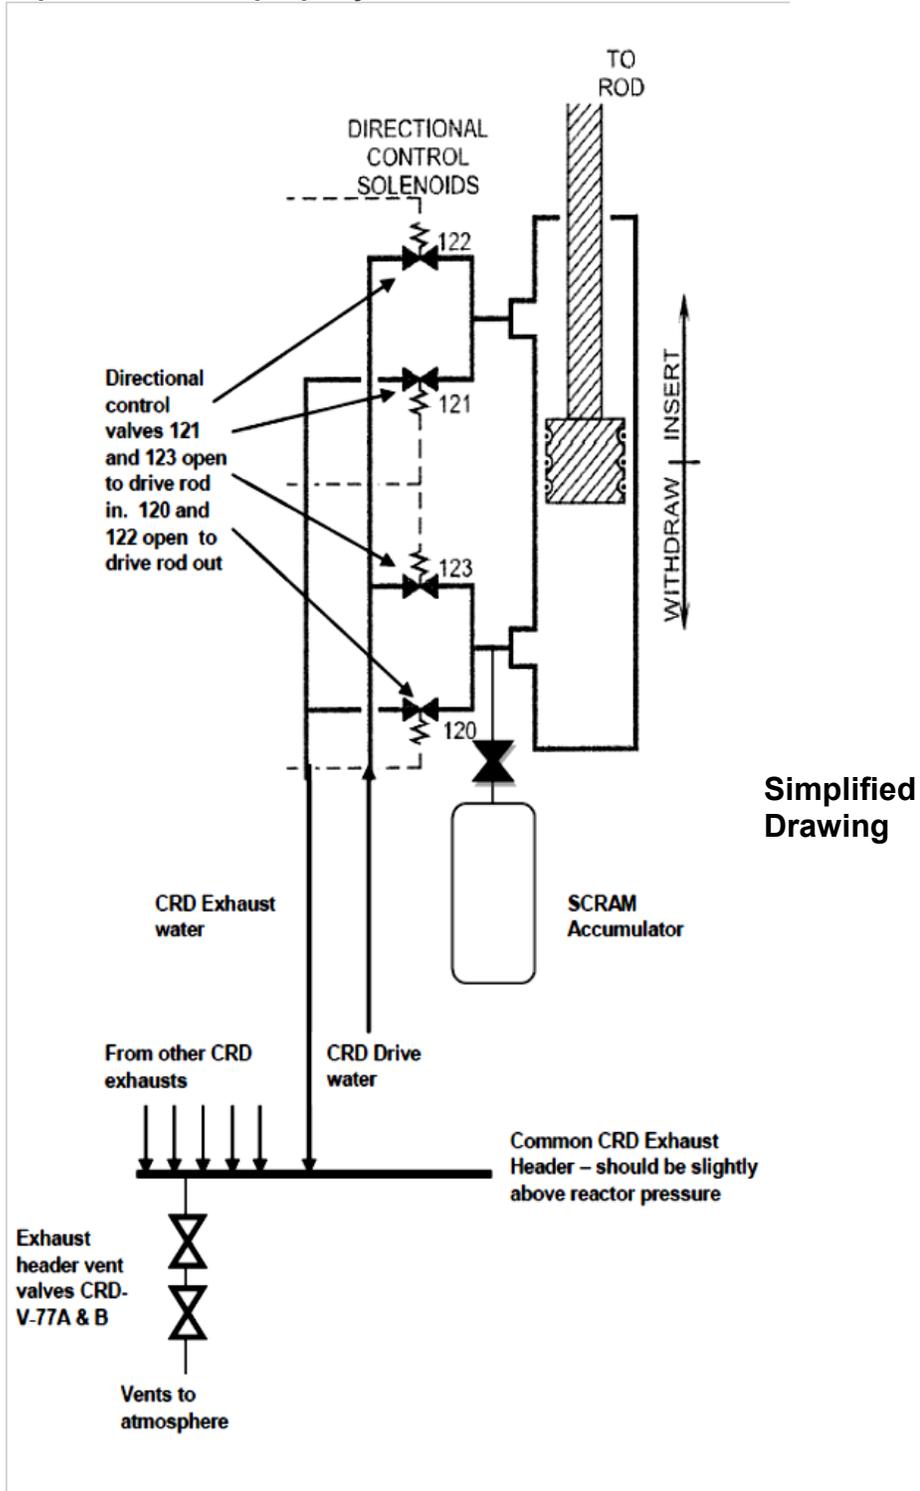
4. Sept 15, failure to properly coordinate control rod drive surveillances:

The reactor was shutdown and depressurized. Maintenance personnel had replaced all of the hydraulic control unit directional control valves during the outage. Each of the 185 hydraulic control units had four of these valves. The hydraulic control units move the control rods in and out of the core. Operators can move control rods out of the core using the control rod drive system manual pushbuttons. Control rods can be inserted manually, using the manual pushbuttons, or they can be scrammed, which is much faster. In response to safety signals, all control rods are simultaneously scrammed into the core and the reactor is shut down.

This step was initiated by a reactor operator as complete. Contrary to this requirement, the operator did not adequately review the open surveillance log or the clearance order log for potential conflicts. Operators had improperly assumed that, because they were performing a reactor hydrostatic test, the control rod drive system had been restored to its normal valve lineup.

Note: The NRC team determined that, at the time of the control rod malfunction, postmaintenance testing on control rod drive 14-51 was already satisfactorily completed. Based on this, it was not reasonable for the operators to have assumed that the control rod malfunction was caused by the directional control valve maintenance. Further, no directional control valve problem could have caused this control rod to insert rapidly into the core in response to a manual insert signal.

In response to the control rod 18-51 malfunctions, operators determined that a potentially generic problem existed and they started to look for the problem. Operators then discovered that the valves to the control rod drive exhaust header were in the improper configuration.
