UNITED STATES  
NUCLEAR REGULATORY COMMISSION  
OFFICE OF NUCLEAR REACTOR REGULATION  
WASHINGTON, D.C. 20555

March 12, 1991

NRC INFORMATION NOTICE NO. 91-19: STEAM GENERATOR FEEDWATER DISTRIBUTION  
PIPING DAMAGE

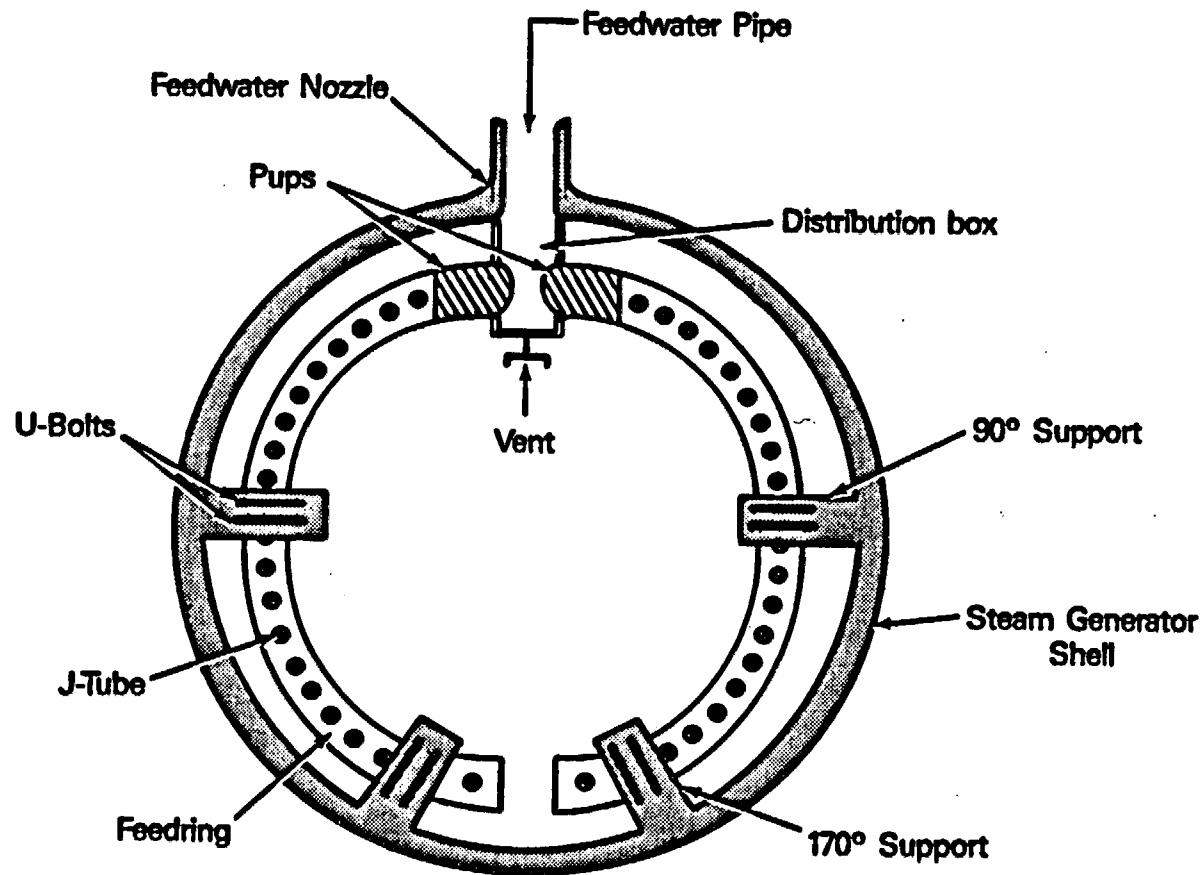
**Figure 1: Top View of the Feedwater Distribution Piping**

At San Onofre Units 2 and 3, both main feedwater and auxiliary feedwater enter the steam generators through a feedwater nozzle. The feedwater enters a distribution box and 12-inch diameter piping (feedring) that distributes the flow through top-mounted discharge elbows (J-tubes) around the periphery of the steam generator shell (Figure 1). The feedring is attached by two U-bolts at each of four supports that are welded to the shell wall. A 3-inch elbow and tee vent assembly is attached to the upper portion of the innermost (toward the interior of the steam generator) end of the distribution box (Figure 2).
