Ginna Reactor Vessel Bottom Mounted Instrumentation Paint Cracking Analysis

October 5, 2011

Written by: Maureen Kuchta
Maureen Kuchta,
Materials Lab, Engineering Programs

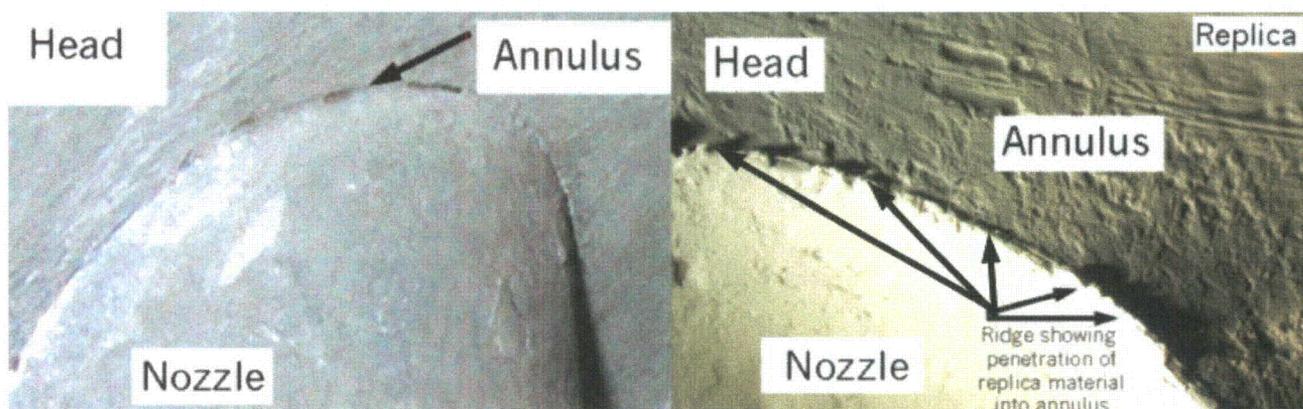
The replicas were taken at the annulus surface between the head and the nozzle. Figures 1a and 1b show images of an annulus compared to a silicone replica. The ridge of material between the head and nozzle is where the replica material penetrated into the annulus gap between the nozzle and head. This could not occur if paint were sealing that area.

Figure 1a
Optical Image of the Head, Annulus,
and Nozzle

Figure 1b
Replica of the Head, Annulus,
and Nozzle

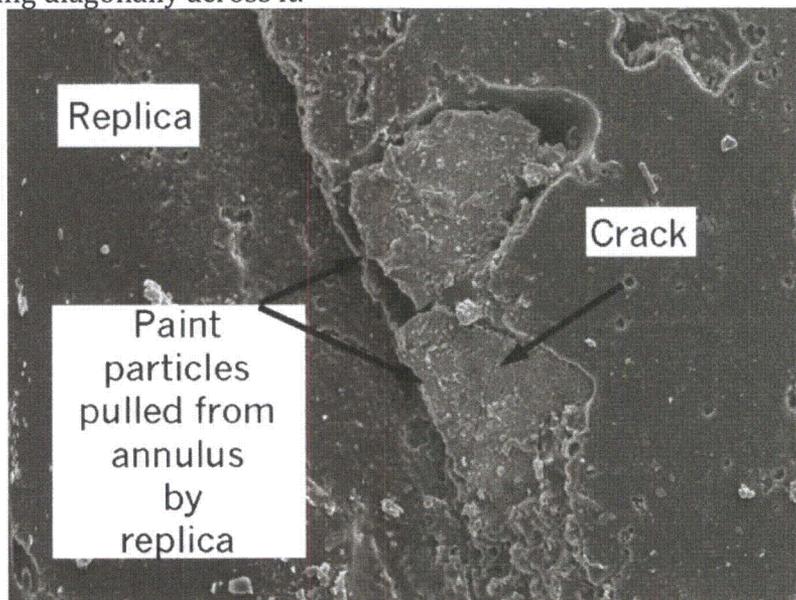
Figure 2 shows an electron microscope image of a replica from the annulus. Two approximately 0.5 mm paint particles pulled away from the metal and adhered to the replica material when it was removed from the annulus. It is likely that cracks in the paint reduced the paint adhesion to the metal. One of the chips has a second crack running diagonally across it.

Figure 2 Location 89-2 Magnification ~ 60x
SEM Image of a replica with paint chips imbedded

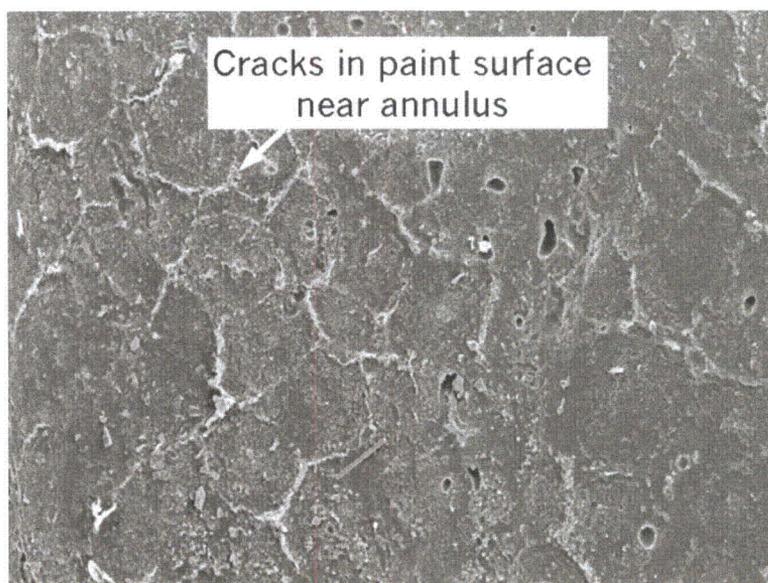
Figure 3 shows a SEM image of the replica of the cracked paint. The cracks show up as protrusions since the replica material penetrates into the cracks and produces an inverse image.

Figure 3 Location 77-1
Replica of Cracked Paint Surface ~ 20x Electron Microscope Image

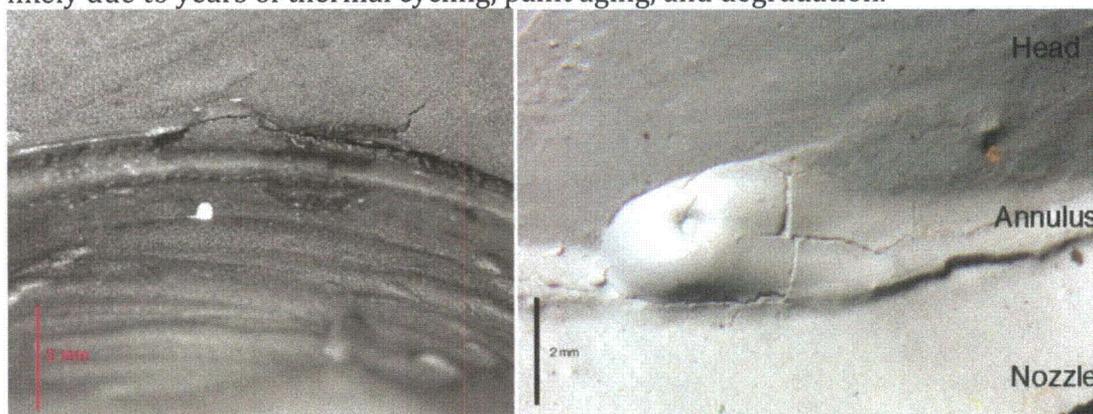
Figures 5a, 5b, 6a, and 6b show optical images of the cracks in the SwRi Mockup annulus compared to the Ginna 2011 annulus replica, Location 89-2. The SwRi mock-up paint cracked more often in a circumferential direction while the 2011 annulus replicas showed cracking in multiple directions. It is possible that some of the circumferential cracking occurred when the paint separated from the annulus during the leak testing. This would not be seen in the Ginna paint since no leakage has occurred. The frequent cracking seen in the Ginna paint and replicas is most likely due to years of thermal cycling, paint aging, and degradation.

SwRi Mockup
annulus with cracking after testing

Figure 5a
Optical image 10x

2011 Annulus Replica
showing paint cracking at annulus

Figure 5b
Optical Image of Replica 10x

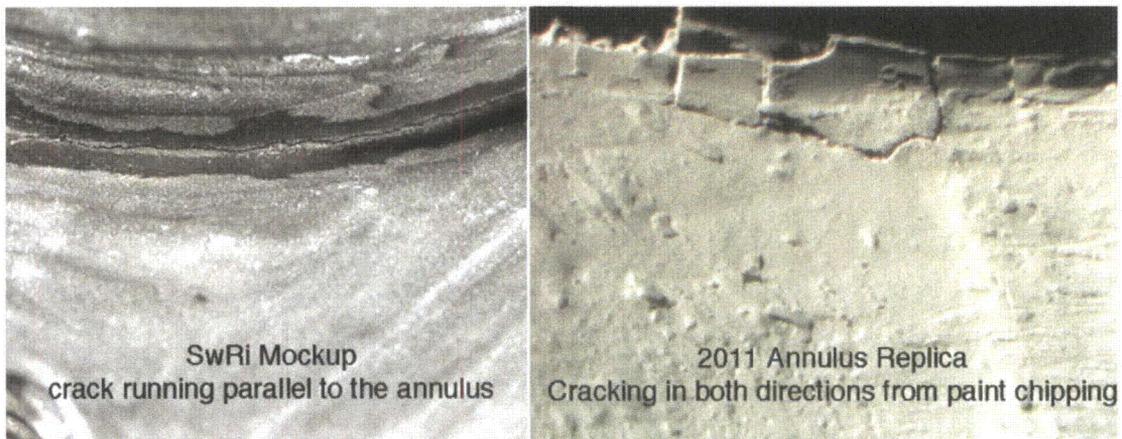
Figure 6a
SwRi Annulus with parallel crack

Figure 6b
2011 Annulus replica with paint micro cracking

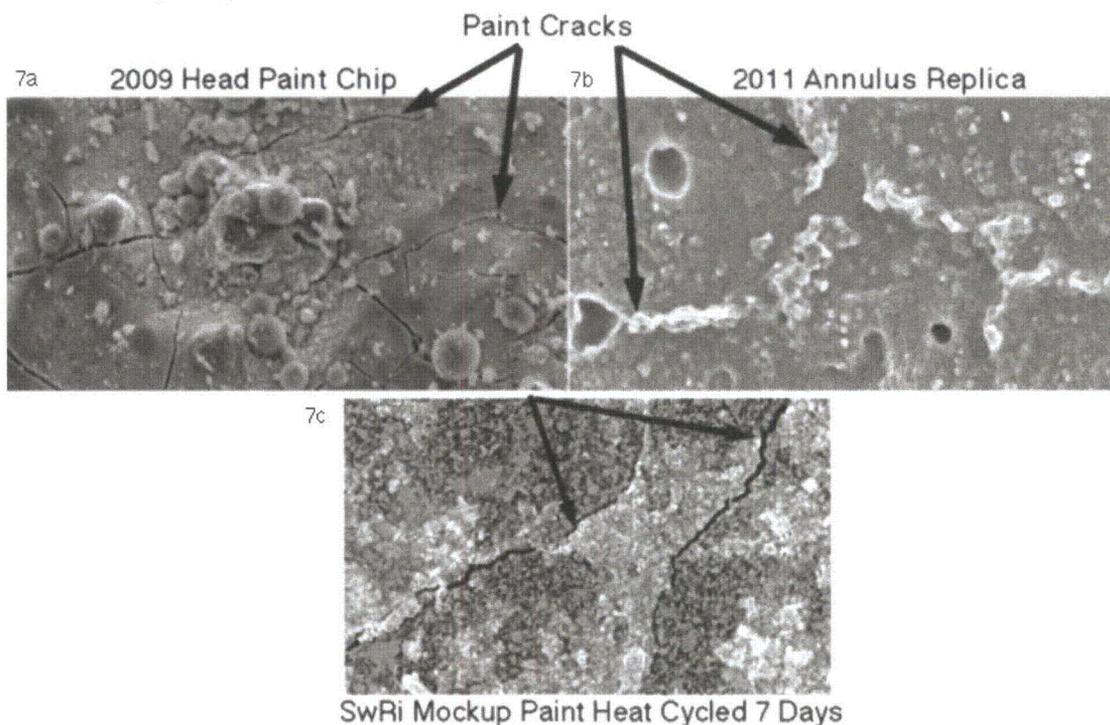
Figures 7a, 7b, and 7c Magnification 50x

At high magnification, microcracking was seen in both the 2009 head paint and the 2011 annulus replicas. No electron microscope images of the actual SwRi Mock-up test paint were available; however, coupon samples of the paint used in the SwRi mockups (Carboline 300 plus zinc) were cycled between room temperature and 350° F for 7 days. After 7 days cracking from thermal cycling was apparent.

Figure 7a, 7b, and 7c show electron microscope images of similar cracks in the 2009 head paint chip, the 2011 annulus paint replica, and the SwRi Carboline 300 paint after heat cycling.
