Subject: 10CFR21 Reporting of Defects and Non-Compliance -
Engine Systems, Inc. Report No. 10CFR21-0098, Rev. 3

Amot Thermostatic Valve Element
P/N: 9760X

Report No. 10CFR21-0098

10CFR21 REPORTING OF DEFECTS AND NON-COMPLIANCE

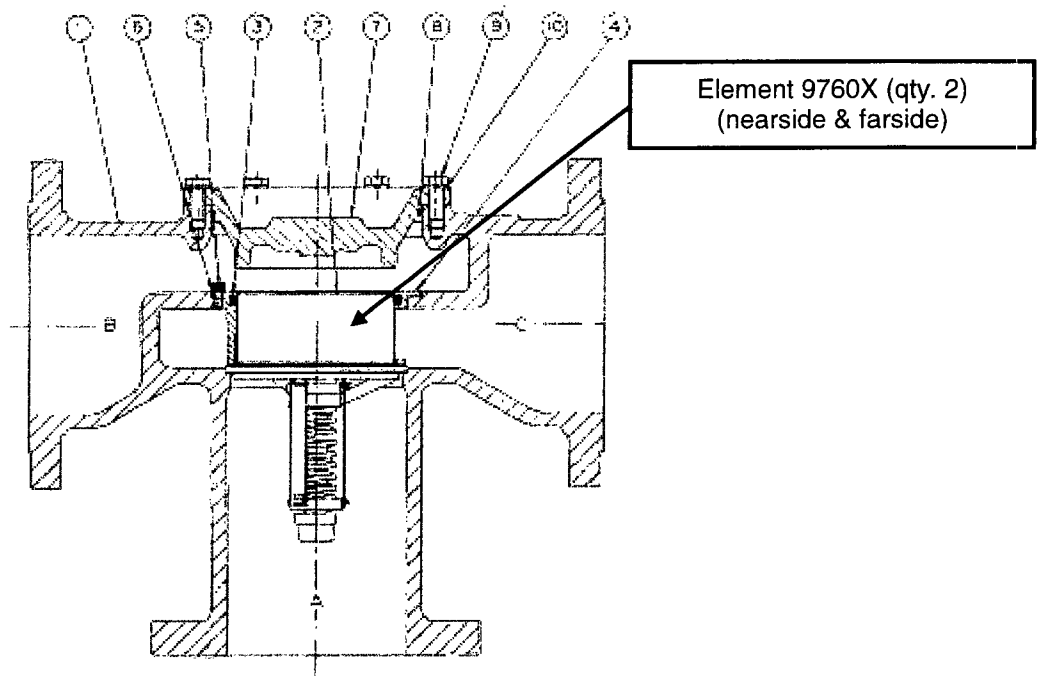
FIGURE 1: AMOT THERMOSTATIC VALVE

Each valve uses 2 thermostatic elements, Amot type 9760X (Figure 1). The elements investigated for the Palo Verde and STP applications have a nominal temperature setting of 160°F and therefore the element part number is 9760X-160.

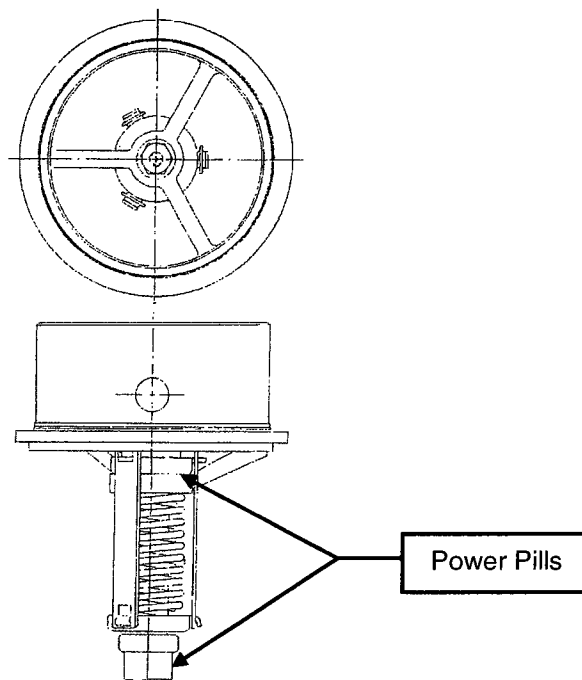
FIGURE 2: VALVE ELEMENT 9760X

- The element failure was attributed to wax leakage past the diaphragm seal on one of two power pills within the element. Evidence of mechanical binding of the piston is believed to have caused the wax leakage. If the piston was jammed, the expanding wax could have over-pressurized the diaphragm seal leading to wax leakage.

The 9760X element contains two power pills (Figure 2). The power pills contain a temperature sensitive wax that expands with increasing temperature and provides the motive force to lift the element off of its seat.

Users should return any 9760X elements in their inventory to ESI for inspection of machining debris. *Note: Elements shipped after March 16, 2011 by ESI are not suspect because additional inspection procedures were implemented at that time.*

Users with installed 9760X elements should continue to trend their EDG lube oil and/or cooling water system temperatures and monitor for any indication of thermostatic element problems. The thermostatic elements should be replaced at the first sign of increasing temperature trends.
