# Root Cause Evaluation Report

Service Water Pump 7-C Line Shaft Coupling Failure

CR-PLP-2011-03902, EVENT DATE: 08-09-2011

REPORT DATE: 09-08-2011, Rev. 0

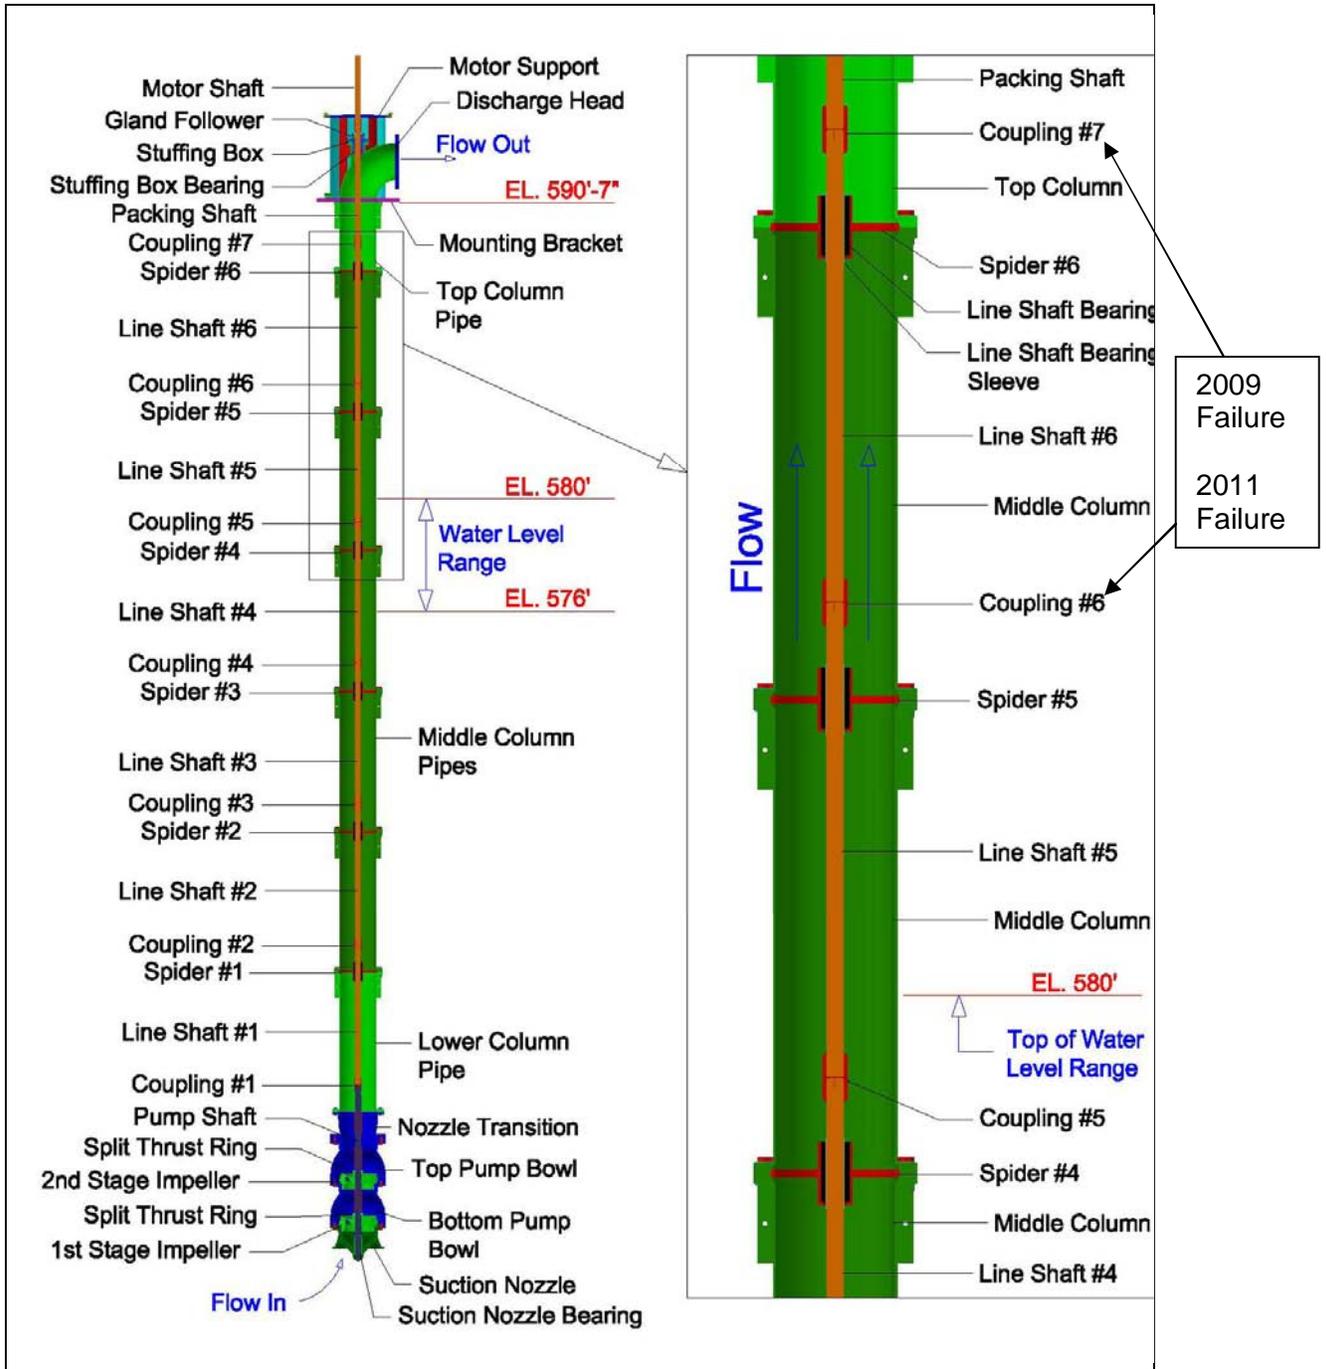
Figure 1: PLP SWP Rendering Showing 9/29/09 and 8/9/11 Coupling Failure Locations

Work to restore P-7C began immediately under WO #286627. During disassembly, it was determined that line shaft coupling #6 had failed. The failure of coupling #6 was similar in nature to the failure of coupling #7 in September, 2009. As can be seen in Figure #1 (page 4), couplings #6 and #7 are above the water line when the pump is not running. This means that when P-7C is in standby, coupling #6 and #7 have the chance to dry out. Coupling #5 may also be dry, depending on lake levels. As is discussed in the metallurgical analysis from LPI (Attachment V), surface deposits of contaminants were found in the area of the fracture surface. Energy Dispersive X-Ray Spectroscopy (EDS) was performed on the surface deposits which were determined to contain oxides, chlorides and sulfides.

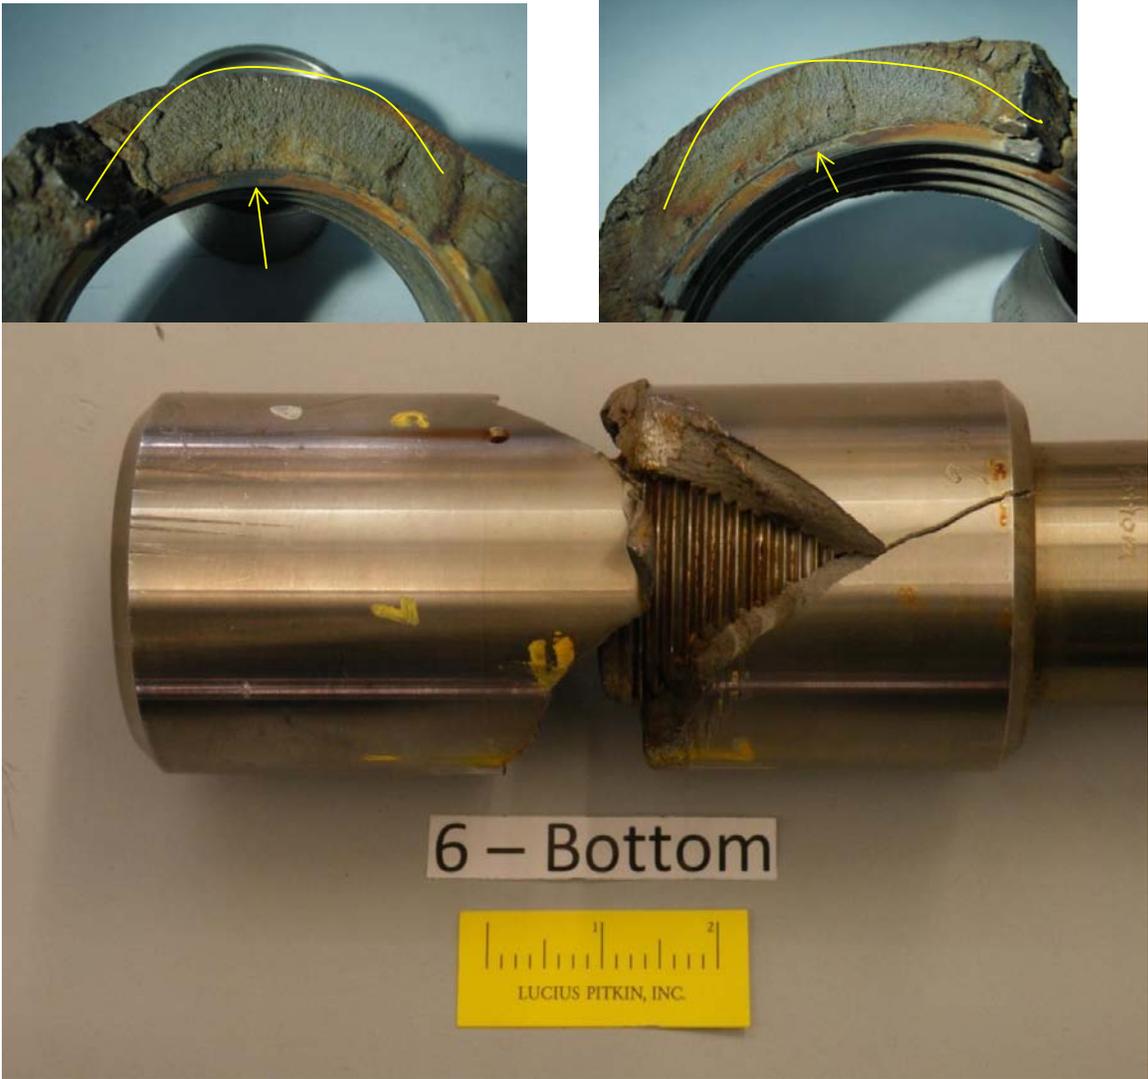
Figure 3: Failed Coupling #6 from P-7C Service Water Pump, Fracture Surfaces

Shown below is a picture of the failed coupling and a close up of the fracture surfaces. Coupling #6 is the second coupling below the stuffing box and is subject to wet/dry cycles.

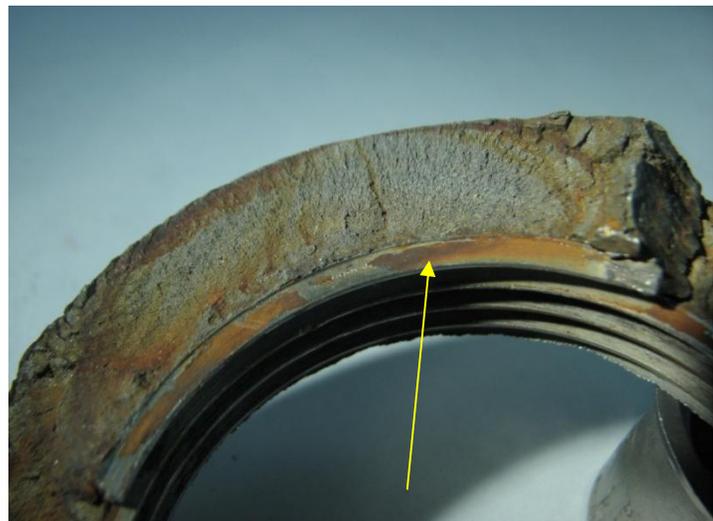
Fracture surface was removed from the bulk of the coupling for analysis.

Elliptical pattern of crack on flat fracture surface, relative to coupling axis. Also, red/brown corrosion

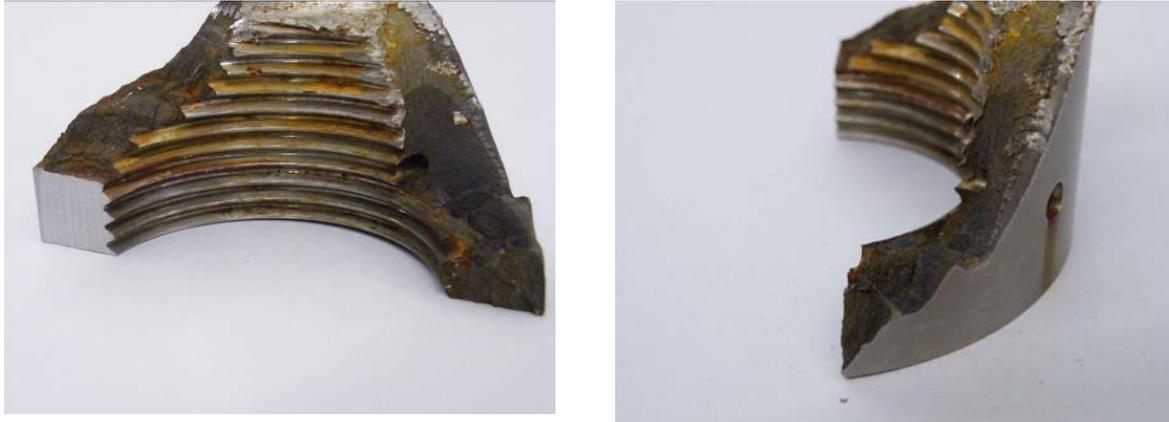
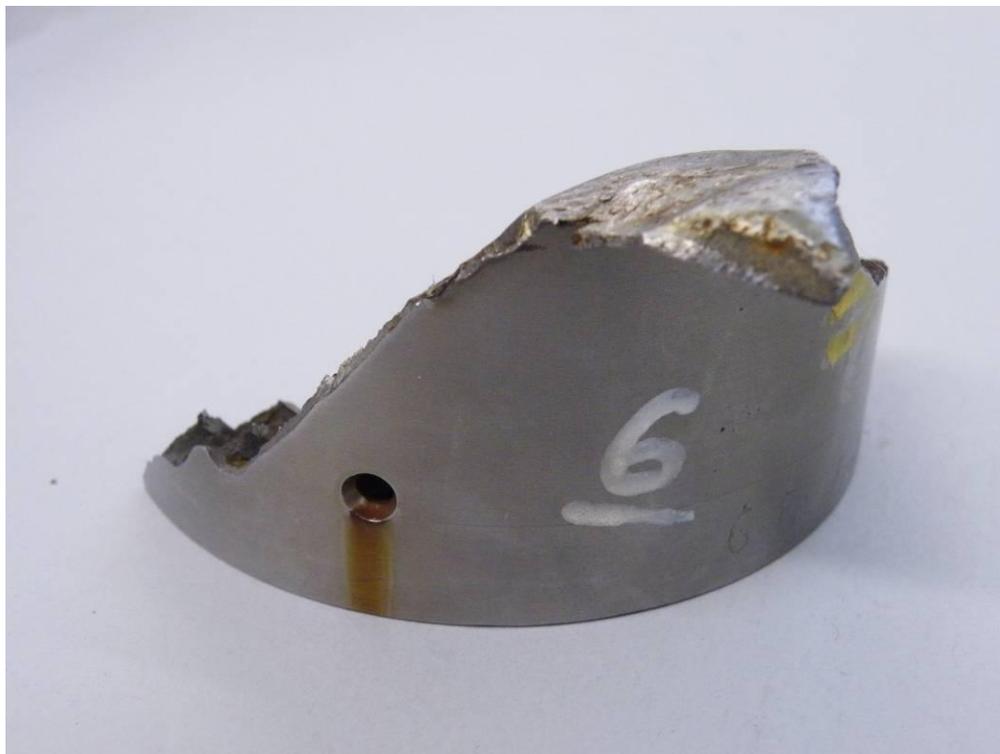
Figure 0-4: 11-P7C-6F showing Corrosion Deposit

Fractured end exhibited mechanical damage (arrow). product found on the insides of coupling threads (arrow)

Figure 0-3: Visual of Fracture Surface on Coupling 11-P7C-6F

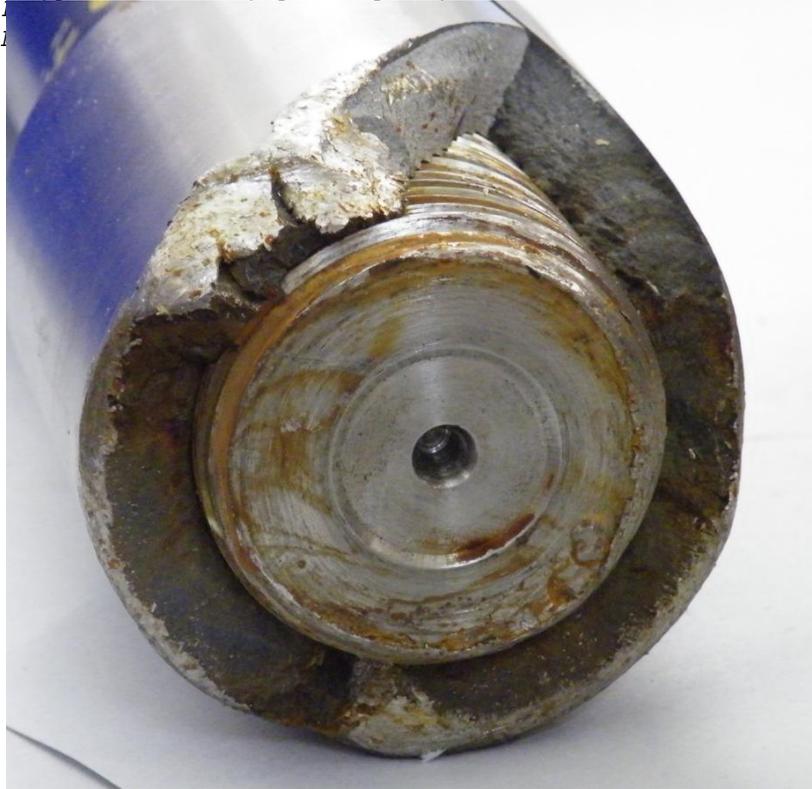
Half of coupling 11-P7C-6F remaining on shaft No. 6 exhibited damage on its fracture surface from contact with the mating coupling half and shaft 5, which occurred after fracture event.

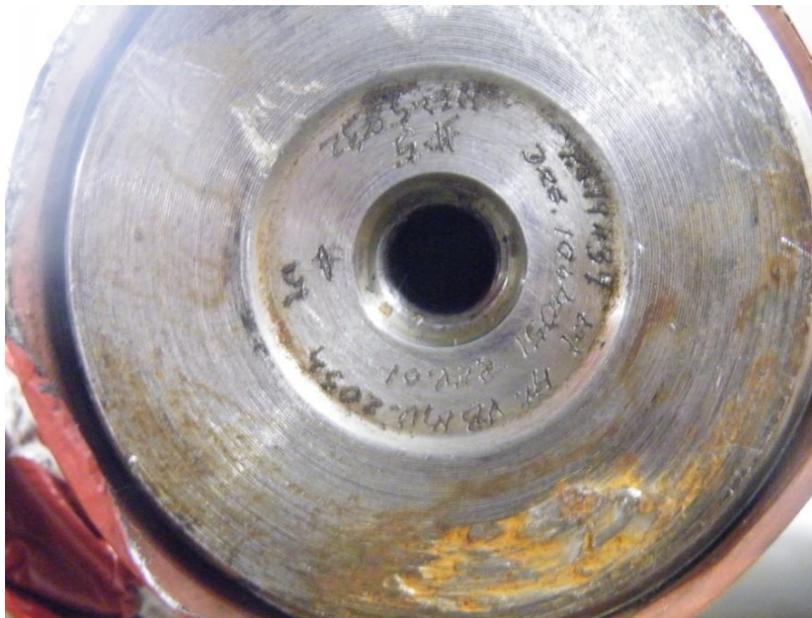
End of shaft No. 5 exhibited gouging damage post 11-P7C-6F final failure.

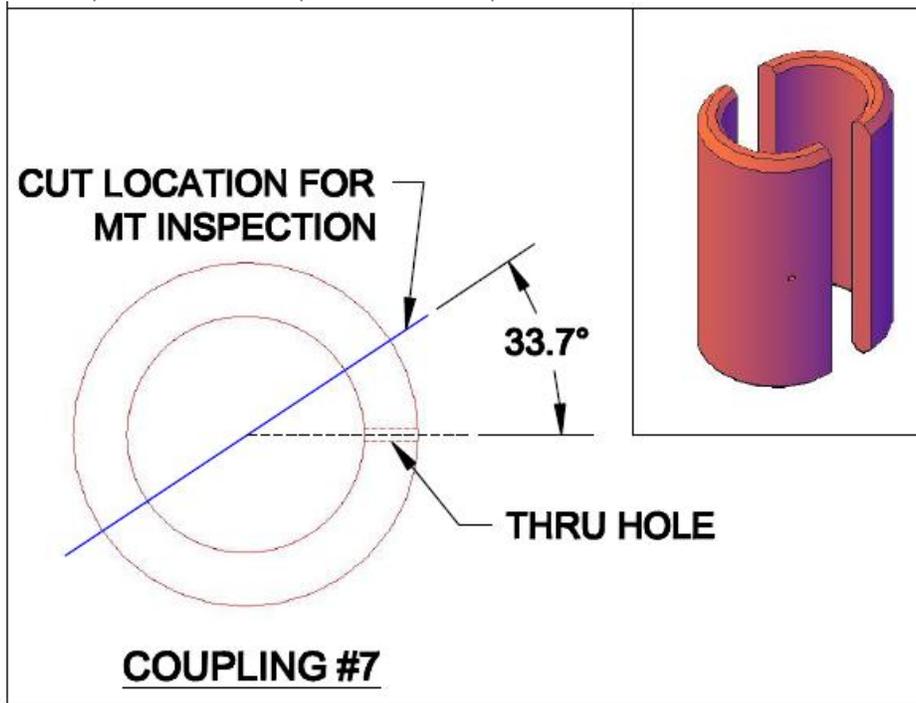
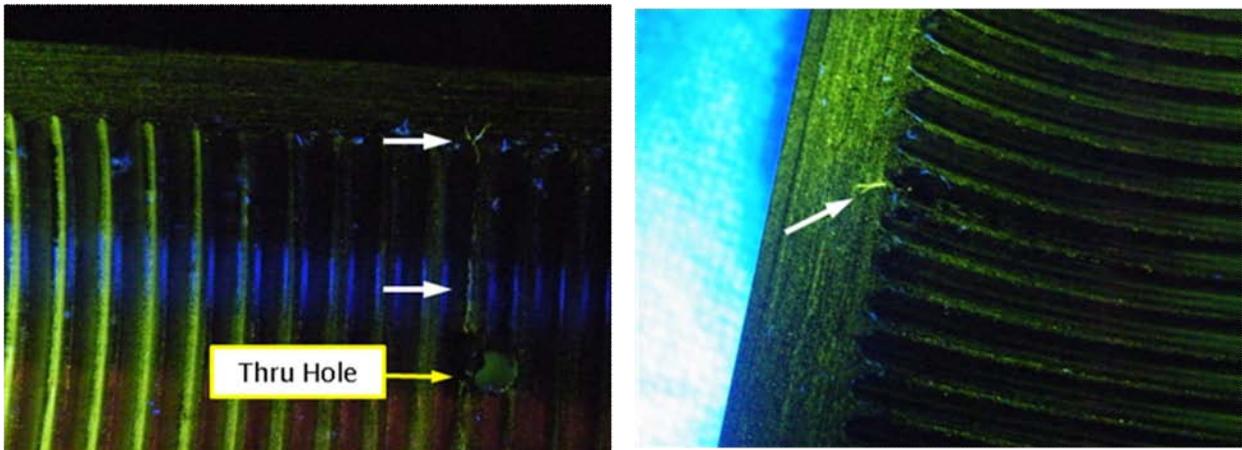
**Figure 0-7: MT Highlighting Crack on Coupling 11-P7C-7**

Top sketch show the cut line for coupling 11-P7C-7. Fluorescent MT examination of this coupling reveals an indication, shown by a well-defined fluorescent line, initiating from a thread root and propagating in the radial direction. The left and right images show the same indication on the two sections of this coupling after cutting in half longitudinally. Arrows show location of the indication.

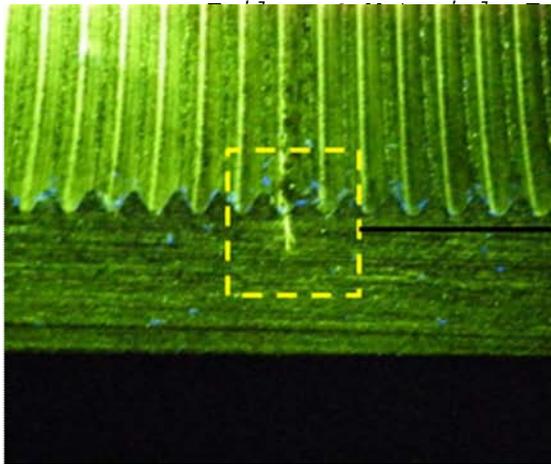
MT

Branched cracking, characteristic of stress corrosion cracking (SCC), initiated from a thread root

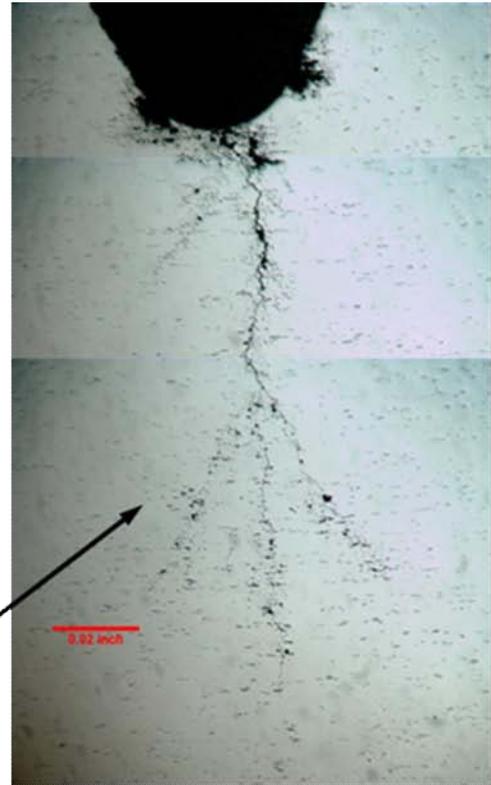
As Polished, 50 X

Branched cracking of the indication found in 11-P7C-7. Specimen in the as-polished condition and viewed at 50x.

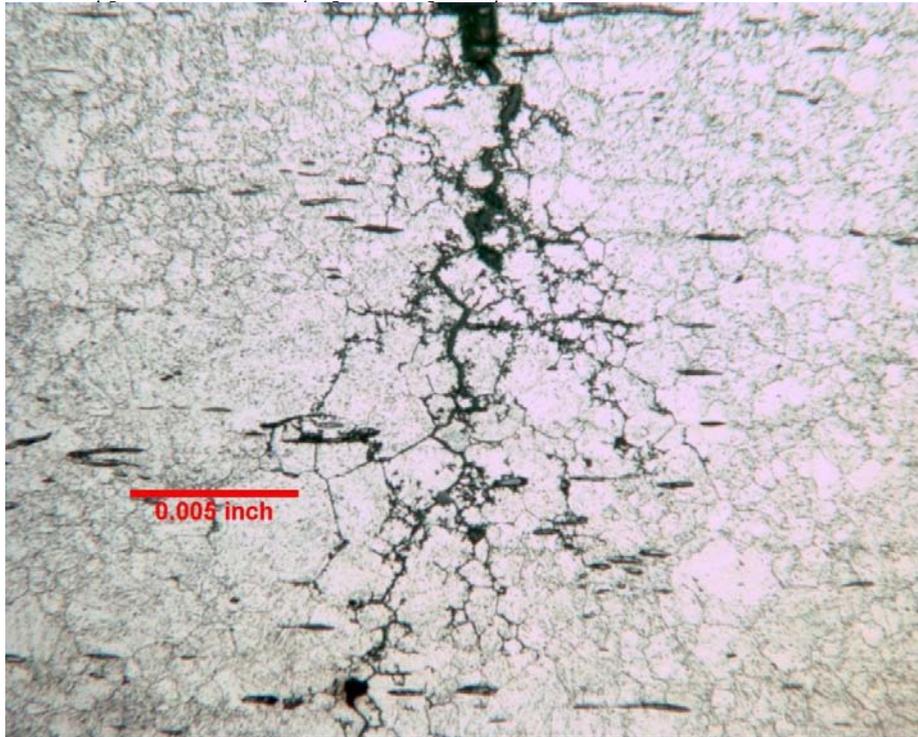
Etched specimen containing indication in coupling 11-P7C-7, showing microstructural features that reveal the intergranular nature of the branched cracking. Viewed at 200x.

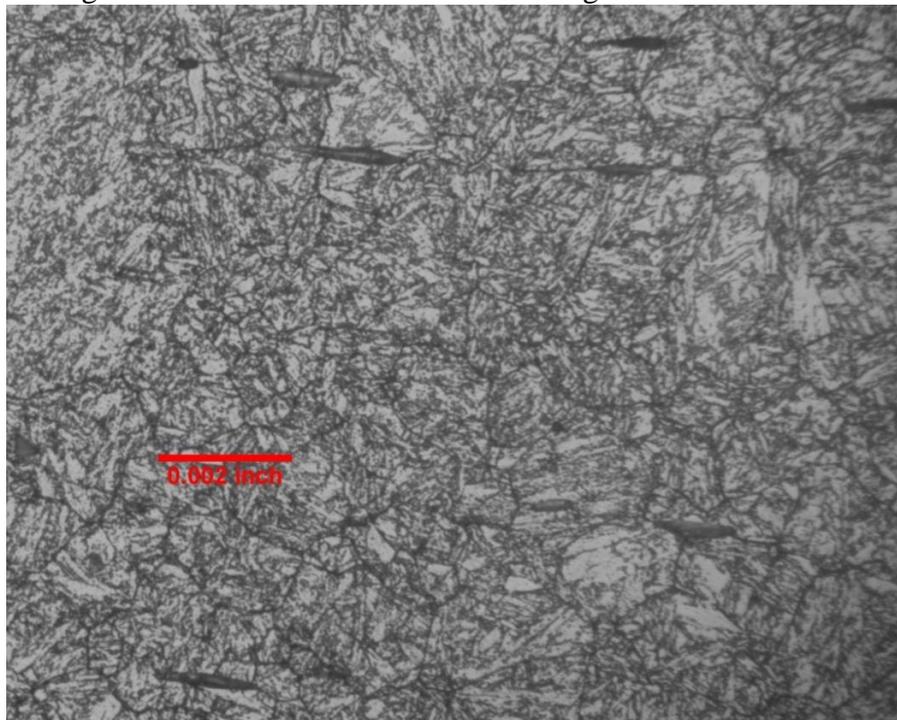
General microstructure of coupling 11-P7C-7 is tempered martensite. Specimen etched and viewed at 400x.

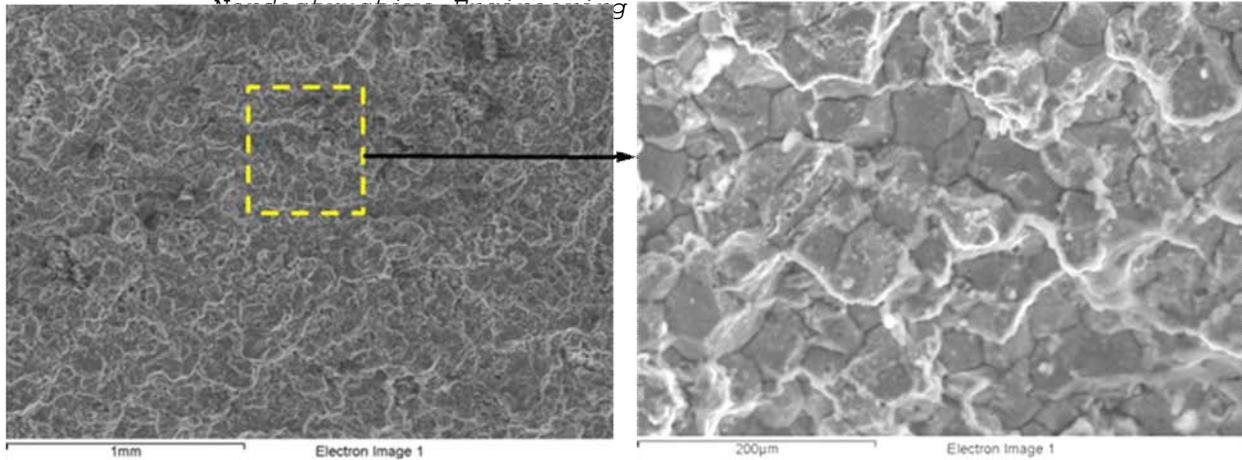
Figure 0-10: SEM of Coupling 11-P7C-6F Surface

Fracture surface morphology exhibited a rock-candy appearance, characteristic of intergranular stress corrosion cracking. This is typical of a quench and tempered steel, such as a 400 series martensitic steel.

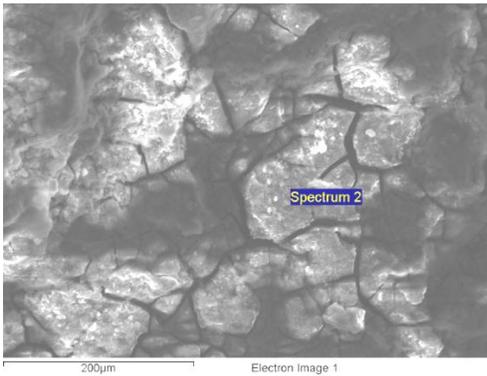
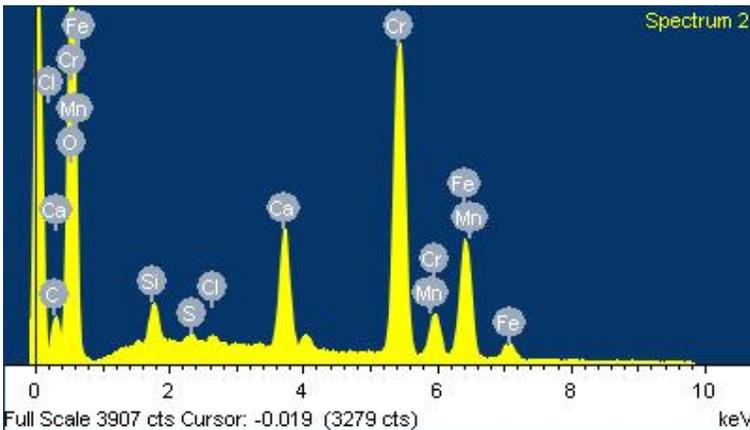
**Figure 0-11: EDS of Coupling 11-P7C-6F Surface Deposit – Spectrum 2**

Element	Weight%
O	40.1
Si	1.7
S	0.3
Cl	0.3
Ca	5.9
Cr	29.5
Mn	0.4
Fe	Bal.

EDS analysis of fracture surface revealed the presence of corrosive agents (chlorides, oxides and sulfides), consistent with stress corrosion cracking. Note the high chromium level in the

spectrum. The high amount could be attributed to a local concentration of chromium carbide in the EDS sampling volume.

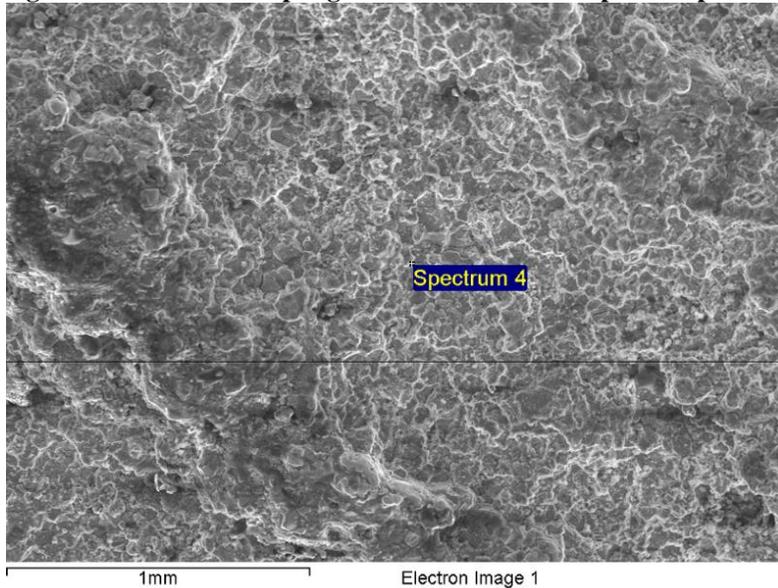
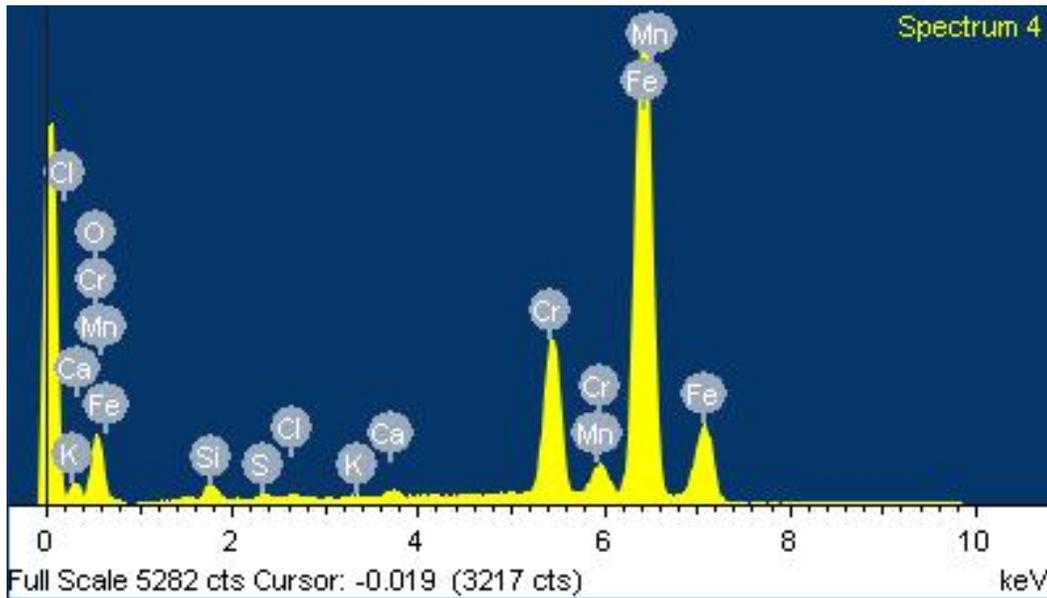
**Figure 0-12: EDS of Coupling 11-P7C-6F Surface Deposit – Spectrum 4**

Element	Weight %
O	7.5
Si	0.9
S	0.3
Cl	0.3
K	0.2
Ca	0.4
Cr	14.6
Mn	1.6
Fe	Bal.
