Root Cause Evaluation Report

Plant Trip During Panel ED-11-2 Maintenance

CR-PLP-2011-4822: 09-25-11

Entergy Nuclear Operations Palisades Plant

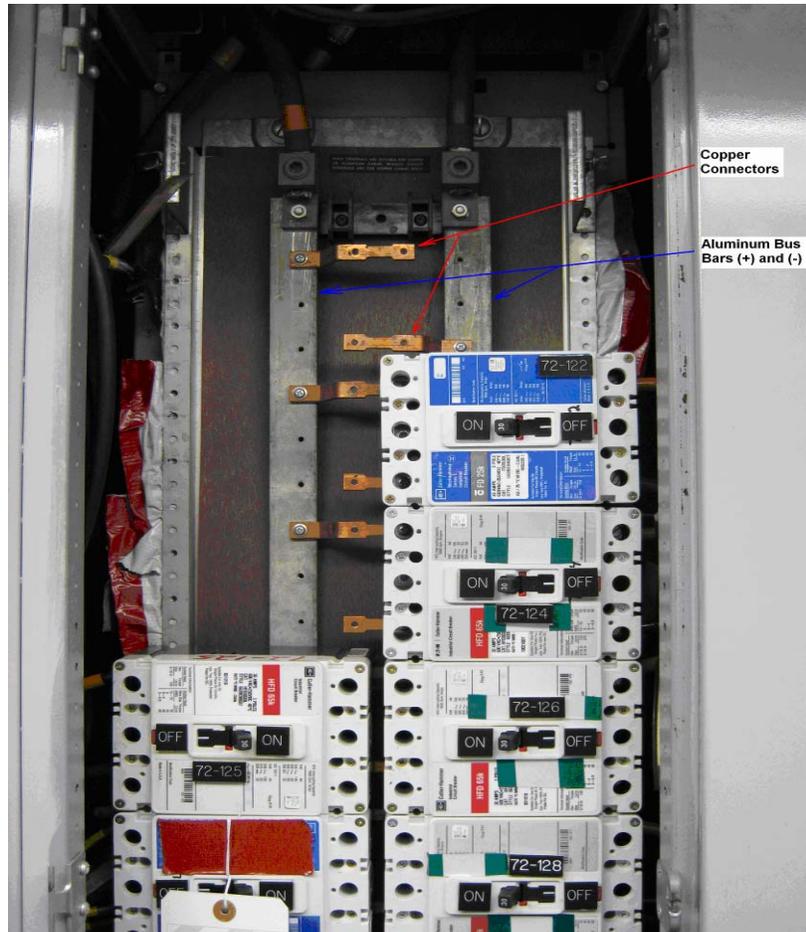
Discovery of cross-threaded bus connectors and a bus connector air gap during troubleshooting under WO291194 on 09/25/11 suggested that the breaker replacement workmanship during 1R21 could have been substandard. An examination of the two removed connectors that was done for this root cause evaluation found that the threads had been partially stripped, either by repeated use or by over-torquing the bolts in the relatively softer metal of the connectors. There was no evidence of damage on the tops of the connectors, such as scoring or gouging, to show that workers had found difficulty replacing the bus connector bolts which should have caused them to stop work and ask for help.

Following the removal of all four breakers, evidence of cross-threading damage was also found on the bus connector for 72-120. With concurrence from engineering, maintenance management and electrical maintenance supervision, the crew reached a decision to remove the bus connectors for both breakers 72-119 and 72-120 from the energized bus and to return them to the maintenance shop where the damaged threads could be repaired by retapping. The work could then be performed away from the energized bus and free from the risk of small metal particles falling into the bus or into other breakers. The following picture shows the two bus connectors that were to be removed:

- An examination of the two removed connectors found that the threads had been partially stripped by over-torquing the bolts in the relatively softer metal of the connectors.

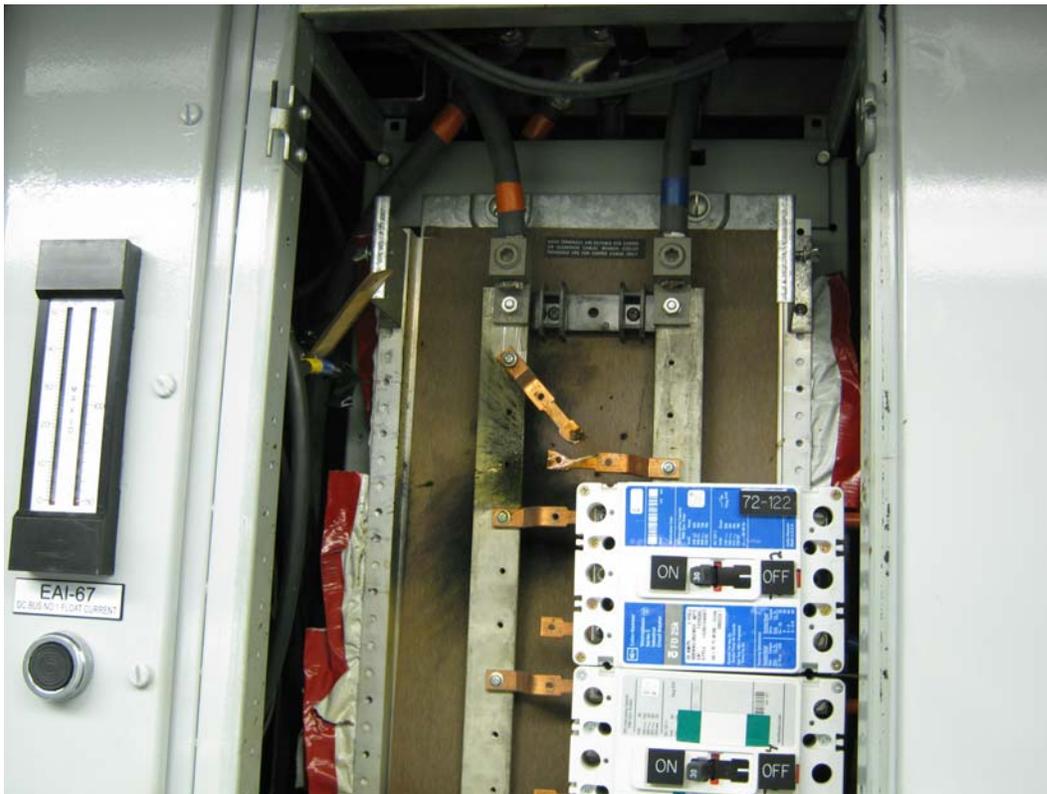
As the connectors were being removed, the worker holding the connector was startled, by an apparent flash or spark, into an involuntary motion that caused him to release the connector. Fortunately, the involuntary motion was such that no electrical shock occurred. The end of the connector, which had by now been loosened at its bus end, was able to swing down and contact the bus connector below it resulting in a short circuit between the positive and negative bus sections. The following picture was taken shortly after the short circuit occurred:

In this situation, both the decision to remove damaged bus connectors from the panel and the decision to use insulating gloves rather than insulating material between the connectors were changes in work scope that should have resulted in a work stop to re-brief.

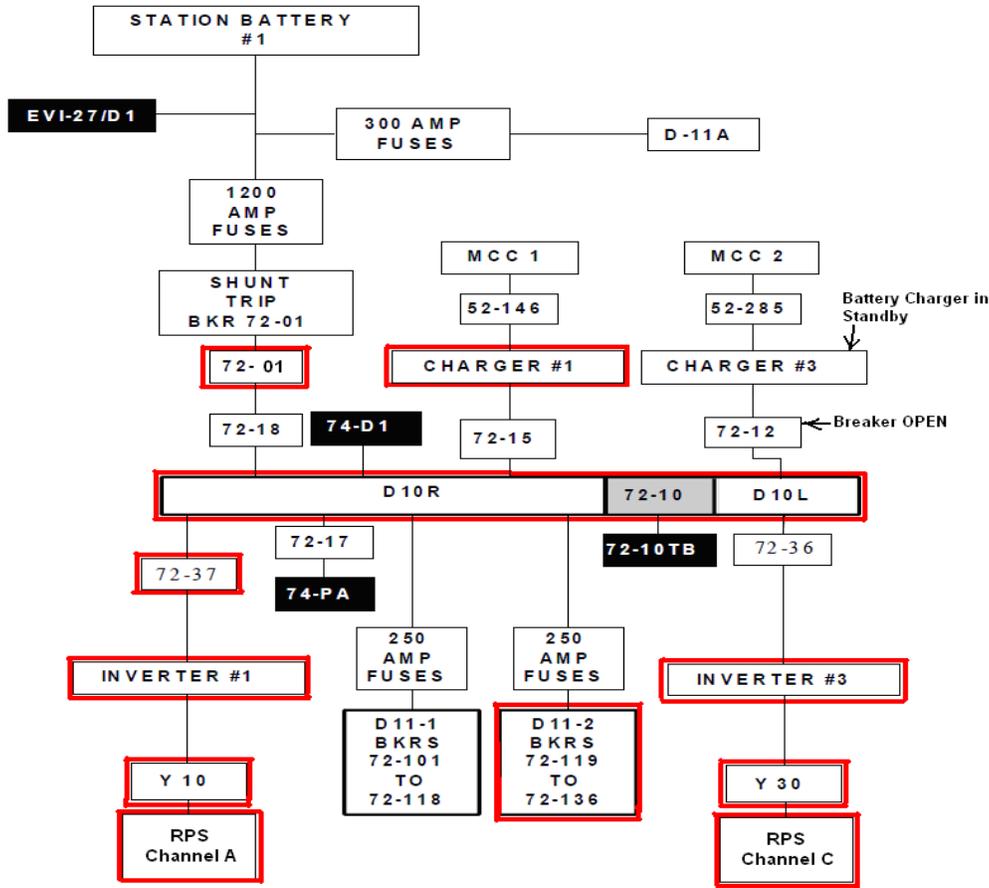
125 VDC System Left Train

As a result of this occurrence, the reactor tripped following a loss of power to ED-11-2. The 125 VDC diagram below can be used to visualize the sequence of equipment events leading up to the Plant trip. Items boxed in red factored into the trip.

Upon completing the short circuit, three events occurred in a short time frame (the actual sequence cannot be determined).

- Breaker 72-37 (Inverter No.1 ED-06 Power Supply Breaker) opened. This was due to internal capacitors on the line side of ED-06 (Inverter No. 1). These capacitors discharged, feeding the fault in ED-11-2 (125 VDC Panel). The discharge resulted in an outrush of current that caused breaker 72-37 to trip open.

This condition was resolved temporarily after the event by changing the magnetic trip setting of breaker 72-01 (and breaker 72-02) to its maximum value – approximately 5600 amperes. This was accomplished via a temporary modification under EC32028 which will remain in force until a permanent method of resolving the design discrepancy is implemented.
