LT - Apparent Cause Evaluation Report

ANO1 Steam Generator (E-24 A&B) Tube to Tube Wear

CR-ANO-1-2011-2609; Event Date: 11-07-2011

REPORT DATE: 12-01-2011, Rev 0

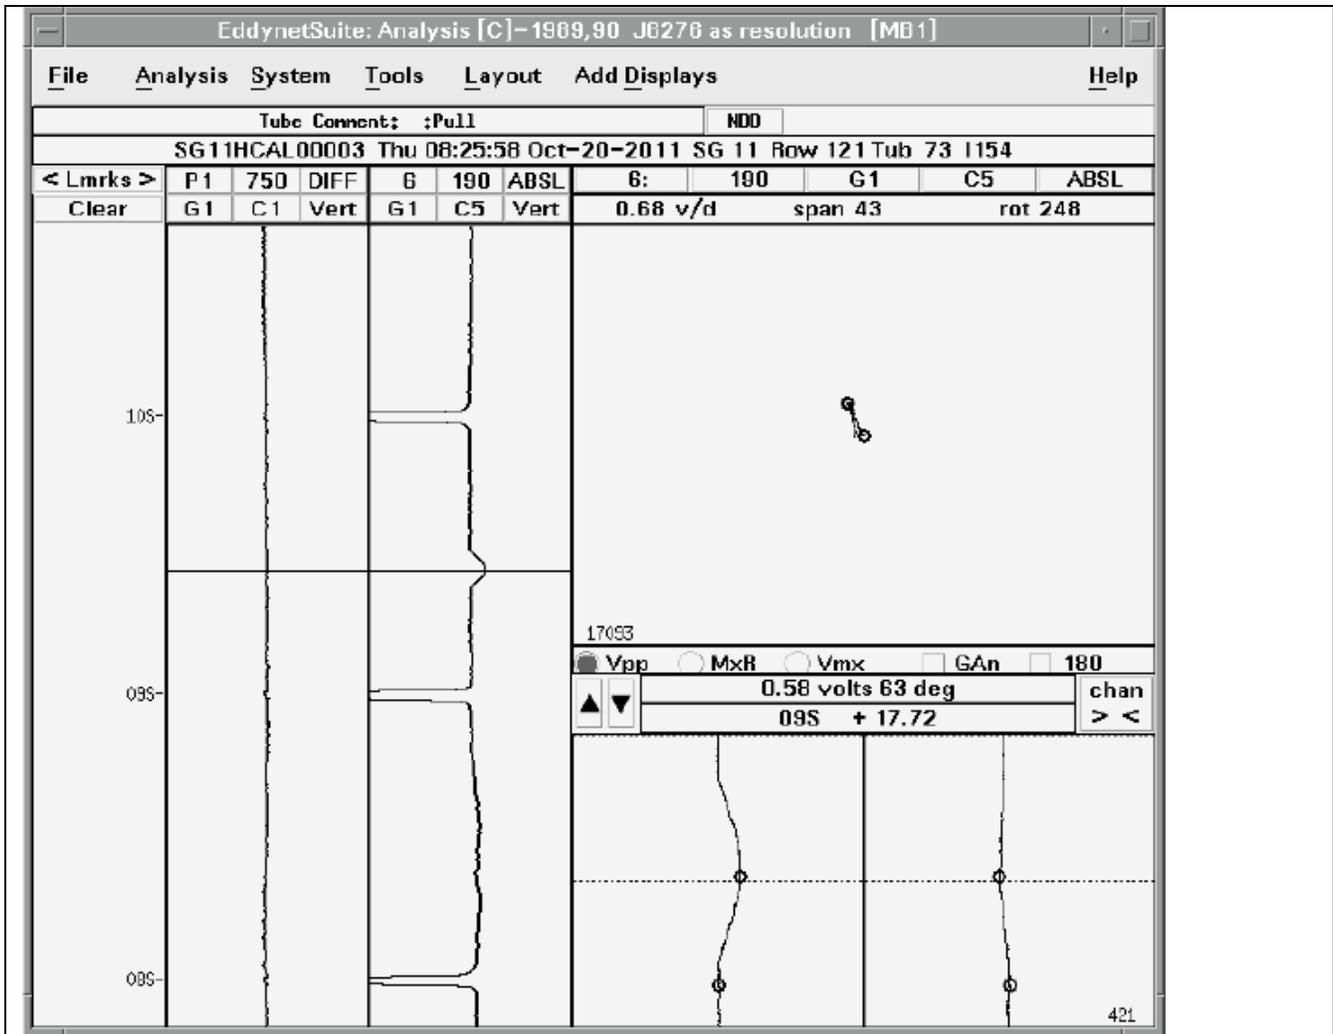
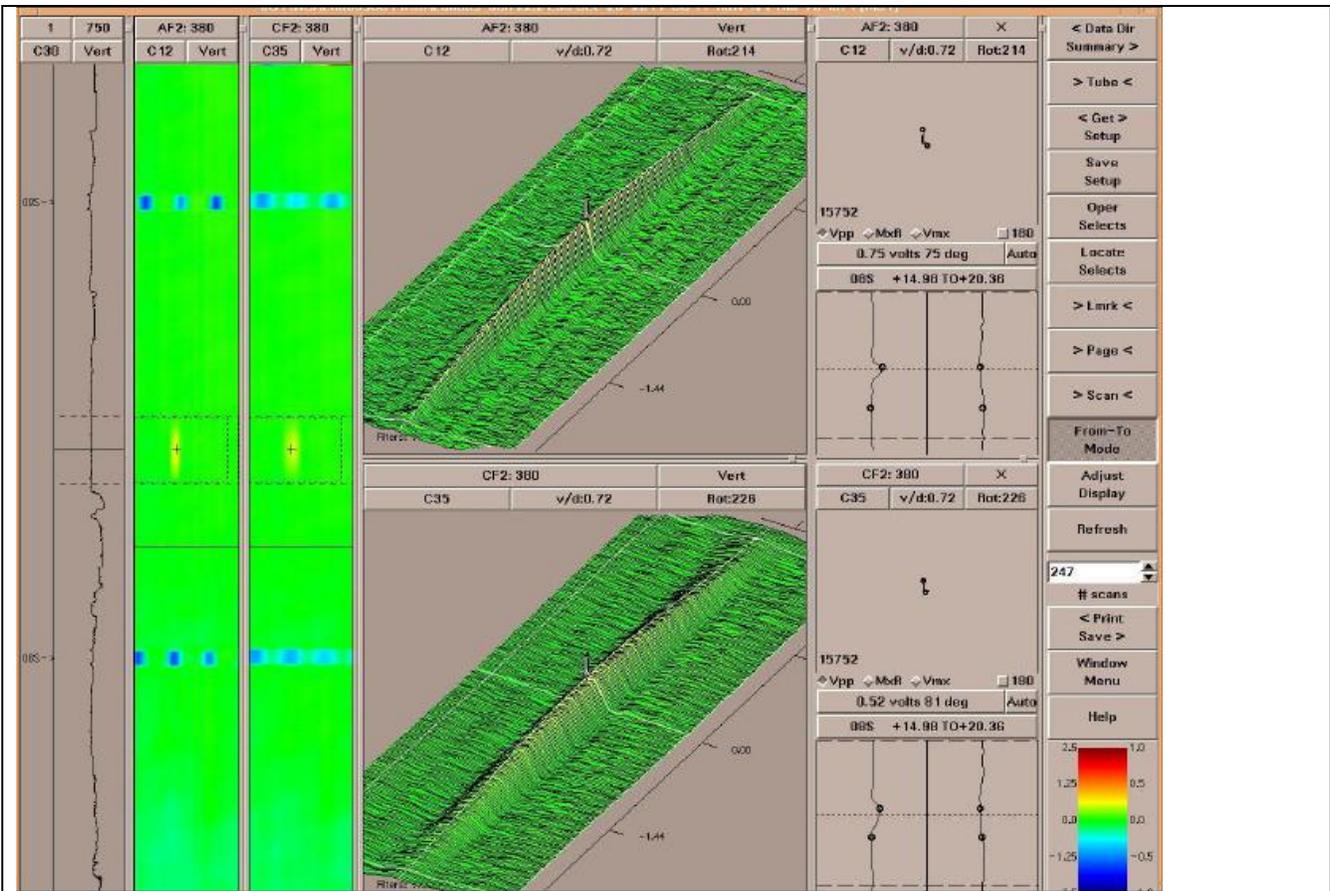
At approximately the mid-point of the tubing, ADI calls were made utilizing the bobbin coil. These indications tend to be in pairs or triplets and are associated with tubes being in compression while at power. This results in the tubes making contact with neighboring tubes. Due to the local velocities, fretting of the tubing material has resulted in a long tapered wear scar. The following is a representative example of the bobbin indication followed by an example of the X-probe data:

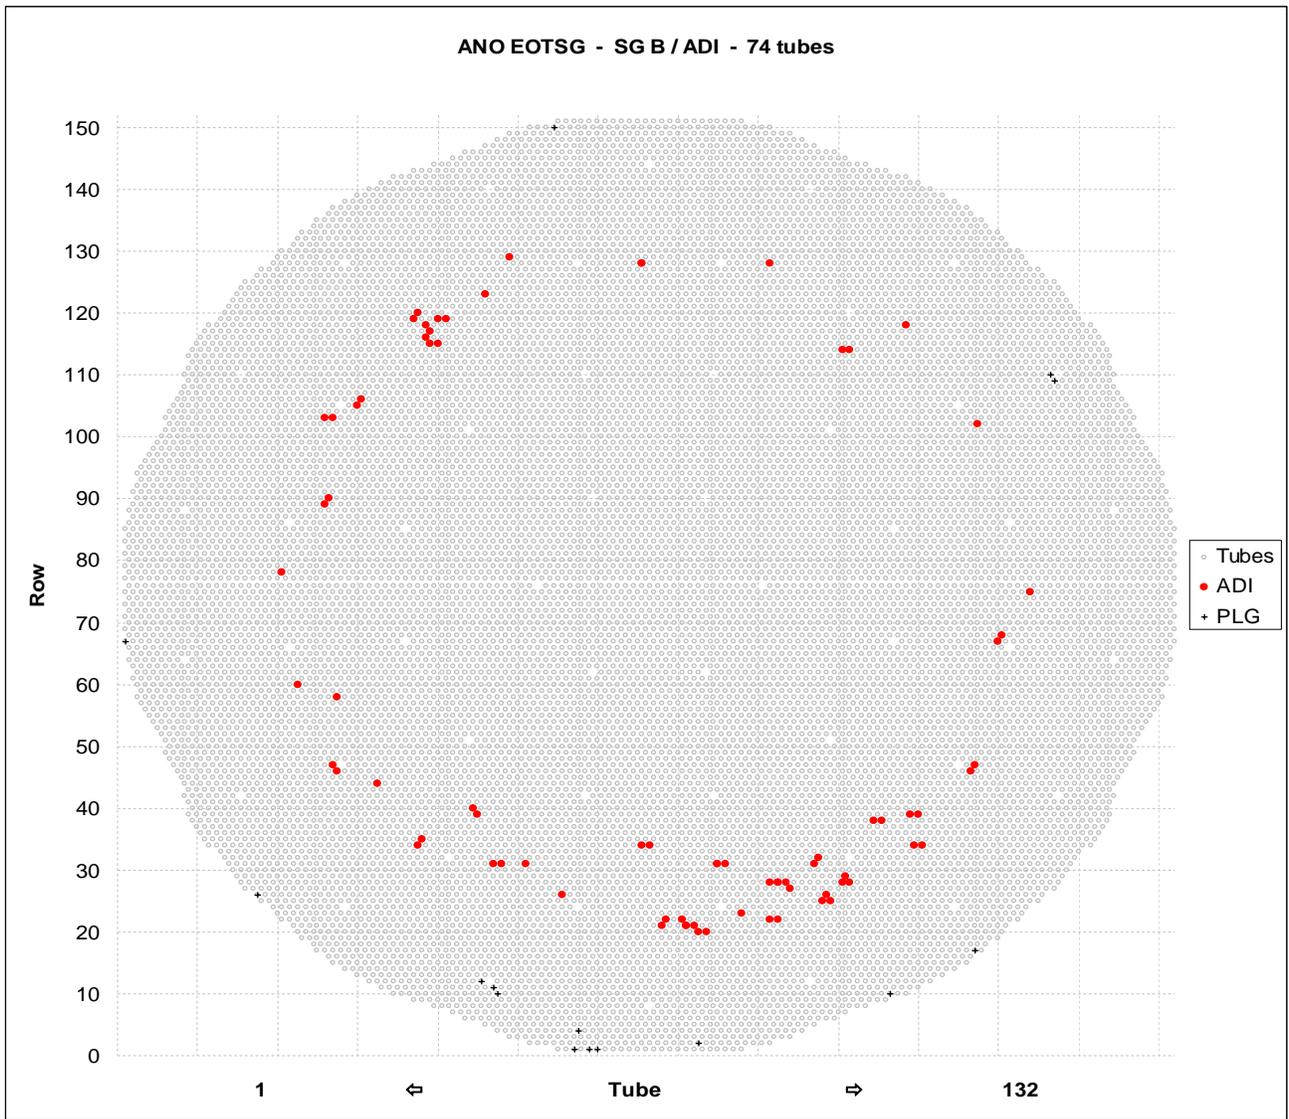
The ANO1 data was re-analyzed using the AIDA automatic computer analysis. The screening threshold was reduced from the original screening voltage of **0.5 v to 0.35 v**. Based on this re-analysis there were 48 tubes in SGA and 74 in SGB that exhibit this type of degradation. The deepest indications are in SGB with the largest being 26% through wall. These indications are in the same circular pattern that has been seen on the 8th tube support plate.

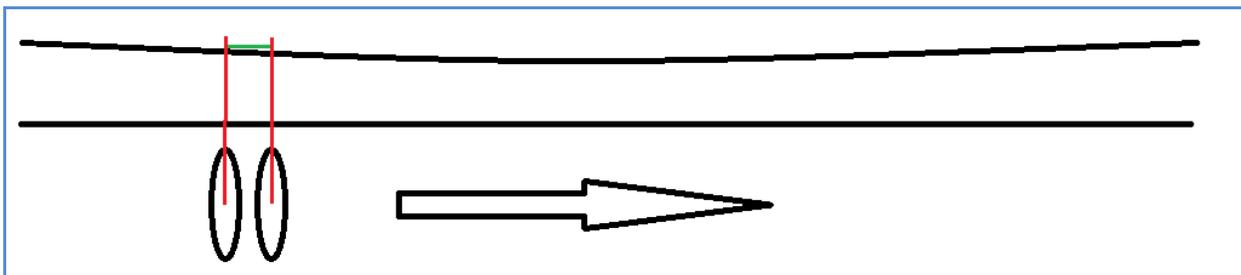
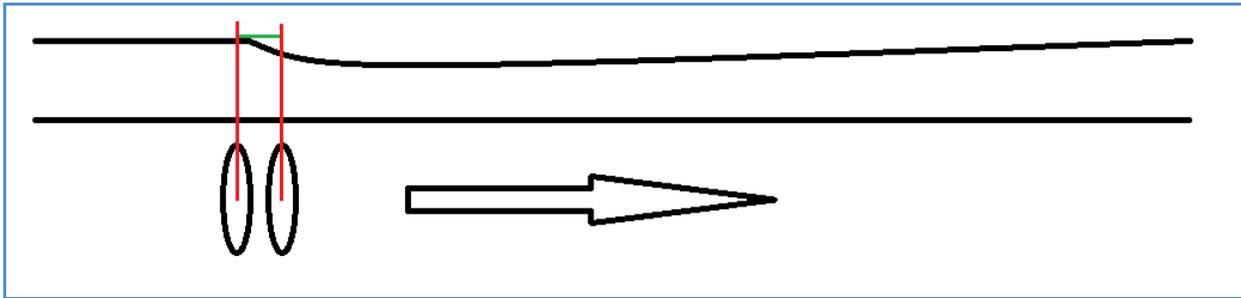
The following graphics display presents a reasonable example of why the indications were mischaracterized:

The above figure depicts why the differential bobbin coils do not respond to the OD wall loss. The tube wall is represented by the two parallel lines; the differential eddy current bobbin coils by the two ellipses; and the direction of the eddy current probe scan by the arrow. The top line represents tube's OD surface and the symmetric tapered tube-to-wear

signal which occurs over several inches. The differential bobbin coil's response relies on a material property change to occur over a short enough distance (within the effective coverage of these two coils) to imbalance the bridge circuitry and produce a measurable impedance change. Wear morphology of this type, which is symmetrically tapered and changing in depth slowly over several inches does not impact the differential coil balance sufficiently to produce a signal. If you do look at the differential channel on a long strip chart you will observe one complete cycle of coil imbalance over the length of this degradation. The below signal depicts the required condition to produce a differential signal and is the typical morphology where at least one end of the wear quickly returns to nominal tube wall where the two wearing surfaces meet (i.e., the edge of structure or loose part).
