EA-PSA-SDP-P7C-11-06
Attachment 9

LPI Ref. F11358-LR-001, Rev. 0

SUBJECT: Past Operability Assessment of Service Water Pumps P-7A and P-7B associated with As-found Evaluation of Pump Shaft Couplings – Palisades Nuclear Plant

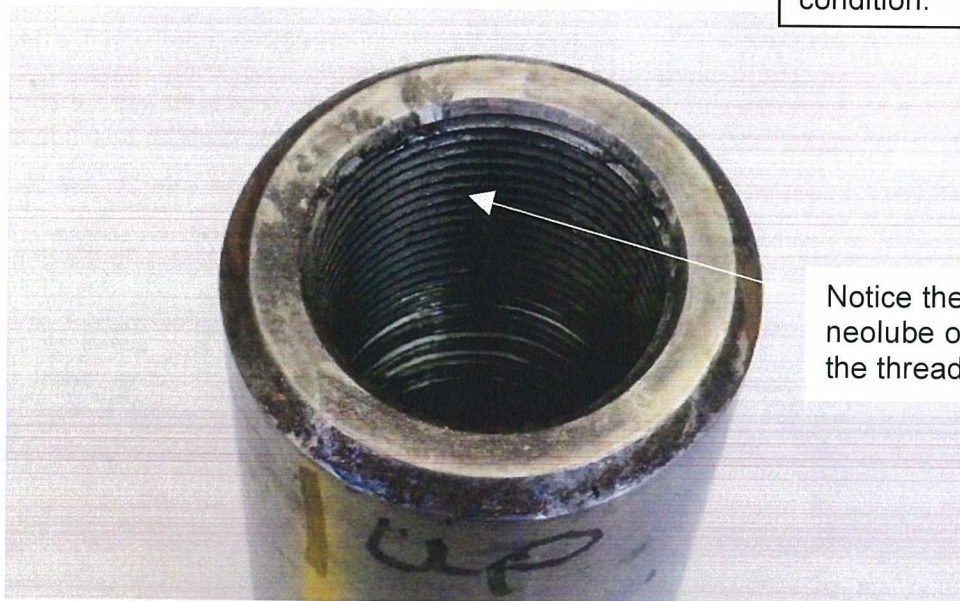
Figure 2-1: As-Received Coupling No. 11-P7A-7

Visual inspection of the P-7A pump couplings 11-P7A-4 through -7 identified the threads to be well coated with lubricant (as-received). This was in contrast to observations of the P-7C couplings in the as-received condition, where lubricant was not observed to be as well coated on the threads. A comparison of this is shown in Figure 3-2. The coating of lubricant on the P-7A couplings could enhance pitting resistance.

Coupling No. 7 (11-P7A-7) shown in its as-received condition.

Notice the neolube on the threads.

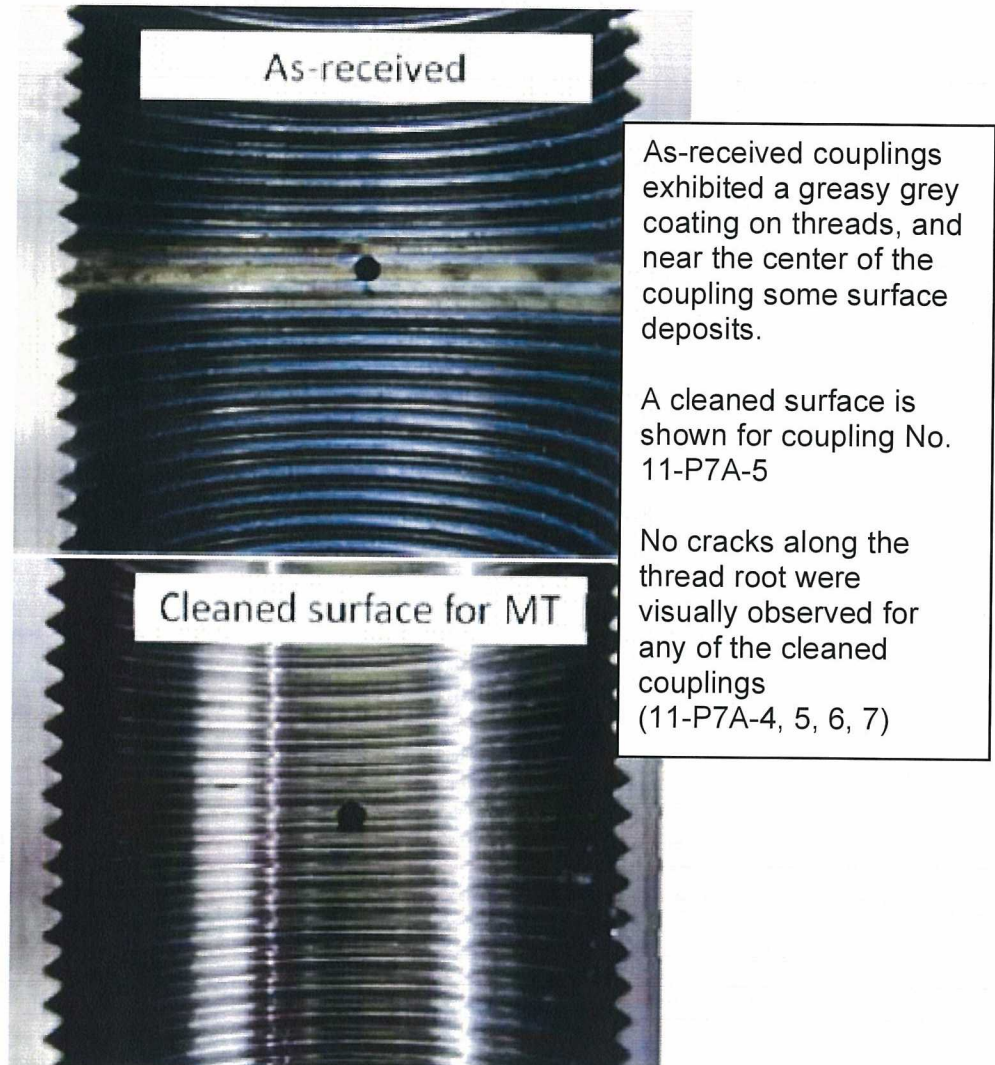
Figure 2-2: Visual Observation of Coupling No. 11-P7A-5

The results of the visual examination and MT inspection are shown in Figures 2-2 and 2-3, respectively. The threads of the P-7A couplings were found to be coated with lubricant, which has previously been identified by PLP maintenance as Neolube [4]. Following cleaning, the threads of couplings 4 through 7 were MT inspected and did not exhibit indications of linear flaws.

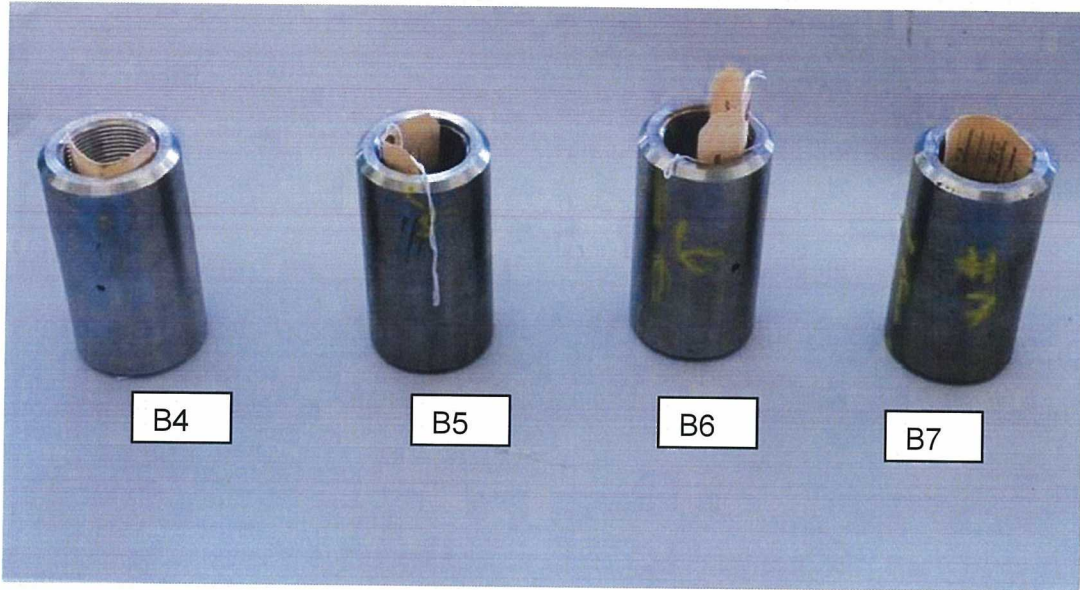
Figure 2-4: As-Received Couplings 11-P7B-4 through 11-P7B-7

Visual inspection of the P-7B pump couplings 11-P7B-4, 11-P7B-5K, 11-P7B-6K, and 11-P7B-7K show the couplings to be generally well coated with Neolube. However, the amounts were generally less than that observed on couplings 11-P7A-4 through 11-P7A-7.

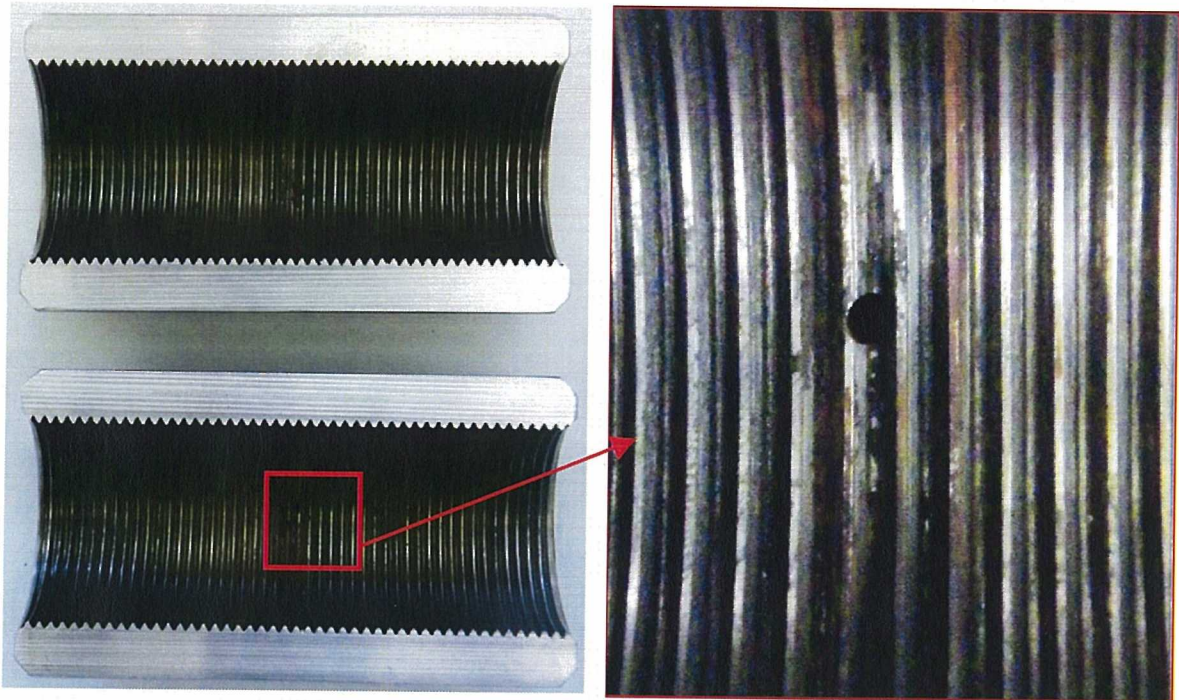
Figure 2-6: As-Split Coupling 11-P7B-5

shown in Figure 2-6 through Figure 2-8. Neolube is present on the threaded surfaces of coupling 11-P7B-5 to 11-P7B-7. However, an apparent band of corrosion product was observed at the center two-to-three threads of couplings 11-P7B-6 and 11-P7B-7. Coupling 11-P7B-5 also exhibited some corrosion at the center threads but not to the extent of couplings 11-P7B-6 and 11-P7B-7 (see Figure 2-6).

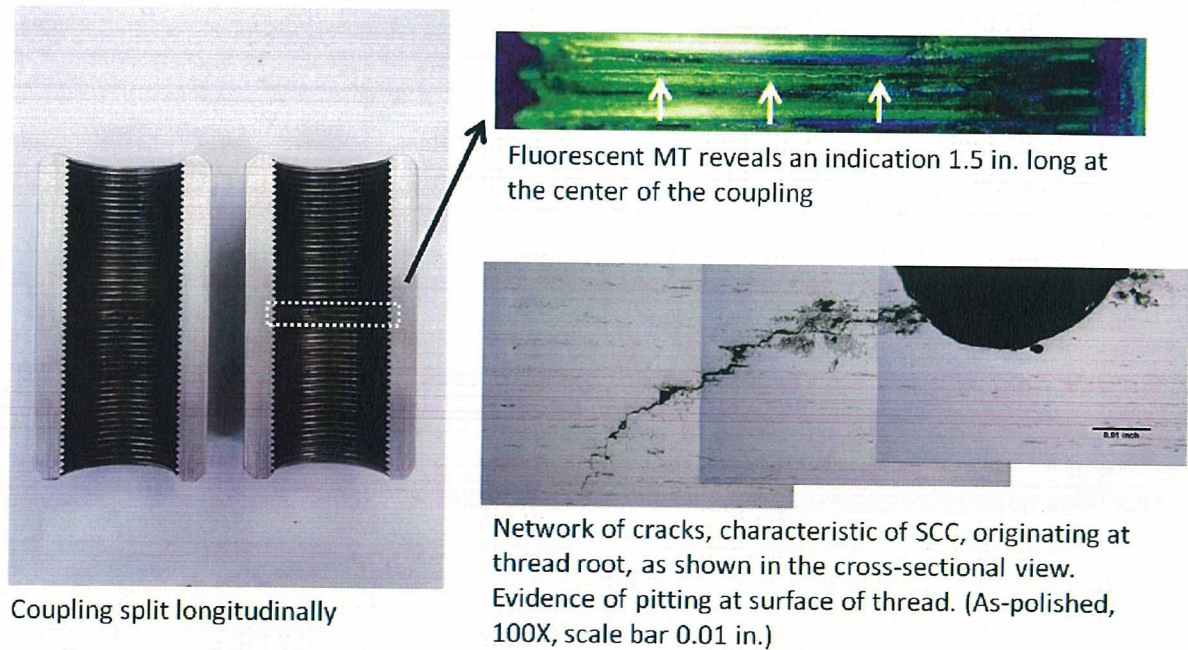
Figure 2-9: Cracks in 11-P7B-5 Initiating at a Pit

Following cleaning, couplings 11-P7B-4 through 11-P7B-7 were MT inspected. MT of couplings 11-P7B-4 through 11-P7B-7, revealed indications at the center (near location of corrosion products) of couplings 11-P7B-5, 11-P7B-6 and 11-P7B-7. An indication was also found at the motor end of coupling 11-P7B-5. No indication was found on coupling 11-P7B-4. Metallographic examination of the MT indications on 11-P7B-5K through 11-P7B-7K revealed a network of branched cracks initiating from pits at the thread roots (see Figure 2-9, Figure 2-10 and Figure 2-11). The branching network of cracks is indicative of SCC. A summary of the as-found cracks on the P-7B couplings follows:

Coupling split longitudinally

Fluorescent MT reveals an indication 1.5 in. long at the center of the coupling

Network of cracks, characteristic of SCC, originating at thread root, as shown in the cross-sectional view. Evidence of pitting at surface of thread. (As-polished, 100X, scale bar 0.01 in.)

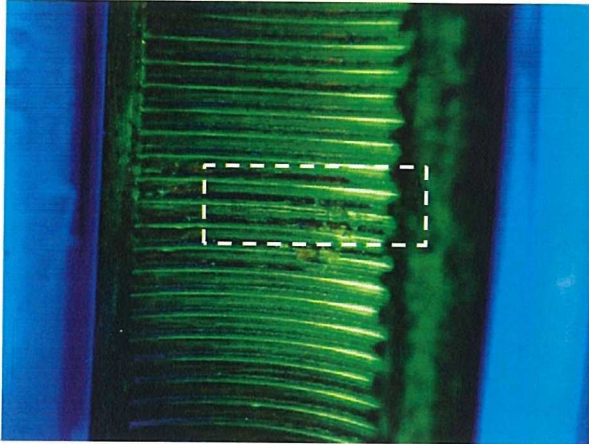
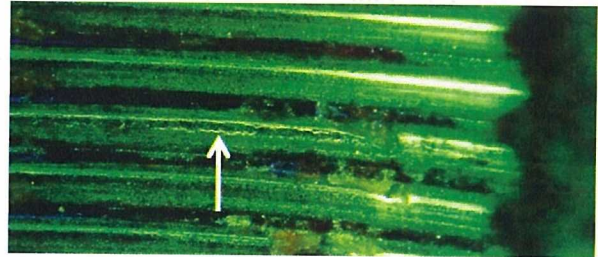
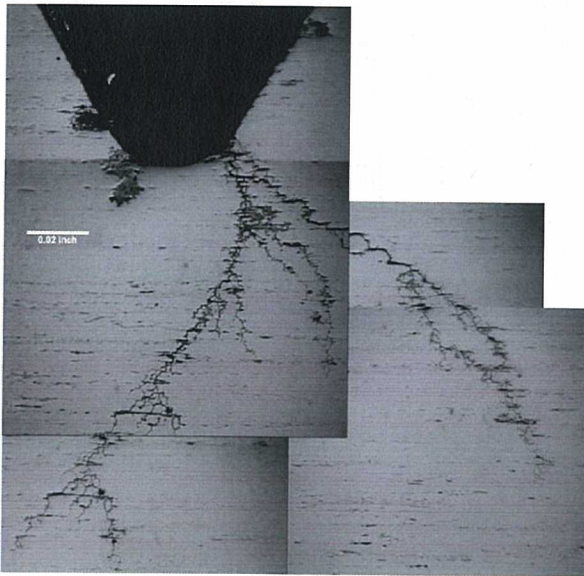
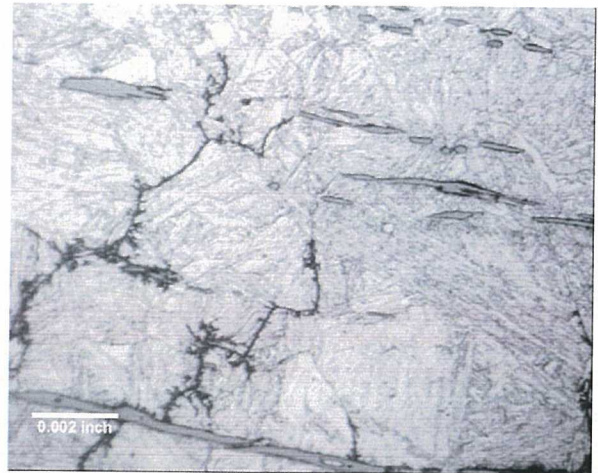
Figure 2-10: Cracks in 11-P7B-6 Initiating at a Pit

0.5 in. long indication found at center of
Coupling No. 6

Network of cracks, characteristic of SCC, originating
at thread root. Evidence of pitting at surface of
thread. (As-polished, 50X, scale bar 0.02 in.)

Path of networked cracks along grain boundaries.
(Etched, 400X, scale bar 0.002 in.)

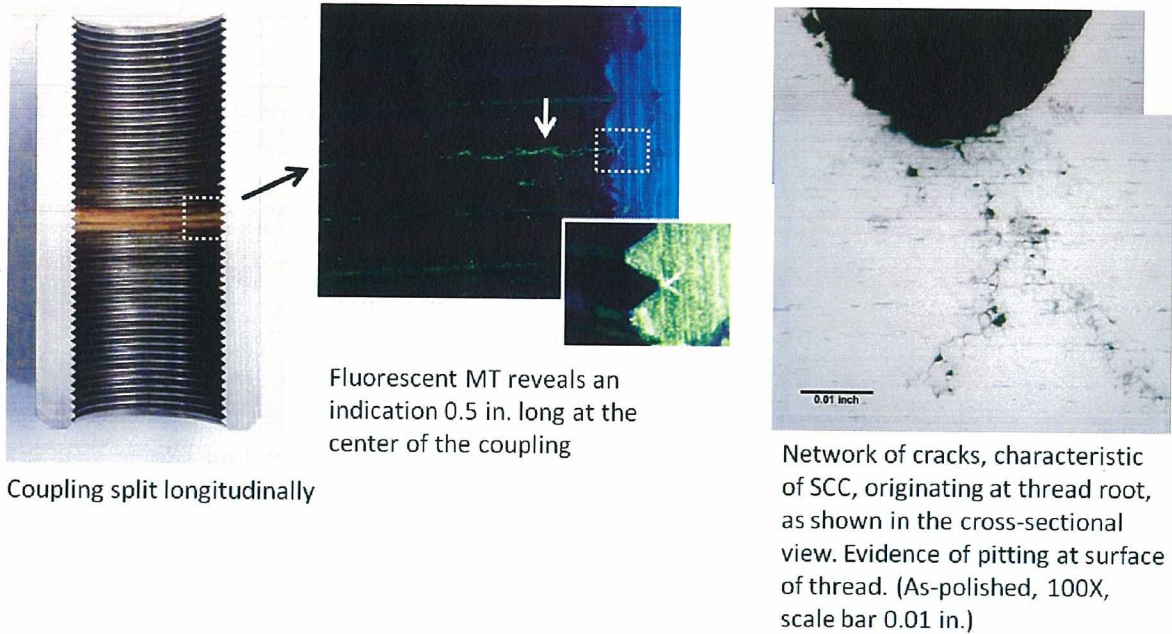
Figure 2-11: Cracks in 11-P7B-7 Initiating at a Pit

Coupling split longitudinally

Fluorescent MT reveals an indication 0.5 in. long at the center of the coupling

Network of cracks, characteristic of SCC, originating at thread root, as shown in the cross-sectional view. Evidence of pitting at surface of thread. (As-polished, 100X, scale bar 0.01 in.)

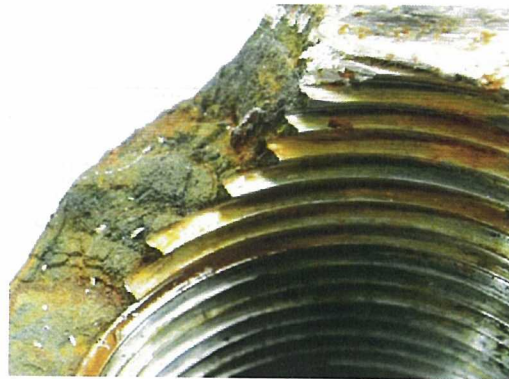
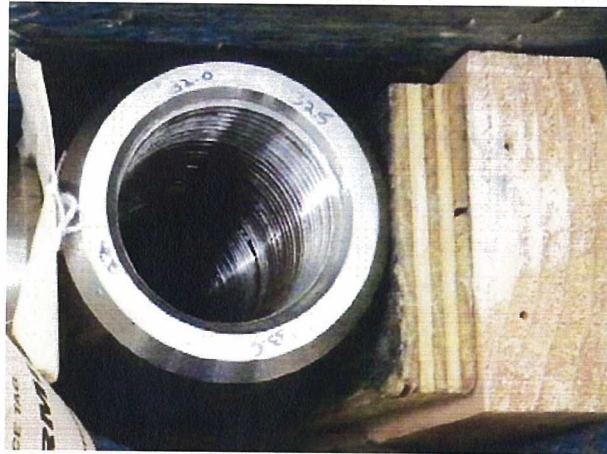
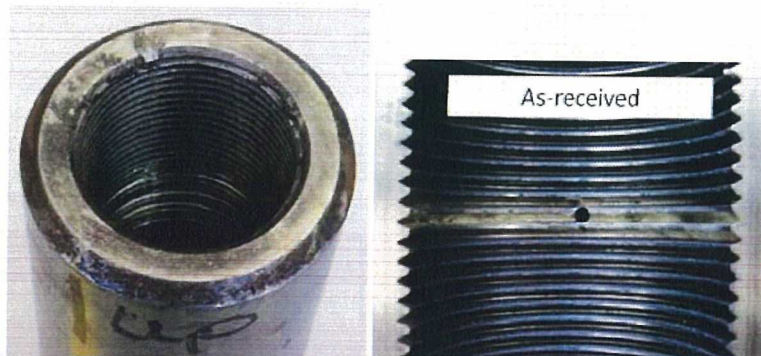
Figure 3-2: Contrast Thread Coating (As-Received) on P-7C Failed and Cracked Couplings to P-7A Coupling

Based on the amount of Neolube on the coupling of P-7A and the absence of observed pits or cracks at the thread roots, it is postulated that the Neolube provided a protective coating that enhanced the corrosion resistance of the P-7A couplings.

11-P7C-7K in the as-received condition does not exhibit the same level of neolube on threaded surface as 11-P7A-7

11-P7A-7 in the as-received condition exhibits significant amounts of neolube on thread surface

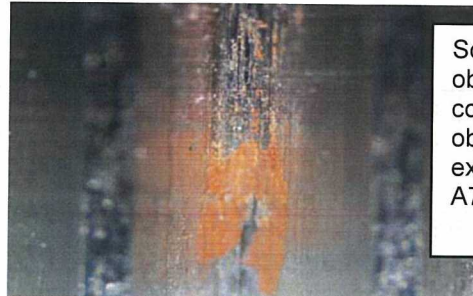
Representative Image of 11-P7A Coupling

Stereomicroscopy of the coupling thread roots indicated that couplings exhibiting cracks tend to contain pitting, whereas couplings without indications contained less or no pitting. That is, pits or cracks were not observed in couplings 11-P7A-4 through 11-P7A-7 and 11-P7B-4, whereas couplings 11-P7B-5 through 11-P7B-7 contained pits and cracks. Figure 3-3 presents a representative comparison of a coupling without pits (and with no indications) and couplings that exhibit pits and contain cracks.

Some corrosion product was observed near the middle of the coupling however no pitting was observed during stereomicroscope examination of couplings A5 through A7.

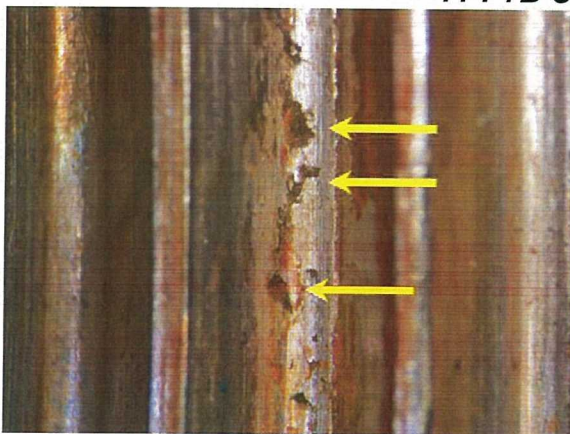
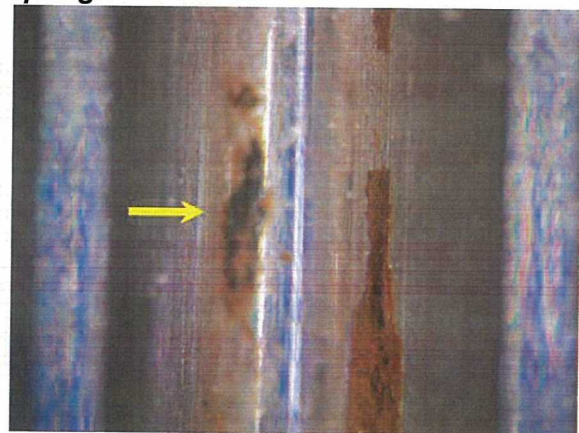
Figure 3-3: Contrast Thread Root Pitting

Pitting at root near middle of fractured Coupling No. 6 (Stereomicroscopy 15X)

Pitting near the root and near middle of Coupling No. 7 (Stereomicroscopy 40X)

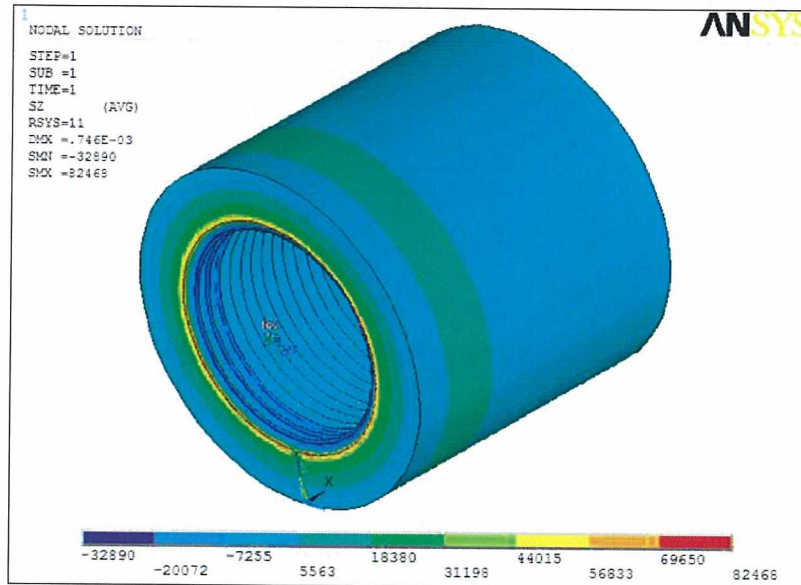
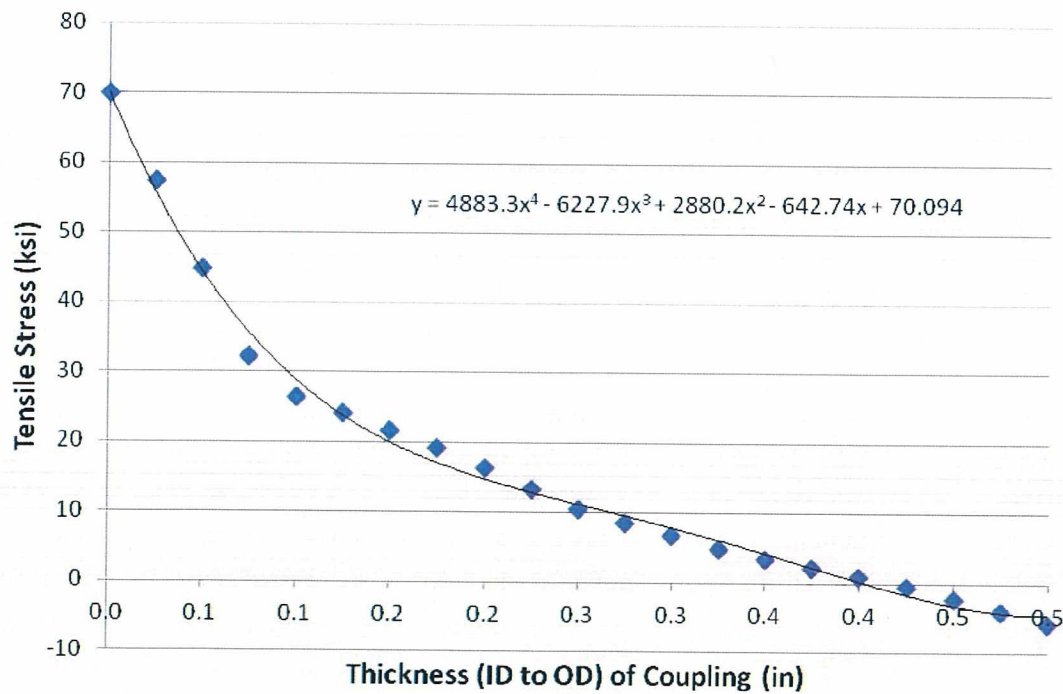
Figure 3-6: Tensile Stress Distribution across Wall Thickness of Coupling
(Based on three threads reacting out applied load)

Therefore, based on three threads taking the load and resulting tensile stress of 70 ksi (see Figure 3-6), the stress intensity of $23\text{ksi}\sqrt{\text{in}}$ would be sufficient to initiate a crack. If the tensile stress at the thread root is 55 ksi or less then the stress intensity would fall below the threshold stress intensity, K_{ISCC} of $18\text{ksi}\sqrt{\text{in}}$ and SCC initiation would not be expected. However, if a pit were to form at the thread root, the stress intensity would be higher for a given tensile stress. For example, a pit 0.01" deep and tensile stress of 55 ksi would result in a stress intensity of approximately $24\text{ksi}\sqrt{\text{in}}$ (see below), which is greater than the threshold stress intensity for SCC initiation.

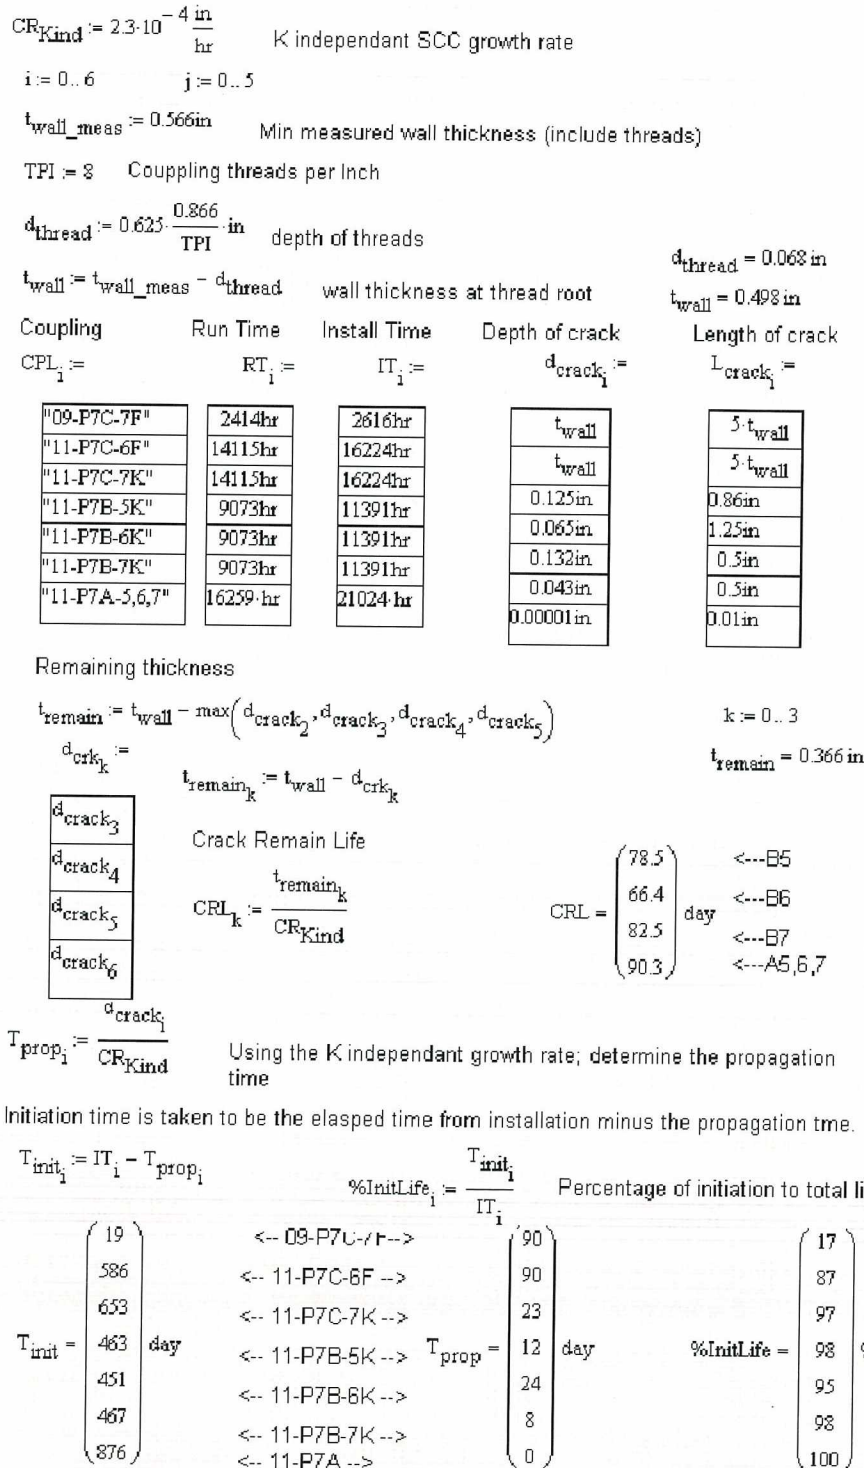
Figure 3-12: Coupling Life Estimate for Crack Propagation Across Wall

Using the stage 2 stress intensity independent crack growth rate (CGR) of $2.3E-4$ in/hr from Figure 3-10, and applying it to the as-found cracks of examined couplings from P-7B, it would require approximately 66 days to propagate through the wall⁵ of the deepest flaw found on the P-7B couplings, i.e. 11-P7B-6K (evaluation is shown in Figure 3-12). Using the same CGR, and assuming a crack initiated at the time the examined P-7A couplings were removed from service, it would require 90 days to propagate through wall. Applying this simplistic approach to couplings 09-P7C-7F and 11-P7C-6F would result in the same 90 days to propagate through thickness (see Figure 3-12).
