SAFETY CULTURE COMPONENT	DESCRIPTION	CR-PLP-2011-4822– Plant Trip During Panel ED-11-2 Maintenance
8. Environment For Raising Concerns	An environment exists in which employees feel free to raise concerns both to their management and/or the NRC without fear of retaliation and employees are encouraged to raise such concerns.	No safety culture weakness determined for any of the identified causes

SDP Assessment of DC Panel D11-2 Fault

EA-PSA-SDP-D11-2-11-07, Revision 1

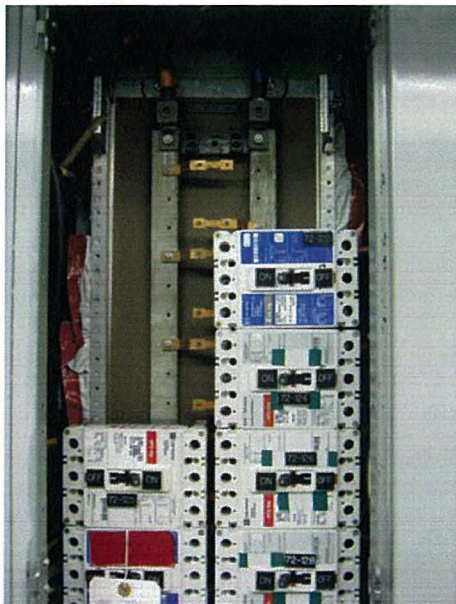
Figure 3-1: DC Panel ED-11-2 – Just Prior to Event

Figures 3-1 and 3-2 below show the configuration of dc panel ED-11-2 just prior to and following the event.

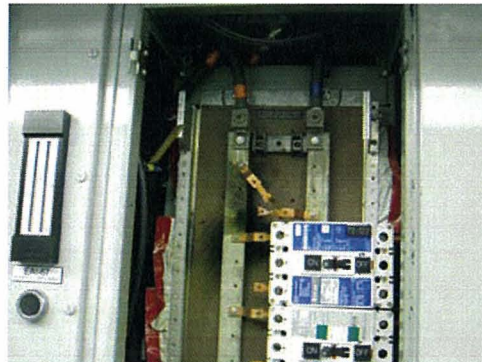
Figure 3-1: DC Panel ED-11-2 – After Fault Event

Since the event was the result of a maintenance activity, personnel qualified to determine the extent of condition with respect to the fault and electrical component failures were present to carry out the recovery actions. Buses ED-10L and ED-10R were re-energized from station battery ED-01 within about 50 minutes.
