**Indian Point 3**

**IP3-RPT-STR-03517, Revision 0**

**IP3  
ASME Section XI, IWL  
Concrete Containment  
Inspection**

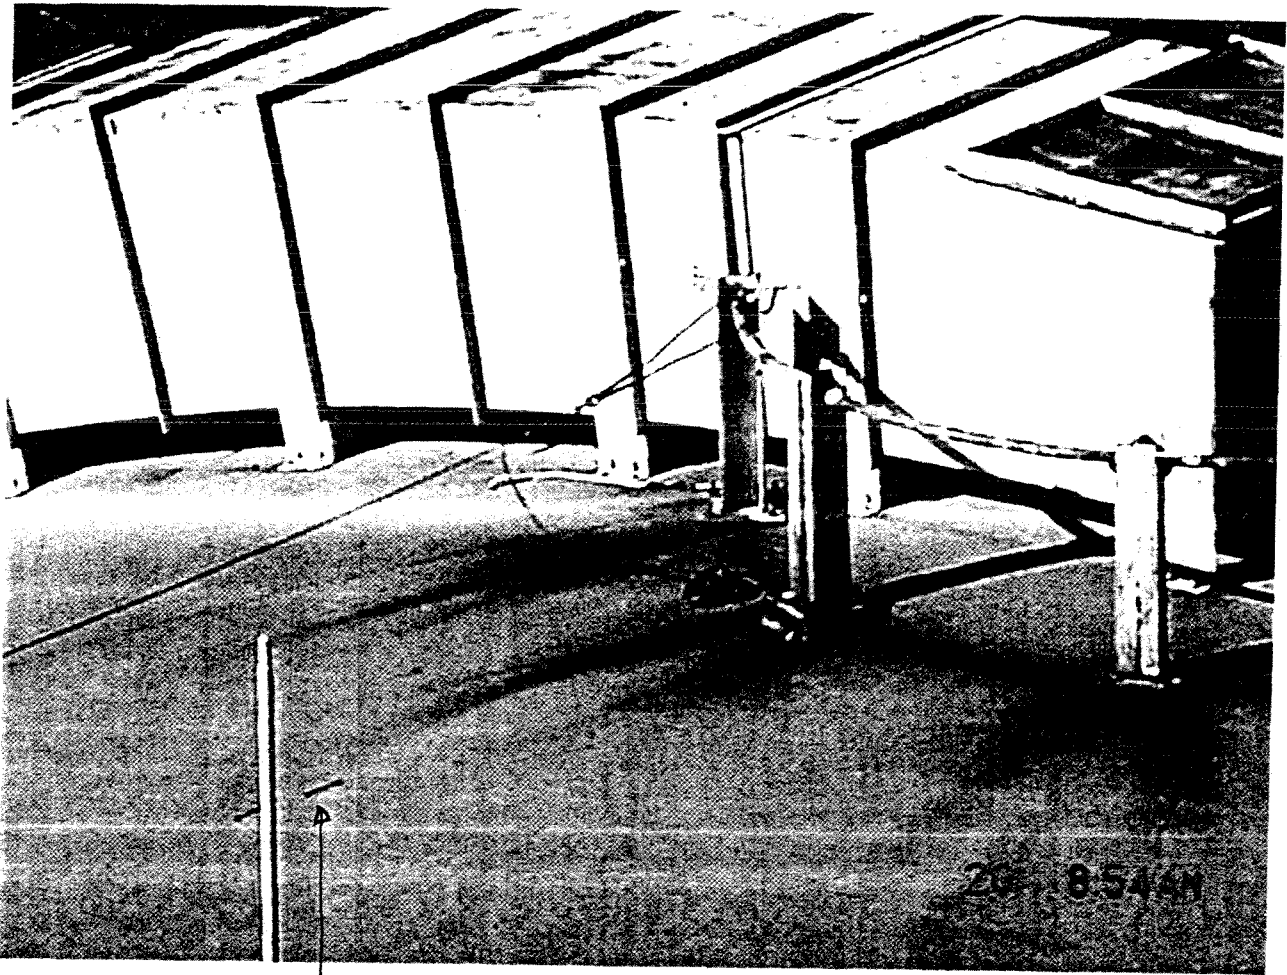
IP3 ASME Section XI, IWL Concrete Containment Inspection	No: IP3-RPT-STR-03517, Rev: 0
	Picture <u>7</u>

WIRE  
SCRAPS
