**IP3 ASME SECTION XI,  
IWL CONCRETE CONTAINMENT INSPECTION  
FOR 2009**

<b>IPEC</b>	IP-RPT-09-00069	REV. 0
		Page 3 of 192	
IP3 ASME Section XI, IWL Concrete Containment Inspection for 2009

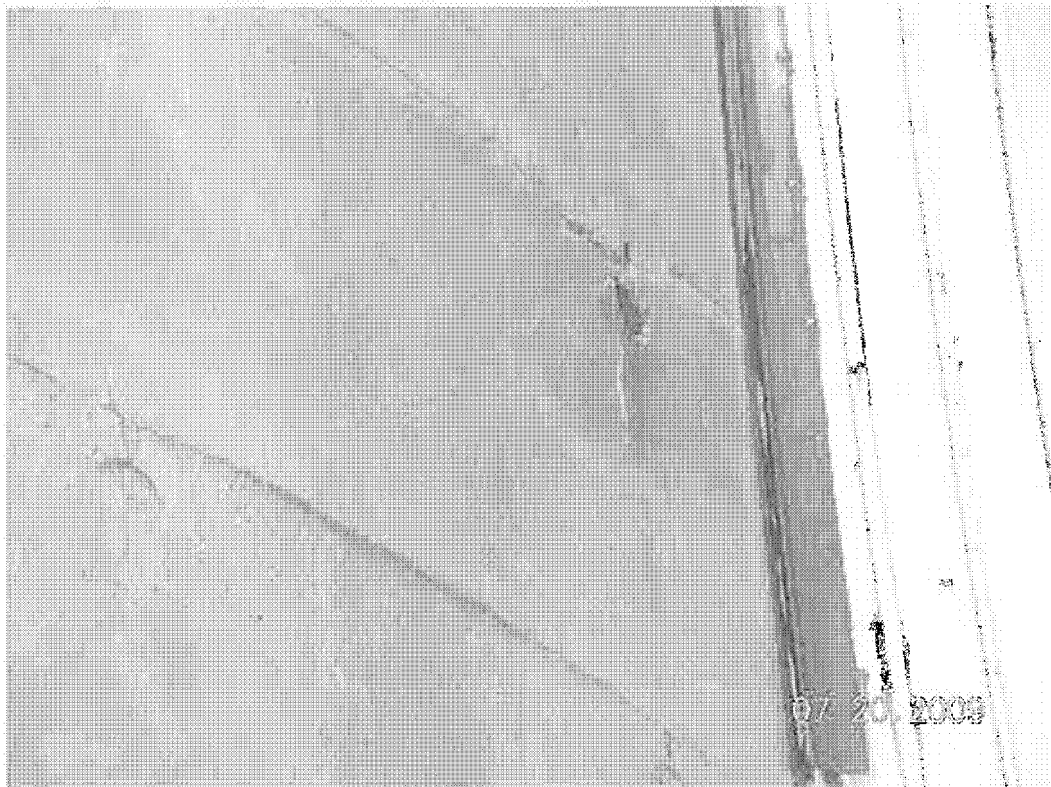
U3-017202

No.	Comment	Initials
1	Numerous bugholes, minor vertical and joint cracks, leaching, scaling, and spalling. These are general conditions noted on containment that have NO impact to the structural integrity and fall below the requirement for thorough characterization of indications for future monitoring. However, this condition was noted prior and continues to be note worthy only.	<i>TMB</i>
2	Approximately 2" to 3" pop out at El. 48'-0" no more than 1" deep. See photo U3-017201.	<i>TMB</i>
3	Scaffold connection hole spalled exposing the steel plate backing with surface corrosion and rust staining, approximately 6" x 8" with over 5' long rust stains (previously identified with no significant change). See photo U3-017202.	<i>TMB</i>

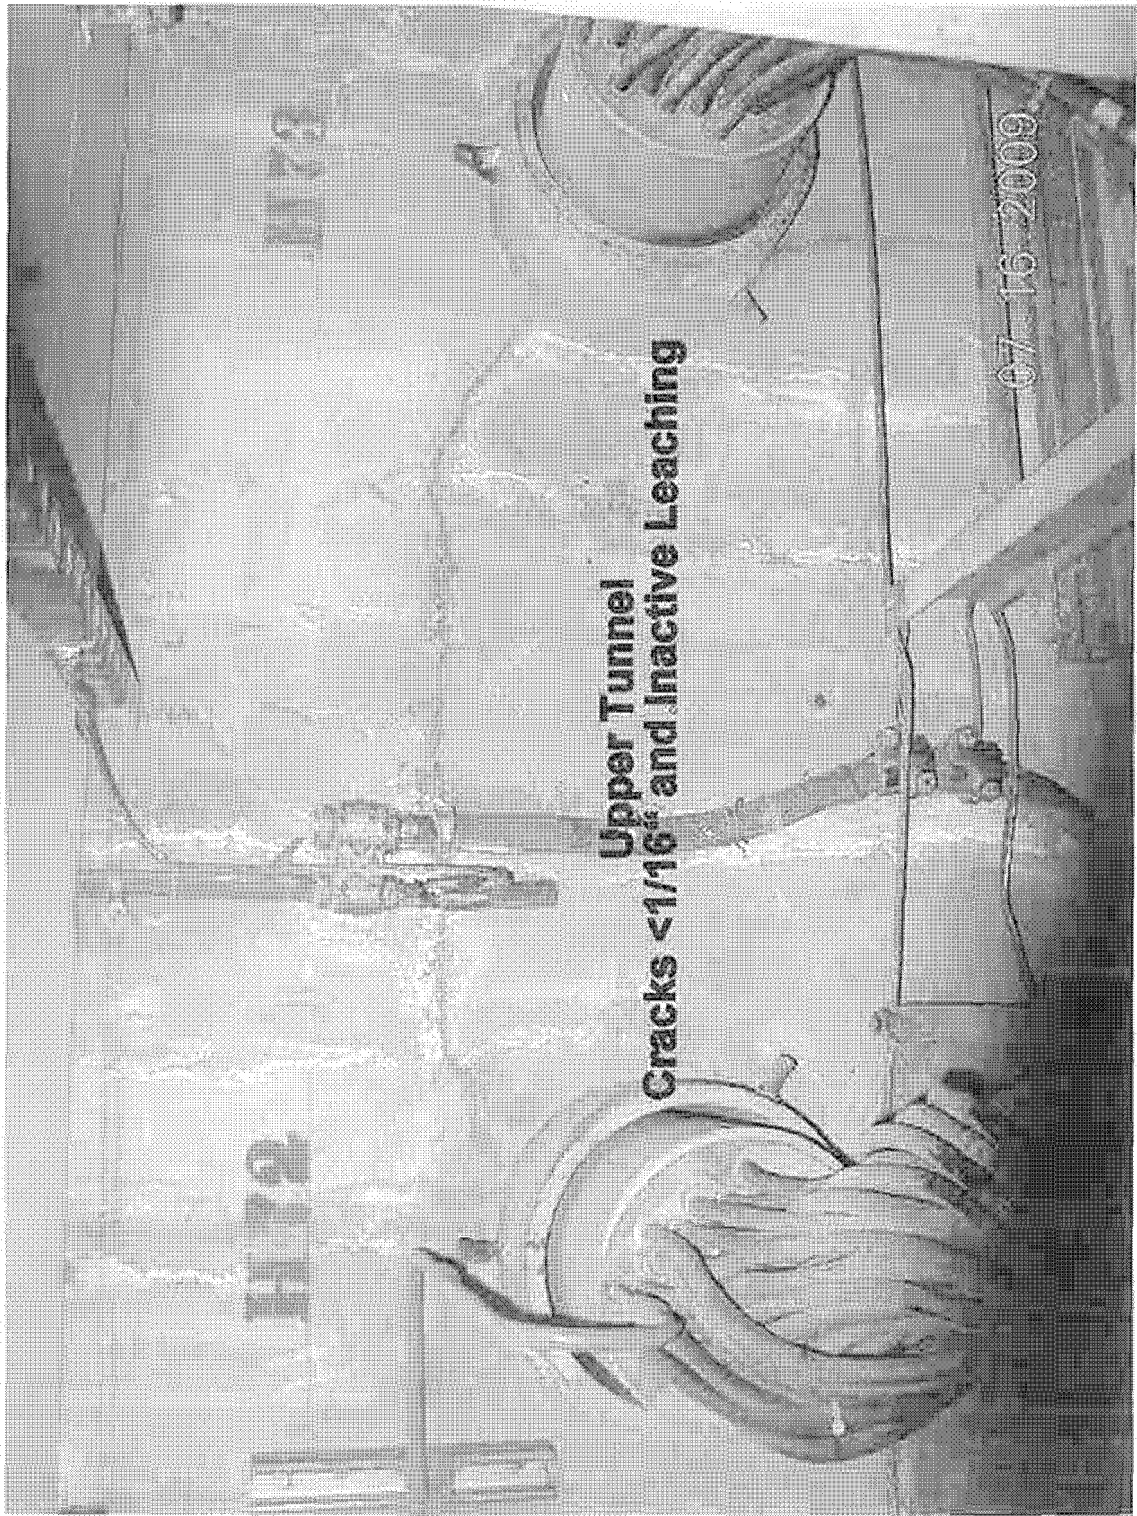
U3-037161

No.	Comment	Initials
1	Minor leaching and discoloration.	PMB
2	Visible rust spots with staining behind penetrations H37, H47, and H49.	PMB
3	Patched area has visible cracking.	PMB
4	Cracking with inactive leaching – minor with no significant crack width. See photo U3-037161.	PMB

Upper Tunnel  
Cracks <math>< 1/16''</math> and Inactive Leaching

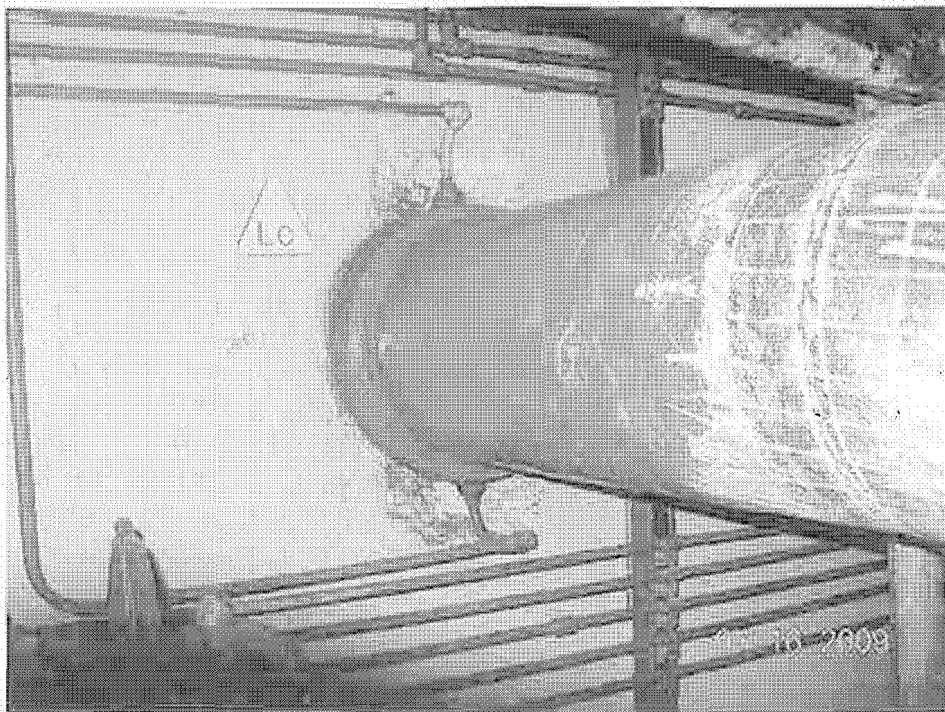
U3-047162

No.	Comment	Initials
1	Minor cracking, less than 1/32" wide, and discoloration.	PMB
2	Spalling, 6"x4"x3" deep, with exposed aggregate around pipe penetration Lc. See photo U3-047162.	PMB
3	General bugholes and coating cracking, flaking, peeling visible from Pipe Penetration Area.	PMB
4	Spalling, 4" x 4", with exposed aggregate around pipe penetration J. See photo U3-047163.	PMB
5	Spalling, approximately 1" out from penetrations PP (180 degrees), Y (180 degrees), and RR (270 degrees).	PMB
6	Localized efflorescent staining throughout the Pipe Penetration Area.	PMB
