SUBJECT: Licensee Event Report 2011-004-01, Turbine-Driven Auxiliary
Feedwater Pump Inoperable in Excess of Technical Specification
Requirements Due to Unexpected Trip

Palisades Nuclear Plant
Docket 50-255
License No. DPR-20

4. TITLE:
 Turbine-Driven Auxiliary Feedwater Pump Inoperable in Excess of Technical Specification Requirements Due to Unexpected Trip

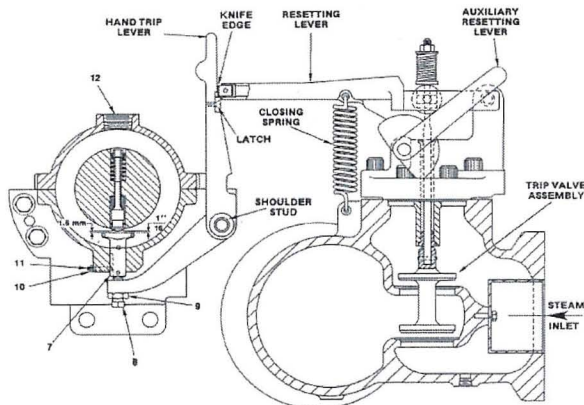
On May 10, 2011, during TS surveillance test, RO-97, "AFW Automatic Initiation Test," P-8B, tripped due to the unexpected actuation of the mechanical overspeed trip linkage allowing the trip valve assembly to isolate steam flow to the turbine-driver. An examination revealed that the knife-edge of the trip resetting lever had disengaged from the hand trip lever latch area allowing the trip valve assembly to isolate steam flow to the turbine-driver.

A past operability evaluation identified there was one instance between October 29, 2010, and May 10, 2011, when the contact point between the hand trip lever and the resetting lever was disturbed. On February 14, 2011, in accordance with TS surveillance test, QO-21, the resetting lever was manually lowered then raised, causing the trip valve assembly to travel from the open to closed to open position (see figure below). This manipulation is performed to verify freedom of movement of the trip valve assembly. A QO-21 post-test check was performed that ensured proper alignment, i.e., no gap, between the resetting lever and the hand trip lever. No physical manipulations are performed as a part of this post-test alignment check. The alignment check was also performed on May 10, 2011, prior to pump operation for TS surveillance test, RO-97. No discrepancies were identified.
