Official Transcript of Proceedings
NUCLEAR REGULATORY COMMISSION

Title: Advisory Committee on Reactor Safeguards
590th Meeting

Date: Friday, January 20, 2012

**North Anna Power Station
Earthquake Assessment**

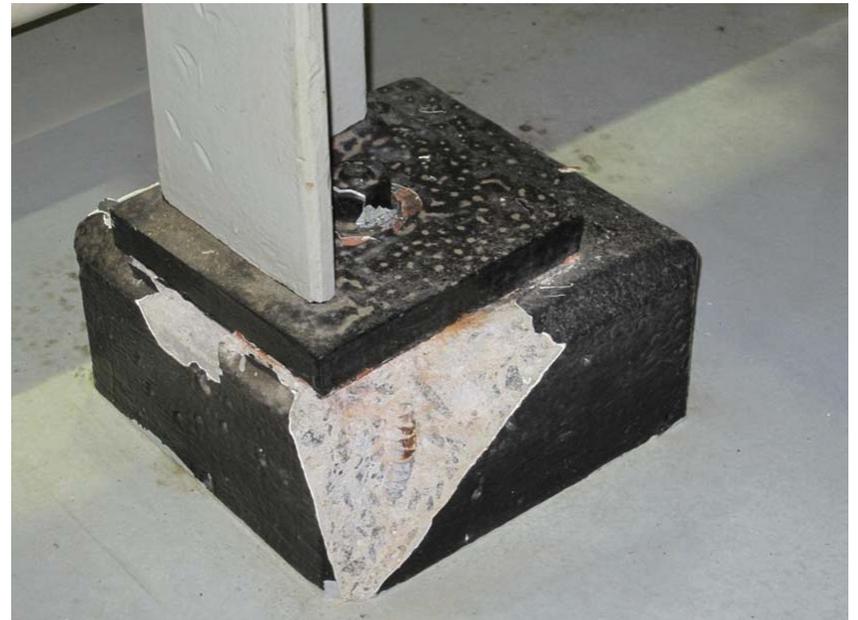
Non-Safety Related
Demineralizer
Tanks

22 And on the right-hand picture is a
23 magnified view of the bottom of one of them. This
24 represents the most serious structural damage that was
25 seen at North Anna.

17 MR. GRECHECK: And so clearly, there was
18 movement and there was some spalling of the corner of
19 the concrete here, but this is it.

Base Pedestal

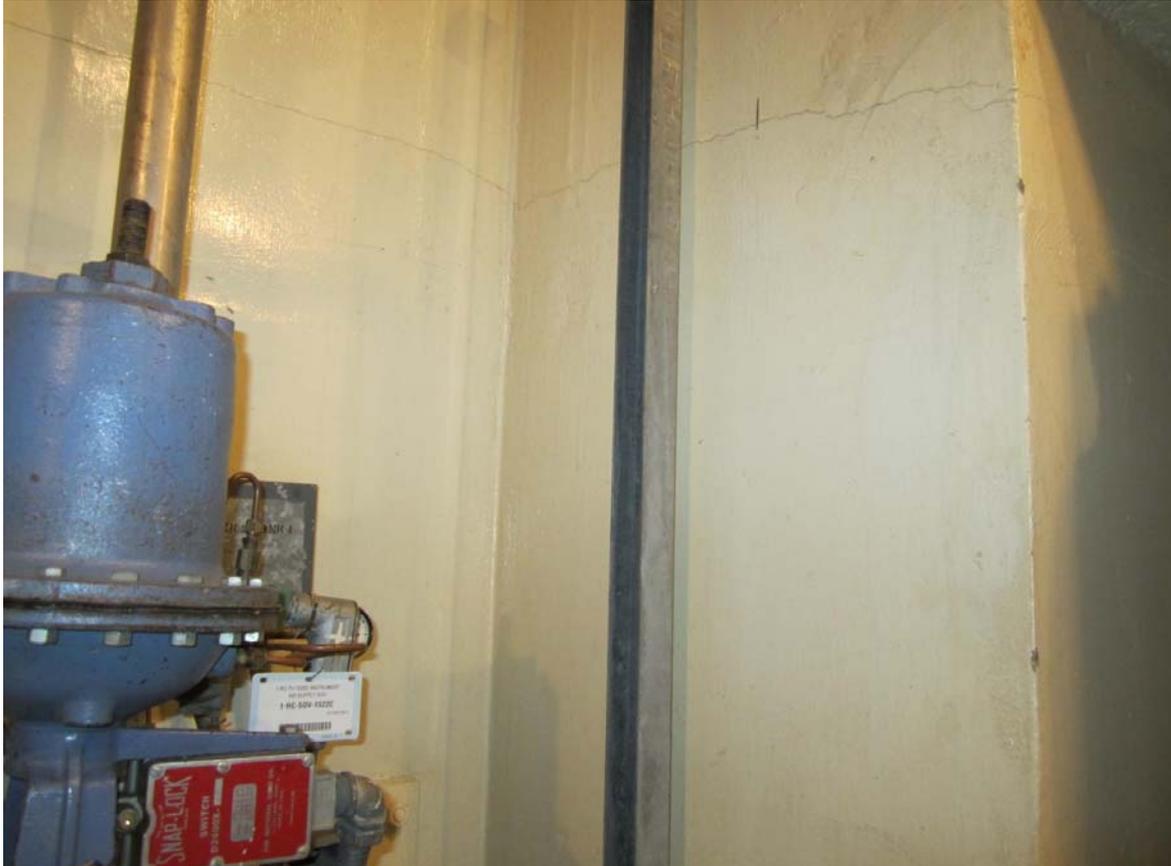
Unit 1 Containment

20 The next represents what was reported in
21 Bloomberg this day as a crack in the North Anna
22 containment wall. This is an interior wall. And the
23 crack that you can see running horizontally across the
24 top of the picture is a crack in grout across two
25 pored concrete slabs. This was simply a grout that

1 was placed during construction, but you could paint
2 the wall. The grout did crack along -- a pretty long
3 distance, probably maybe 20 feet or so, a horizontal
4 distance. But this was not structural. It was not in
5 the concrete. It was in the grout.

Surface Crack In Interior Containment Wall

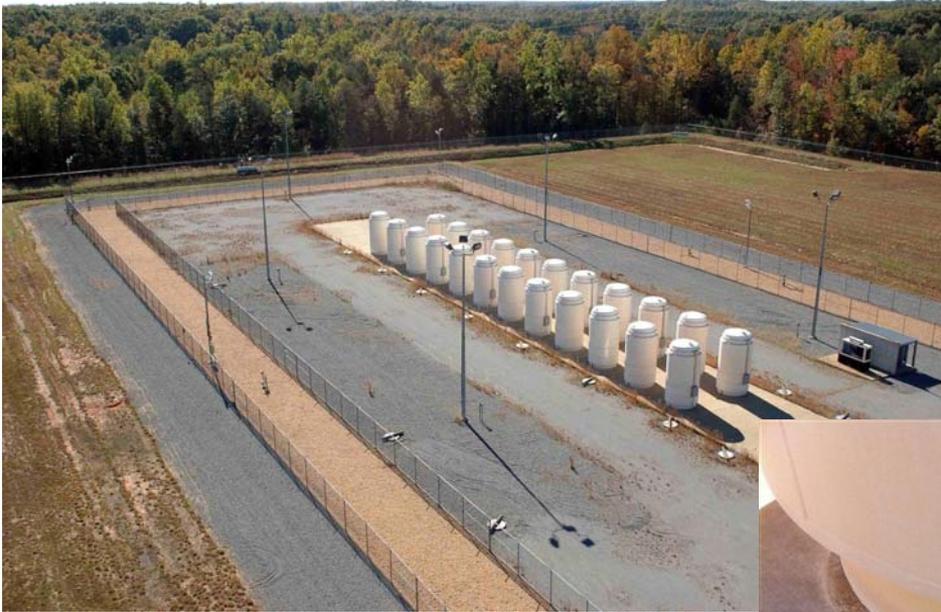
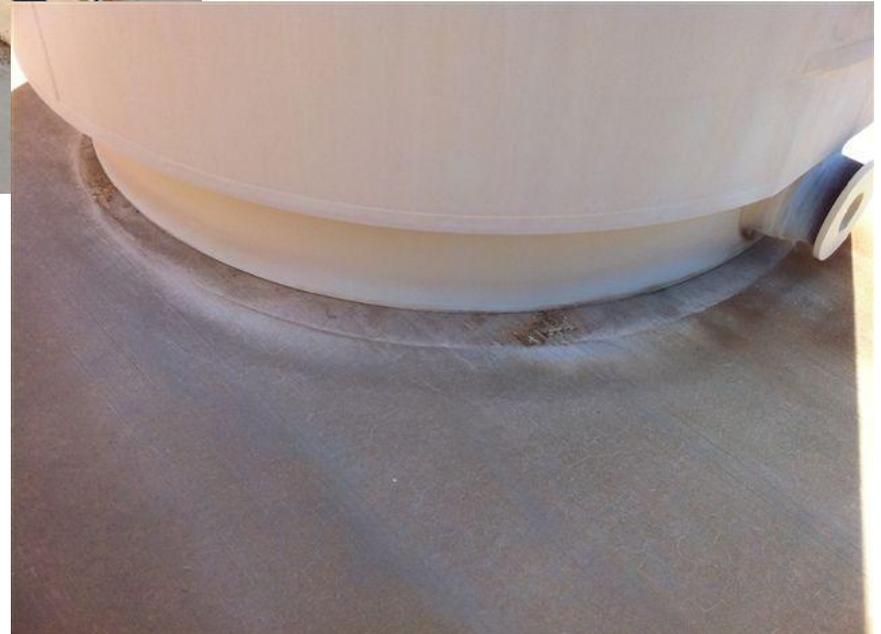
Dry Cask Storage

21 Your first glance is oh, why did this
22 move? But again, you're talking about a smooth bottom
23 tank on a concrete -- relatively smooth concrete pad.
24 The pad itself is seismically designed. The pad
25 didn't see any damage. The casks are monitored for

1 leakage across their seal. There was nothing detected
2 there. But it did actually --

Casks moved
between 1 and
4½ inches

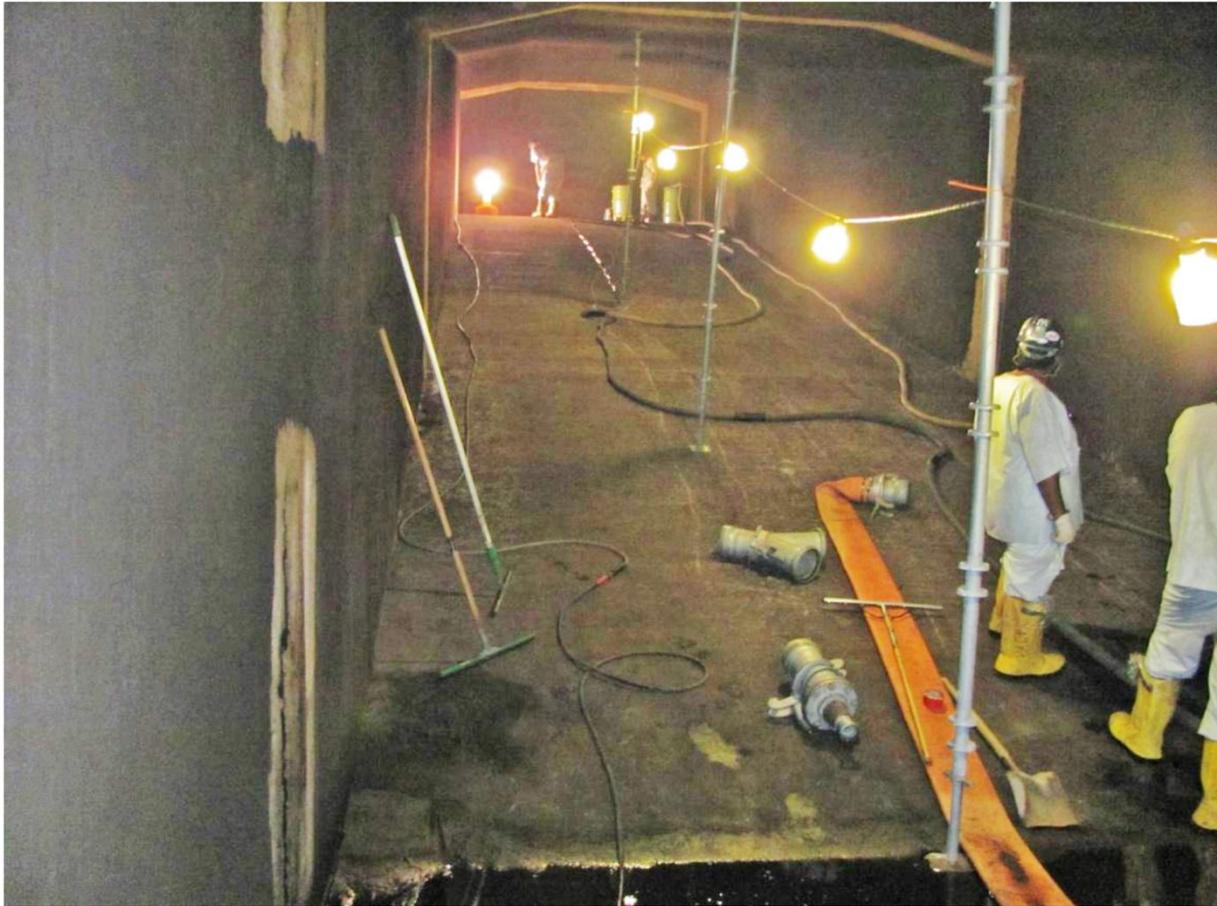
Unit 2 Tunnel Inspection

14 This is a picture of the Unit 2
15 circulating water tunnel. This is a picture that
16 you're not going to often see because normally there's
17 hundreds of millions of gallons a minute traveling
18 through here. But this is basically a horizontal
19 concrete box that is underground. Again, if there was
20 going to be lateral motion you would see it here
21 because you've got this rectangular box here that
22 would be susceptible to damage. There was no damage
23 found in this tunnel. But we did take the opportunity
24 of the outage to be able to go in here and do a very
25 extensive inspection of this tunnel.

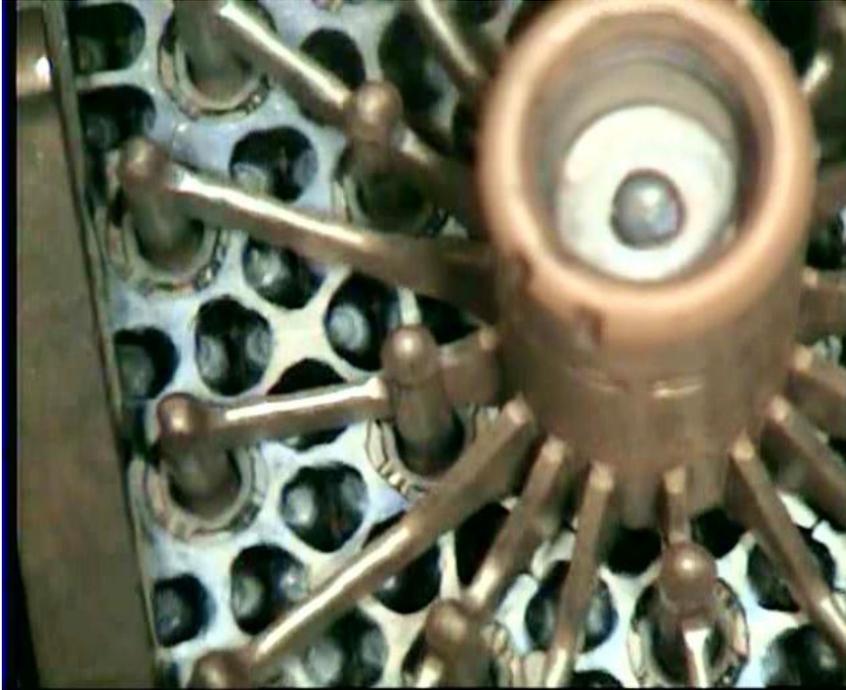
11 MR. GRECHECK: They had both units down.
12 Unit 2 was scheduled for refueling -- a refueling
13 outage about three weeks after the event, so we
14 entered into the refueling outage early, defueled the
15 Unit 2 reactor, looked at all the fuel assemblies as
16 they came out. Looked at fuel assemblies in the spent
17 fuel pool. Looked at new fuel assemblies which had
18 been delivered to the site in anticipation of the
19 refueling. Did not see any fuel damage.

Extensive Fuel Inspections

Visual inspection of RCCA hubs

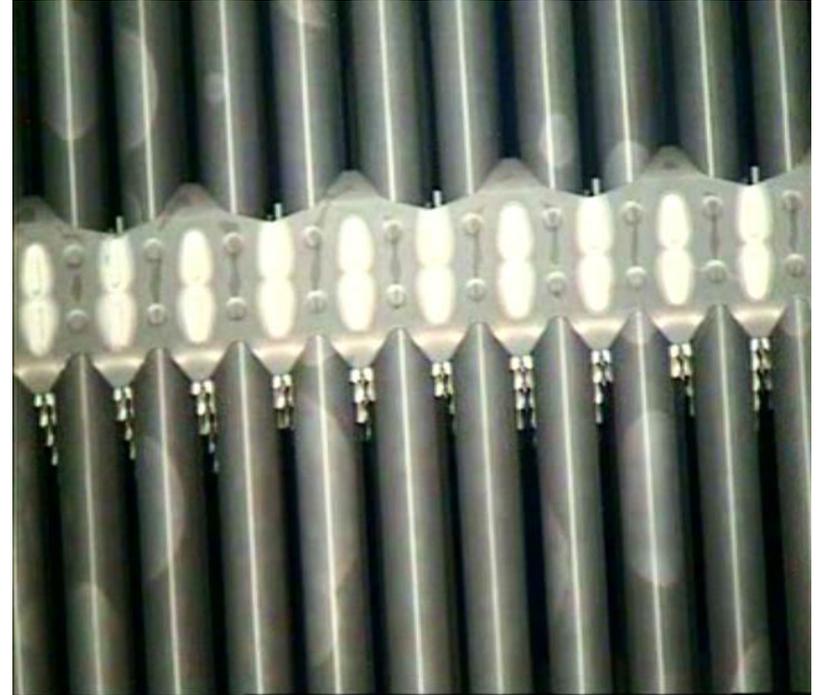
Examination of underside of a mid-span mixing grid

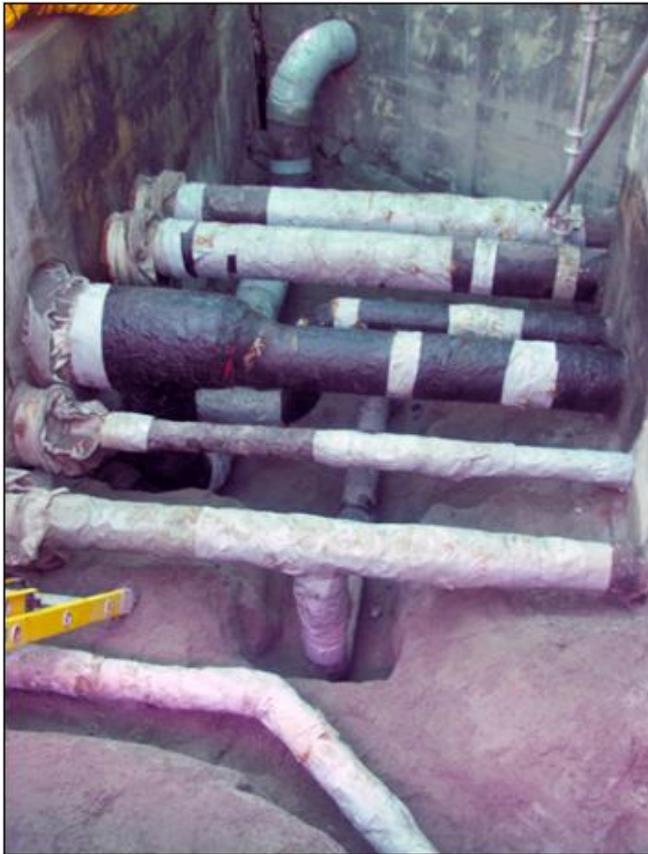
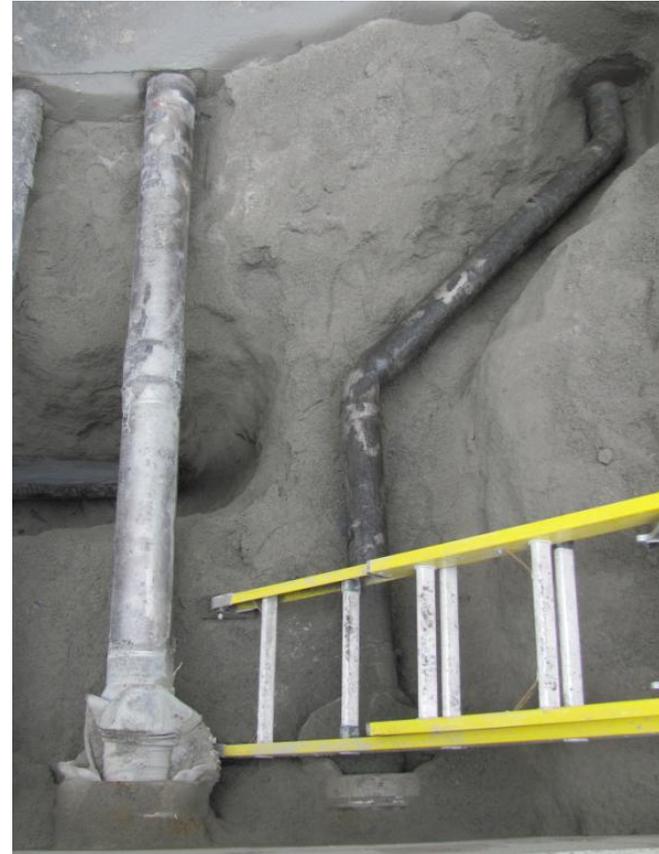
Buried Piping

8 MR. GRECHECK: But anyway, we excavated
9 all the way down there to look at these locations
10 where we would have expected to see damage. Again,
11 did not see any damage to any of this.

~ 100 ft of safety-related buried pipe visually inspected with wall thickness verified by Ultrasonic Testing

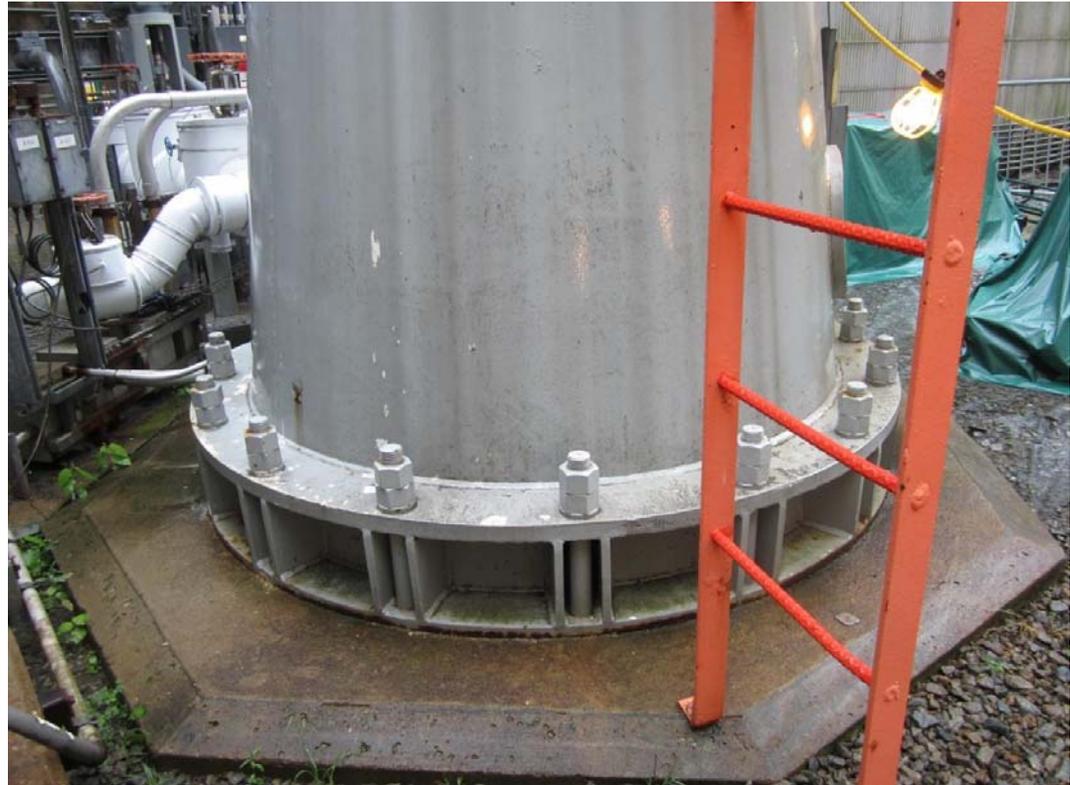
Chemical Addition Tank

15 MR. GRECHECK: Here's an example of one of
16 those earthquake indicators. This tank is one of the
17 susceptible tanks that came out of the list of the
18 IPEEE. This has this high confidence, low probability
19 failure HCLFPF value of only .19. So this would be
20 anticipated to be something that would be done of the
21 first things to show damage. And again, there was
22 nothing see here.

HCLPF value
= 0.19
No seismic
damage
identified

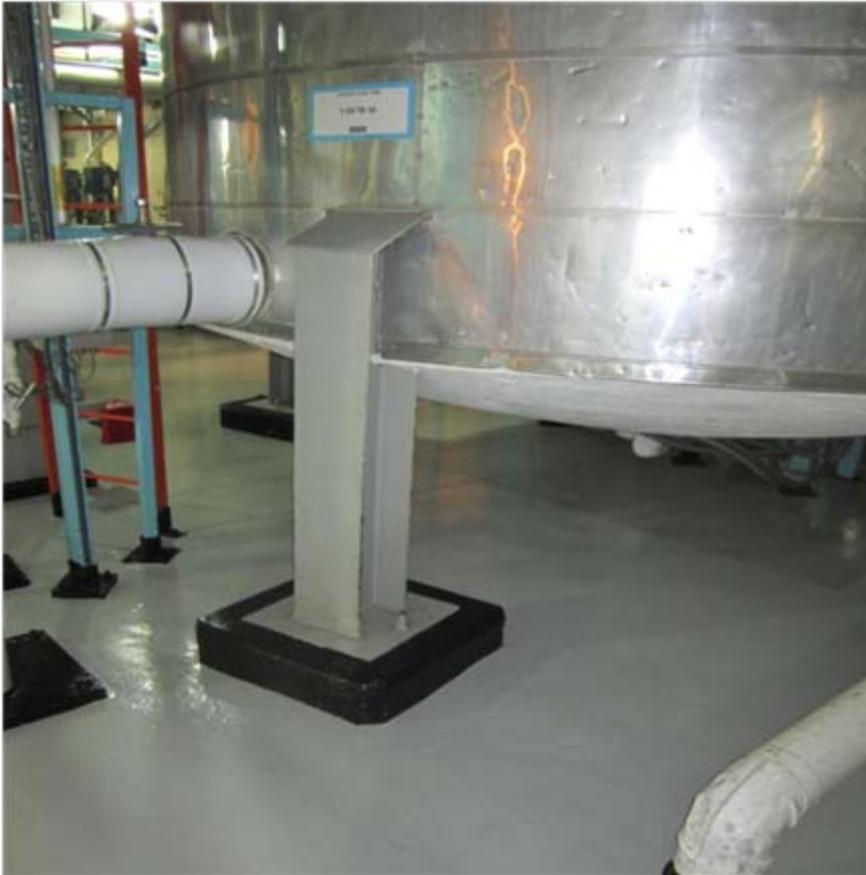
Boric Acid Storage Tank

23 This is another low HCLFPF component
24 again. This is an as-found picture. You can see that
25 there is not even any disruption to the insulation.

HCLPF value
= 0.21
No seismic
damage
identified
