**GE Hitachi Nuclear Energy**

February 01, 2012  
MFN 12-006 R0

**Subject: Part 21 60-Day Interim Report Notification:  
Failure of CRD Collet Retainer Tube/Outer Tube Weld**

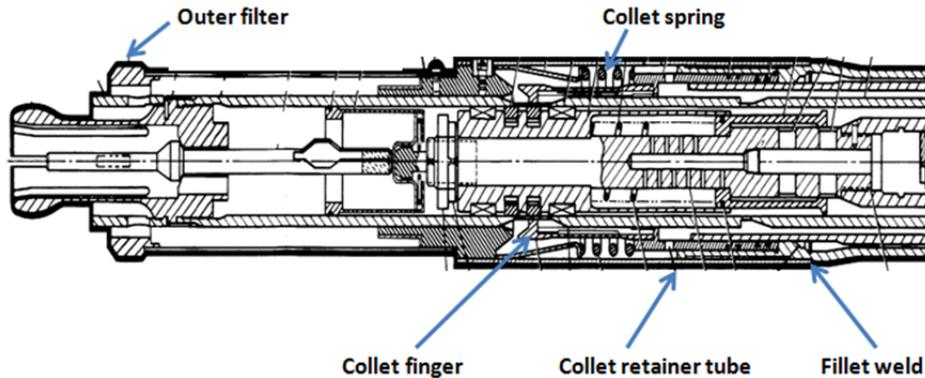
The recent refurbishment of a CRD G003 CTF assembly revealed a 360 degree failure around the collet retainer tube weld which was also completely separated, with a 0.15” displacement of the collet housing from the outer tube. This is the first occurrence of this type failure on any CTF assembly observed by GEH. It is noted that the CRD continued to perform normally, including scram, while in service.

The fillet weld design in question is applicable to all 919D258G002 and G003 Cylinder, Tube and Flange assemblies since the collet retainer tube material, part configuration and fillet weld design are the same for both groups. This fillet weld is located on the Outer Tube Assembly and is part of the Cylinder, Tube and Flange (CTF) assembly of the CRD mechanism.

The G003 CTF containing the failed fillet weld was removed from service in 2011. The collet retainer tube displacement was observed to be 0.15 inches. In addition to this observed displacement, two other dimensions provide an upper bound to the potential movement of the collet retainer tube:

- Per drawing dimensions after separation the collet retainer tube could displace a nominal distance of ~1.3 inches, before the top of the CRD outer filter would stop against the bottom of the control rod guide tube base.
- After separation a displacement of ~1 inch would result in the collet spring, which is maintained in a compressed state per design requirements, returning to its free length state. The collet spring in its free length state would restrict the collet fingers from deflecting outward and clear of the index tube notches.

Testing is being performed to validate if weld shrinkage restricted the further displacement of the collet retainer tube from the outer tube after separation. CRD index tube movement would likely begin to be inhibited if the collet retainer tube separated and displaced an approximate distance of 1 inch. This degree of separation could potentially result in a stuck control rod (no insert, withdraw or scram motion).

Although not confirmed, preliminary indication suggests that the weld failure may be attributed to the lack of weld penetration and fusion to the base materials.

GEH recommends normal CRD surveillance testing in accordance with the plants' Technical Specification Surveillance Requirements. A failure of this fillet weld resulting in separation and full displacement of the collet retainer tube and affecting the operation of the CRD would be identified during the surveillance testing.

GEH recommends that all sites continue to perform scheduled maintenance on CRD assemblies and perform dye penetrant inspections of this weld area as previously described in GE SIL139 supplement 6.
