GE Hitachi Nuclear Energy

February 01, 2012
MFN 12-006 R0

**Subject: Part 21 60-Day Interim Report Notification:
Failure of CRD Collet Retainer Tube/Outer Tube Weld**

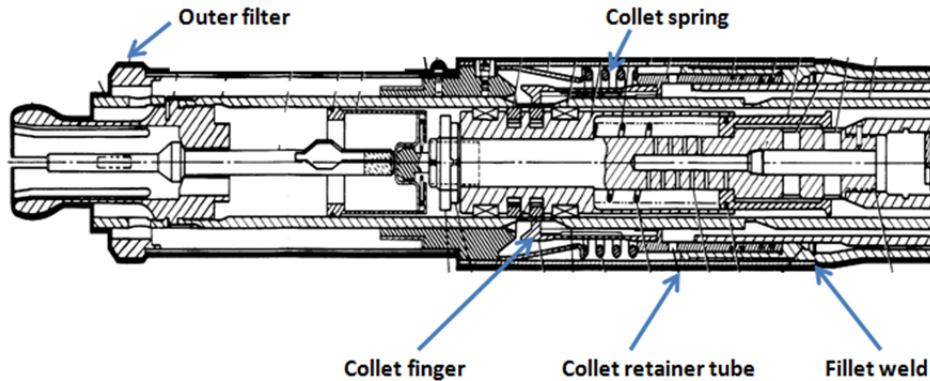
The fillet weld design in question is applicable to all 919D258G002 and G003 Cylinder, Tube and Flange assemblies since the collet retainer tube material, part configuration and fillet weld design are the same for both groups. This fillet weld is located on the Outer Tube Assembly and is part of the Cylinder, Tube and Flange (CTF) assembly of the CRD mechanism.

The G003 CTF containing the failed fillet weld was removed from service in 2011. The collet retainer tube displacement was observed to be 0.15 inches. In addition to this observed displacement, two other dimensions provide an upper bound to the potential movement of the collet retainer tube:

Although not confirmed, preliminary indication suggests that the weld failure may be attributed to the lack of weld penetration and fusion to the base materials.

The collet retainer tube fillet weld completely failed 360 degrees around the weld and separated and displaced 0.15" from the outer tube. GEH is currently evaluating the cause and if this type of weld failure could credibly result in ~1 inch movement of the collet retainer tube and subsequent restriction of collet fingers and prevention of CRD operation.

GEH recommends normal CRD surveillance testing in accordance with the plants' Technical Specification Surveillance Requirements. A failure of this fillet weld resulting in separation and full displacement of the collet retainer tube and affecting the operation of the CRD would be identified during the surveillance testing.

GEH recommends that all sites continue to perform scheduled maintenance on CRD assemblies and perform dye penetrant inspections of this weld area as previously described in GE SIL139 supplement 6.
