Summary of Earthquake Information for the North Anna Nuclear Power Plant
(Last Update: September 9, 2011)

North Anna Independent Spent Fuel Storage Installation **Response to Earthquake**

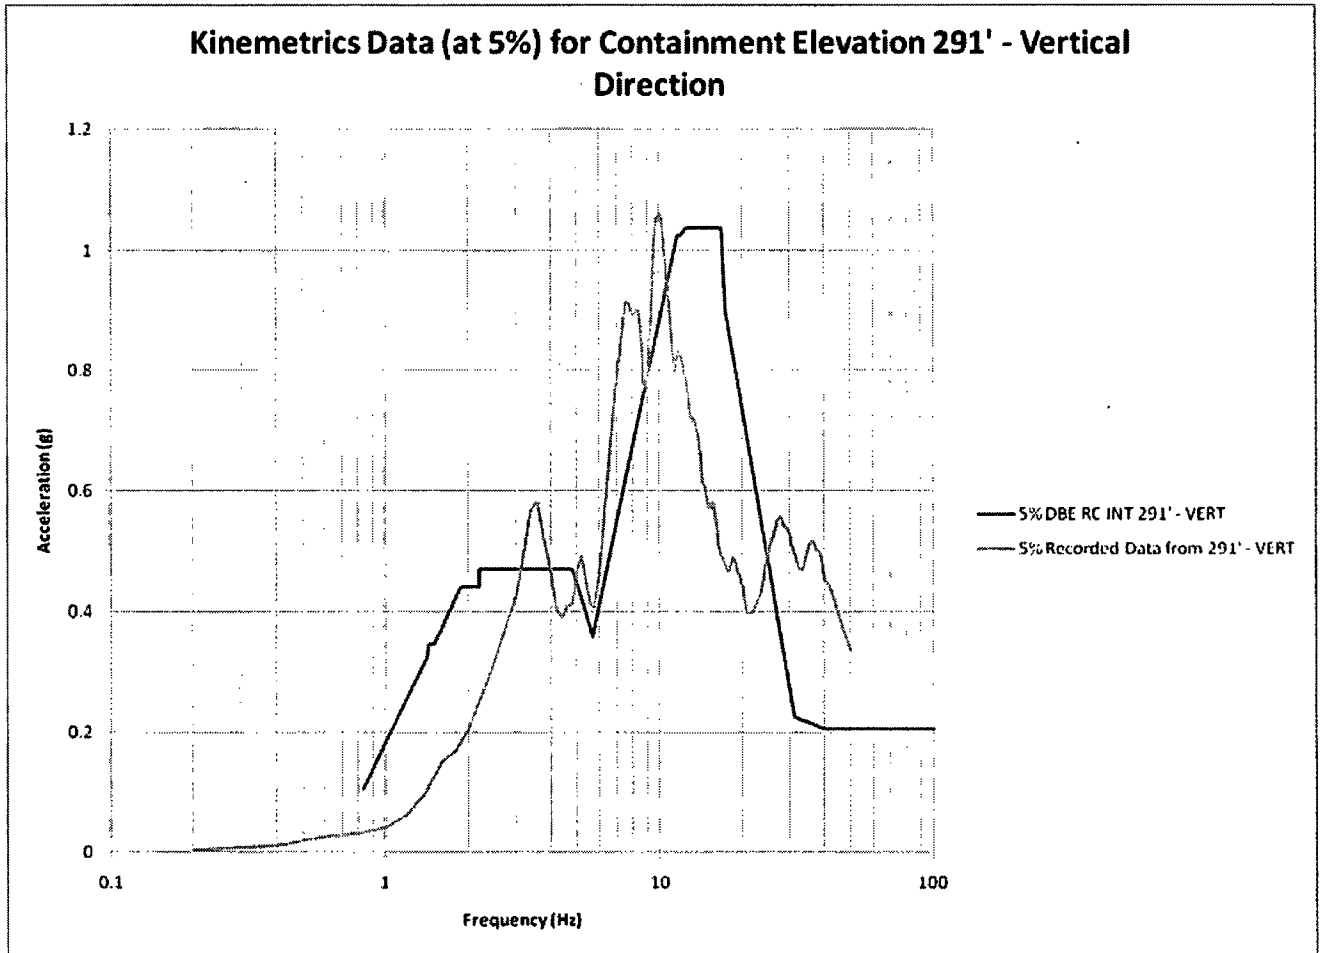
- Preliminary data provided by the licensee indicate that the DBEs at different elevation levels have been exceeded in both the horizontal and vertical directions at different frequencies (see attached sample figure).
- The licensee's inspections have not identified any safety related equipment which failed during the event except for the 2H EDG. When it became evident that the DBE had been exceeded, the licensee declared all the safety related equipment in both units inoperable and took action to place the units in cold shutdown.
- Preliminary data from the licensee's investigation with regards to the 2H EDG failure indicates that a cooling water system gasket may have been installed incorrectly.

The figure above, as submitted by the licensee, compares the observed ground motion in the vertical direction to the exceeded design motion at various frequencies. The blue curve is from the observed readings and the purple curve is the design spectrum at the same elevation level.
