PART 21 REPORT - FAILURE OF CRD COLLET RETAINER TUBE/OUTER TUBE WELD

February 01, 2012  
MFN 12-006 R0

**Subject: Part 21 60-Day Interim Report Notification:  
Failure of CRD Collet Retainer Tube/Outer Tube Weld**

Attachment 1 – Description of Evaluation

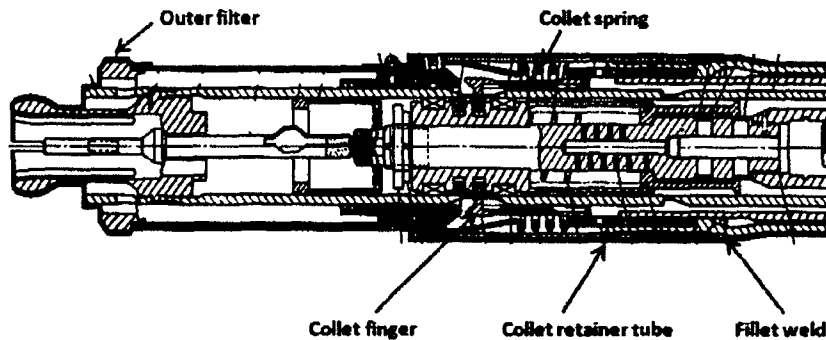
The recent refurbishment of a CRD G003 CTF assembly revealed a 360 degree failure around the collet retainer tube weld which was also completely separated, with a 0.15" displacement of the collet housing from the outer tube. This is the first occurrence of this type failure on any CTF assembly observed by GEH. It is noted that the CRD continued to perform normally, including scram, while in service.

The fillet weld design in question is applicable to all 919D258G002 and G003 Cylinder, Tube and Flange assemblies since the collet retainer tube material, part configuration and fillet weld design are the same for both groups. This fillet weld is located on the Outer Tube Assembly and is part of the Cylinder, Tube and Flange (CTF) assembly of the CRD mechanism.

The G003 CTF containing the failed fillet weld was removed from service in 2011. The collet retainer tube displacement was observed to be 0.15 inches. In addition to this observed displacement, two other dimensions provide an upper bound to the potential movement of the collet retainer tube:

- Per drawing dimensions after separation the collet retainer tube could displace a nominal distance of ~1.3 inches, before the top of the CRD outer filter would stop against the bottom of the control rod guide tube base.
- After separation a displacement of ~1 inch would result in the collet spring, which is maintained in a compressed state per design requirements, returning to its free length state. The collet spring in its free length state would restrict the collet fingers from deflecting outward and clear of the index tube notches.

Testing is being performed to validate if weld shrinkage restricted the further displacement of the collet retainer tube from the outer tube after separation. CRD index tube movement would likely begin to be inhibited if the collet retainer tube separated and displaced an approximate distance of 1 inch. This degree of separation could potentially result in a stuck control rod (no insert, withdraw or scram motion).

Although not confirmed, preliminary indication suggests that the weld failure may be attributed to the lack of weld penetration and fusion to the base materials.

GEH recommends normal CRD surveillance testing in accordance with the plants' Technical Specification Surveillance Requirements. A failure of this fillet weld resulting in separation and full displacement of the collet retainer tube and affecting the operation of the CRD would be identified during the surveillance testing.

GEH recommends that all sites continue to perform scheduled maintenance on CRD assemblies and perform dye penetrant inspections of this weld area as previously described in GE SIL139 supplement 6.
