PART 21 REPORT - FOREIGN MATERIAL FOUND IN EMERGENCY DIESEL GENERATOR HIGH PRESSURE FUEL HOSE

Report No. 10CFR21-0104

**10CFR21 REPORTING OF DEFECTS
AND NON-COMPLIANCE**

COMPONENT: NPPD fuel hose 2-01H-050-003

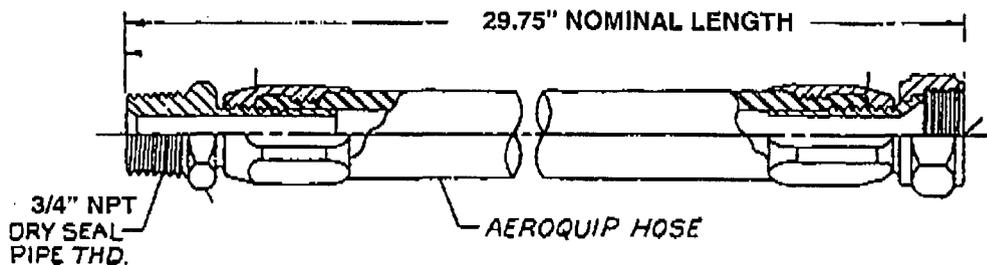
FIGURE 1

The foreign material found during inspection of the returned hose assembly was determined to be very small pieces of the elastomer tube internal to the hose. It appears these pieces were introduced during assembly of the end fittings onto the hose during fabrication of the hose assembly.

FUEL HOSE #2-01H-050-003

Hoses remaining in customer inventory should be inspected to verify they are free of foreign material prior to installation. Any hoses previously installed on the EDG are not suspect as operability has been confirmed via functional testing.

To prevent recurrence of this issue, the dedication report for the hose assembly has been revised to include a requirement to solvent flush each hose prior to shipment. Filtered solvent will be pumped through the hose for a minimum of 5 minutes. After flushing, nitrogen will be blown through the hose to remove excess flushing fluid and a detailed visual inspection will be performed to ensure there are no visible contaminants immediately prior to installation of the hose end caps. This flushing requirement was already included in the dedication reports for other critical application hose assemblies so this notification is being limited to this part number only.

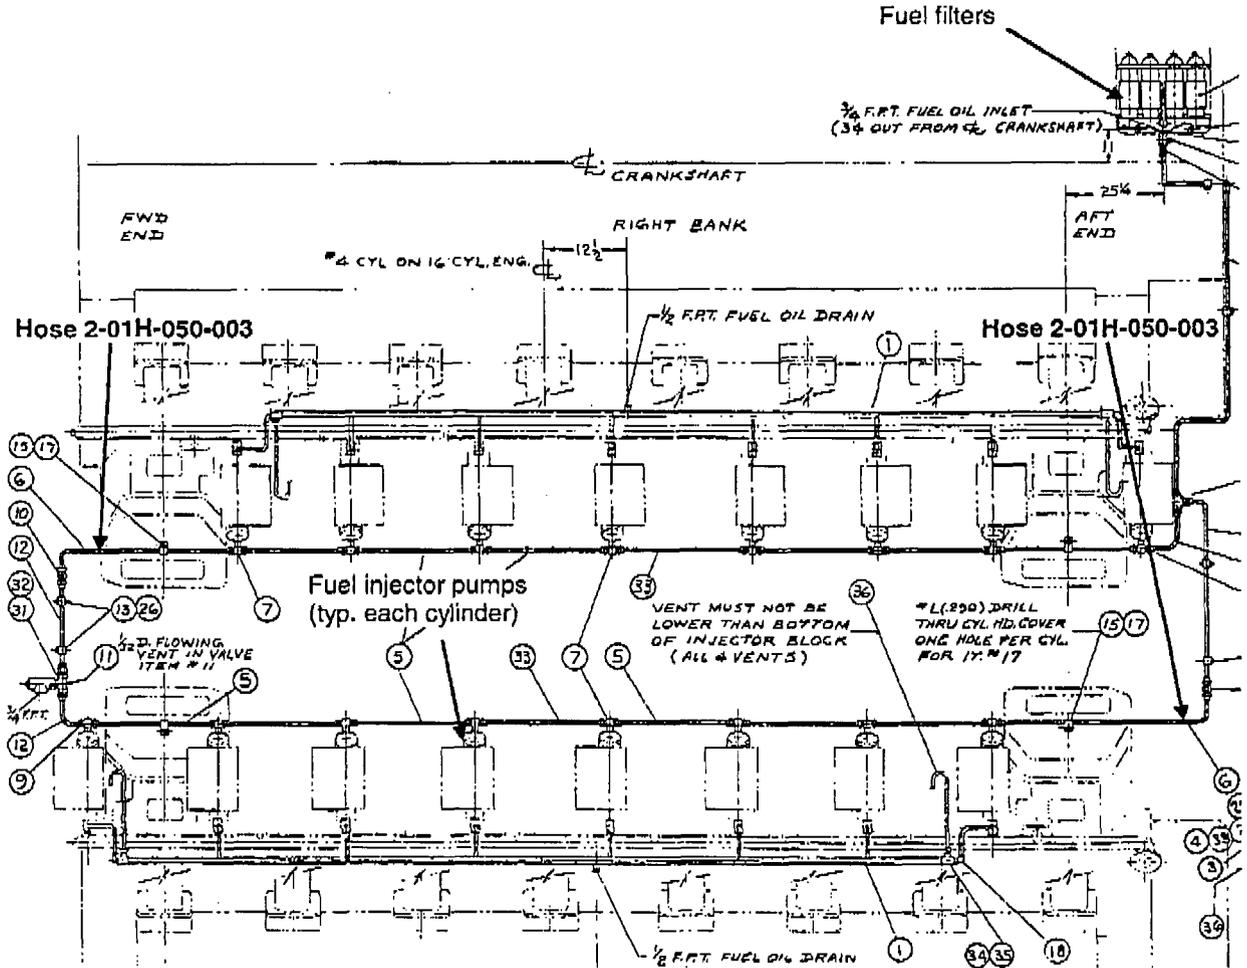
FIGURE 2
LOCATIONS OF FUEL HOSE #2-01H-050-003

The hose, P/N 2-01H-050-003, is located after the engine fuel filter and before the fuel injection pumps. Foreign material within this hose could migrate to the fuel injection pumps. The entrance of foreign material could impact operability of one or more fuel injection pumps and therefore affect fuel delivery to one or more engine cylinders. This could impact the load carrying capability of the diesel engine or possibly complete engine shutdown. Either scenario has the potential to prevent the emergency diesel generator from performing its safety related function.

This hose is used in the fuel oil supply piping on the KSV diesel engine; it is located in the piping between the engine fuel filter and the fuel injector pumps (see Figure 1 and 2) and is unique to the NPPD-Cooper Station engines.
