VIRGINIA ELECTRIC AND POWER COMPANY (DOMINION)
NORTH ANNA POWER STATION UNIT 1
STEAM GENERATOR TUBE INSPECTION REPORT

**NORTH ANNA UNIT 1
180-DAY NRC REPORT REGARDING STEAM GENERATOR TUBE INSPECTION
PER TECHNICAL SPECIFICATION 5.6.7**

FALL 2011 - NORTH ANNA UNIT 1 STEAM GENERATOR INSPECTIONS

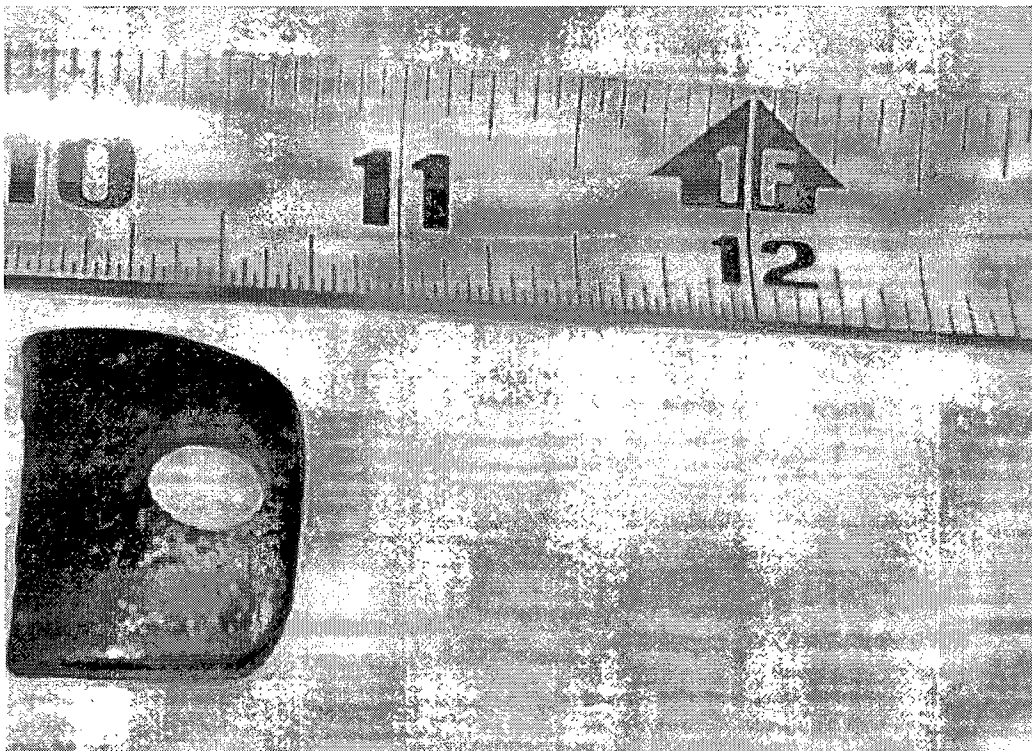
Figure 1 – SG A Primary Side Foreign Object

Two foreign objects were identified within the hot leg channel head of SG "A." One object was found to be protruding slightly from tube SGA R29C21. This object was removed from the tube (Figure 1). Post-removal, full length bobbin probe examination, and +Point probe examination of the full tubesheet depth confirmed that the foreign object caused no tube degradation. The second object was identified lying on the bottom of the hot leg channel head bowl and was successfully removed (Figure 2). Both objects appear to have originated from the same part (Figure 3) – possibly a conduit / pipe support clamp – and are 300 series stainless steel. A visual examination of the tubesheet revealed no evidence of tube end or cladding damage.
