**From:** Nieh, Ho - (COMM)  
**Sent:** Thursday, September 01, 2011 1:28 PM  
**To:** Ostendorff, William  
**Subject:** FW: Updated One Pager on North Anna Earthquake  
**Attachments:** One Pager on North Anna Earthquake Issue updated 9-1-11.docx

## Summary of Earthquake Information for the North Anna NPP as of August 24, 2011

## North Anna Independent Spent Fuel Storage Installation Response to Earthquake

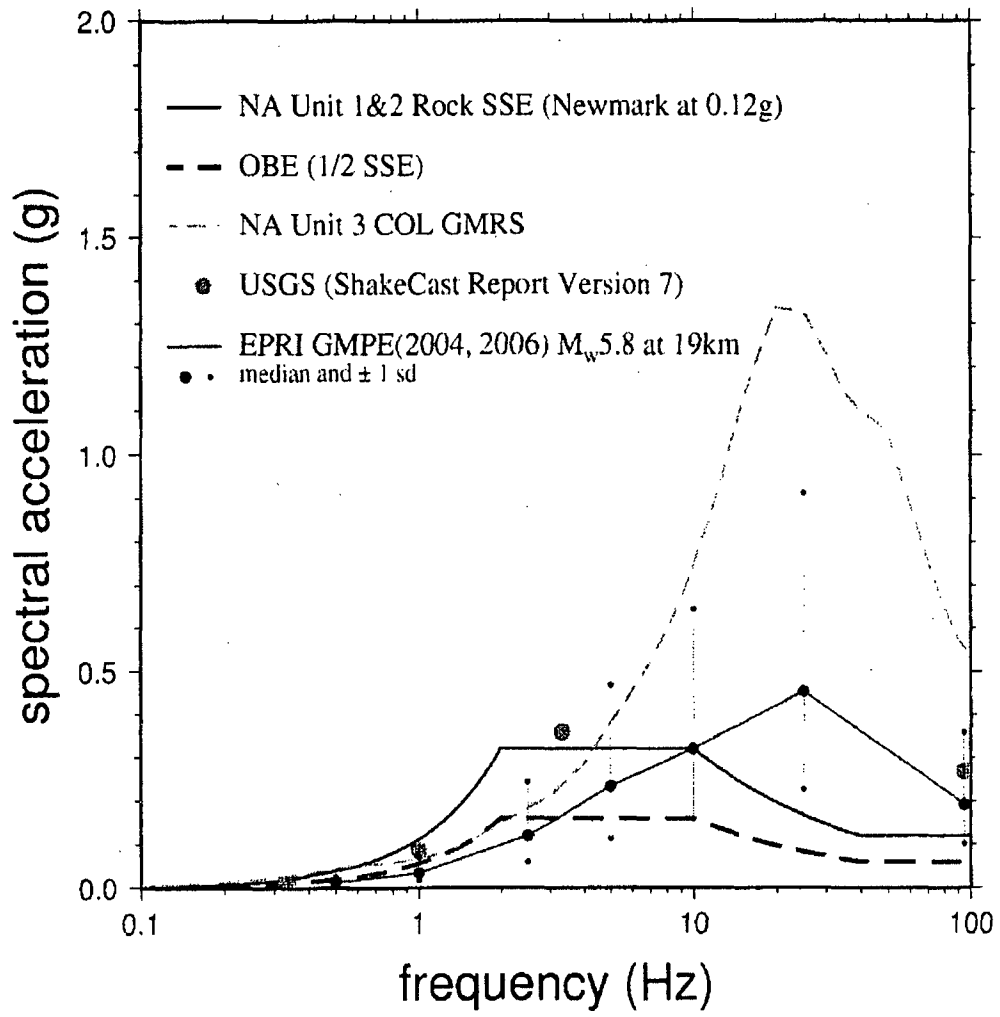
### North Anna Spectrum Curves

The current best estimate of the Peak Ground Acceleration (PGA) for the NANPP site is 0.26g, which contains uncertainty and may be updated later. This estimate indicates that the ground motion likely exceeded the SSE response spectra for NANPP Units 1 and 2 (0.12g) over a considerable frequency range, as shown by the green and red points in the figure. The estimated ground motion from the earthquake was not a surprise based on the combined operating license application (COLA) ground motion response spectrum for NANPP Unit 3. This preliminary estimate appears to validate the NRC's current seismic hazard assessment approaches and models for new reactors, as well as the basis for GI-199 reviews.
