# **North Anna Nuclear Power Plant Seismic Event**

Presentation to the Commissioners  
August 30 and September 1, 2011

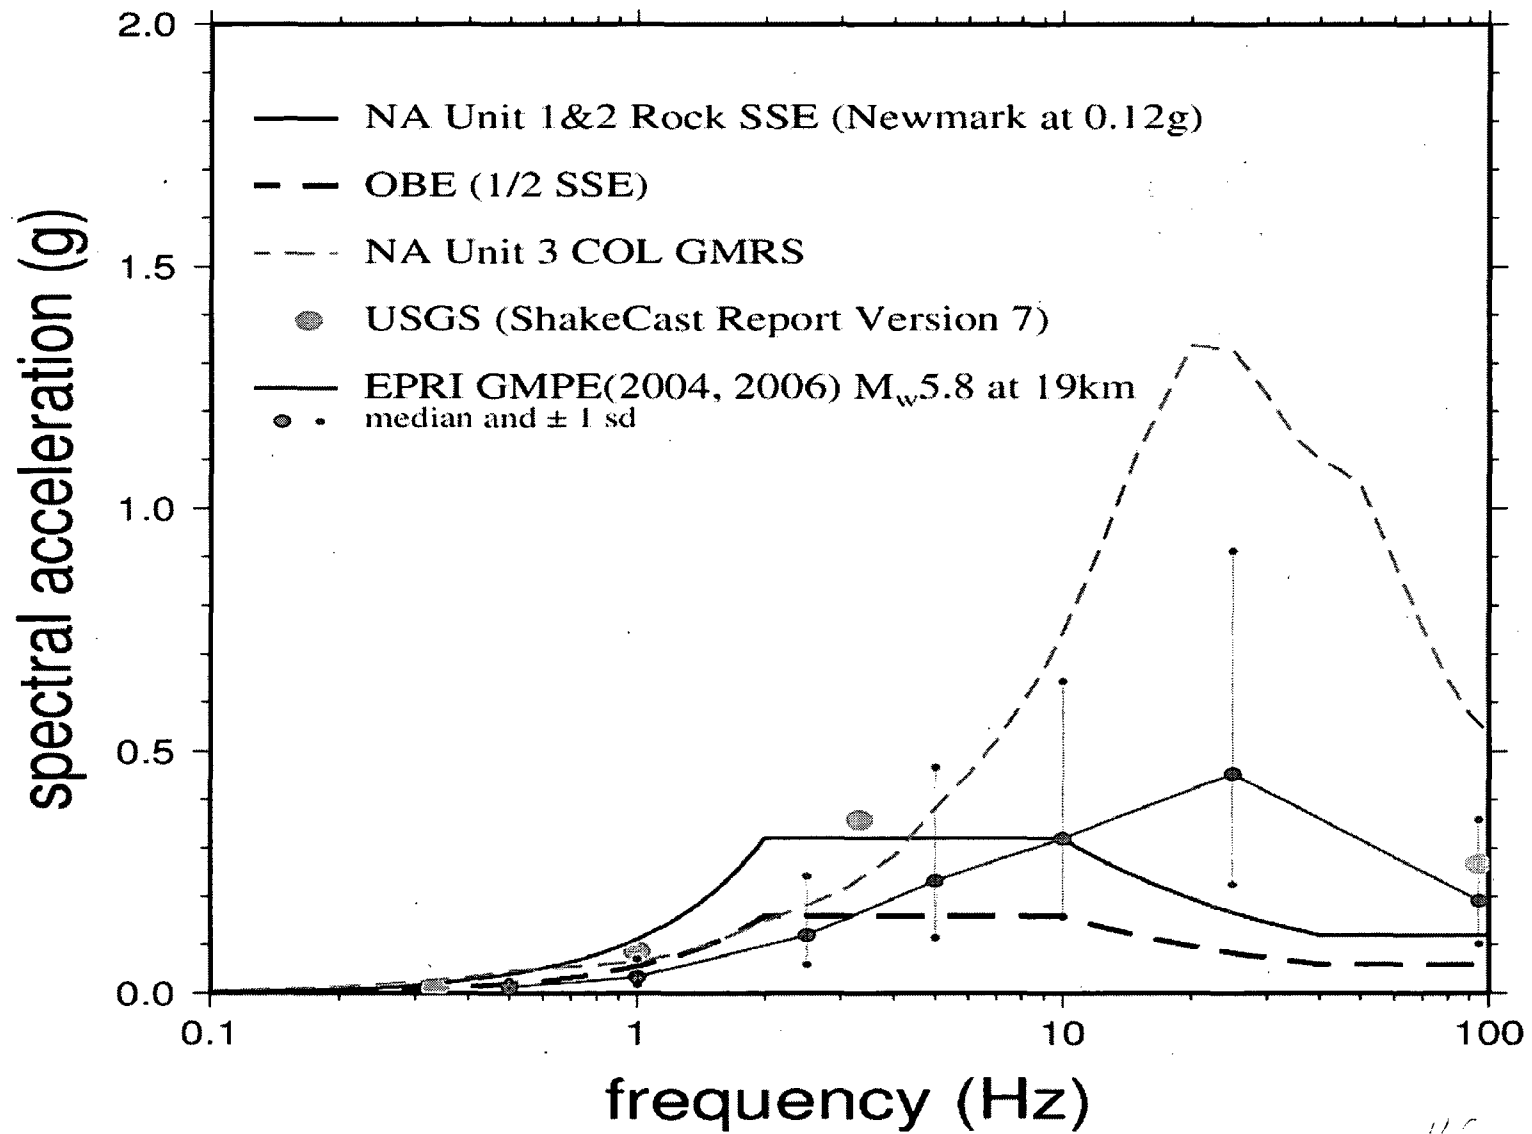
# Figure 1

- Exceedance of the DBE is an unprecedented event at an operating unit
- However, while Perry Unit was under construction, an earthquake occurred that exceeded SSE at high frequency (15hz)
  - A special safety inspection was conducted by the NRC's Region III Staff on February 5–7, 1986. See Inspection Reports 50–440/86005 and 50–440/86006. This included a post-earthquake walkdown and visual inspection of an extensive list of safety-related systems and components.
- NRC staff performed independent analysis (See Figure 1)
