THE UNIVERSITY OF TEXAS AT AUSTIN

Nuclear Engineering Teaching Laboratory · <http://www.me.utexas.edu/~nuclear/index.php/netl>  
1 University Station, R9000 · Austin, Texas · 78712 · (512) 232-5370 · Fax (512) 471-4589

Subject: Docket 50-602, License no. R-129 Licensee Event Report 47625 Followup Report

#### EVENT DESCRIPTION

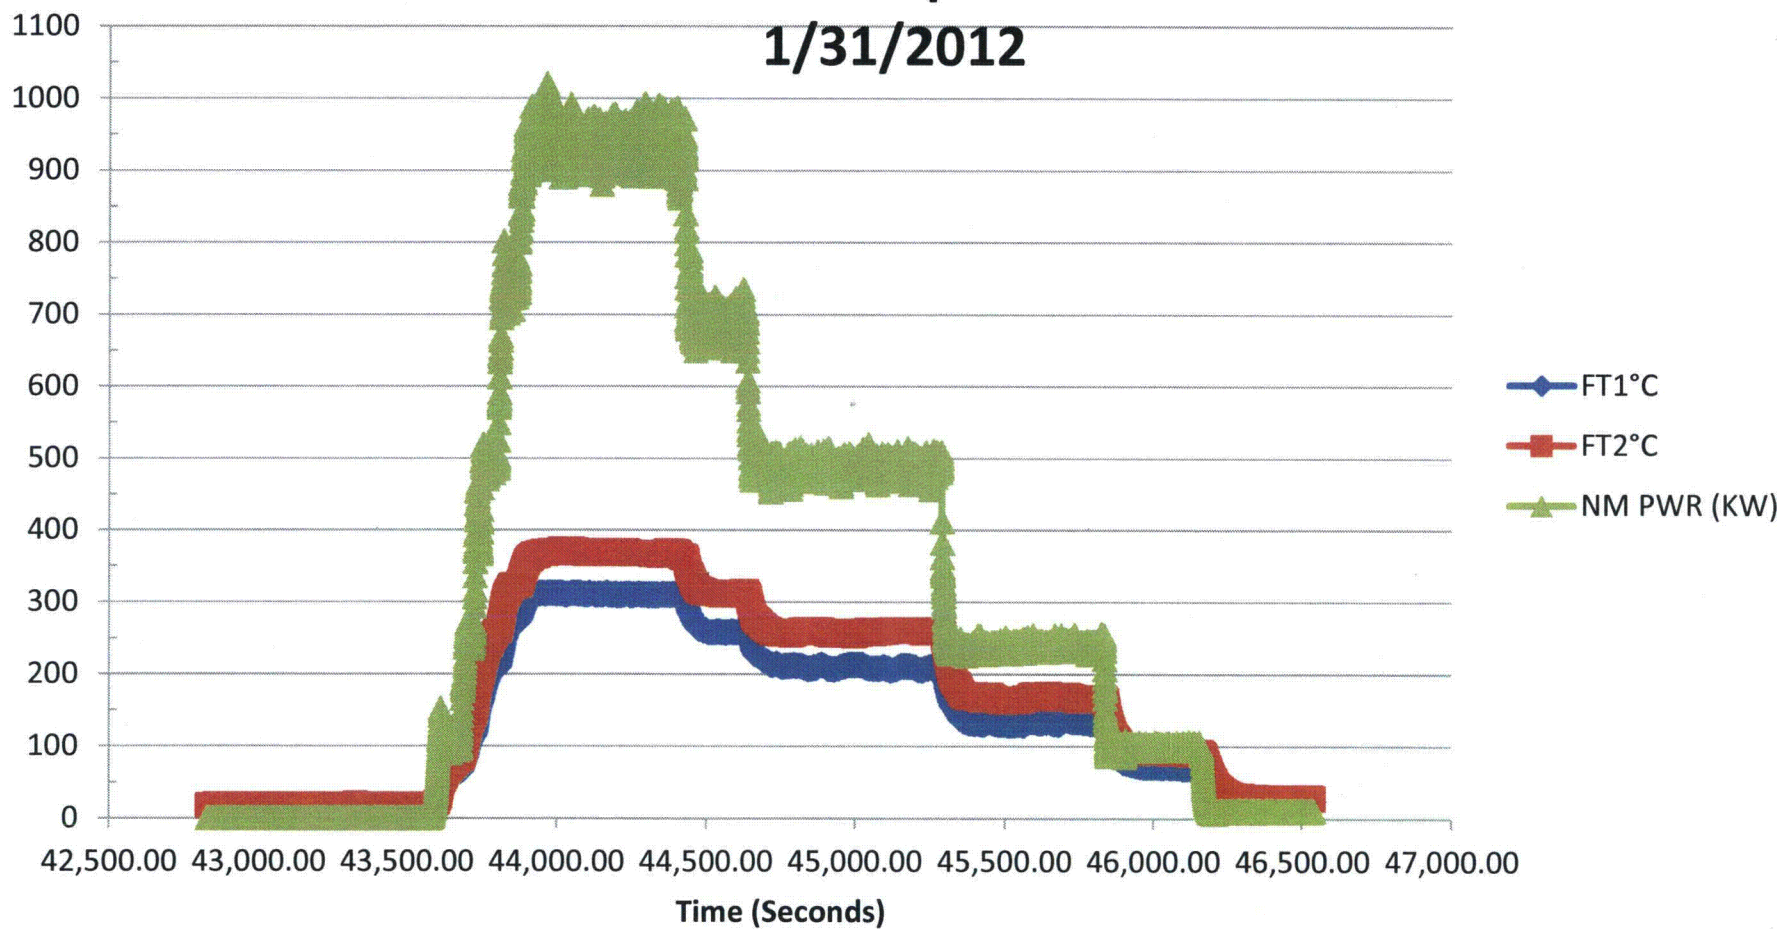
# Pwr & FT vs Time with repaired TC

*Resistance checks were completed on January 31, 2012. Testing indicated the short circuit was resolved. The thermocouple is considered restored to service, pending routine calibration checks conducted in accordance with approved operating/maintenance procedures.*
