**Subject: January 2012 Inspection Report
Cameco Resources, Permits 603 & 633**

**PERMITS 603 & 633 INSPECTION REPORT
JANUARY 2011
DISTRICT 1/LAND QUALITY DIVISION**

COMPANY: Cameco Resources, Incorporated

LOCATION: North of Glenrock, Converse County (Smith-Highland Ranch Uranium Project)

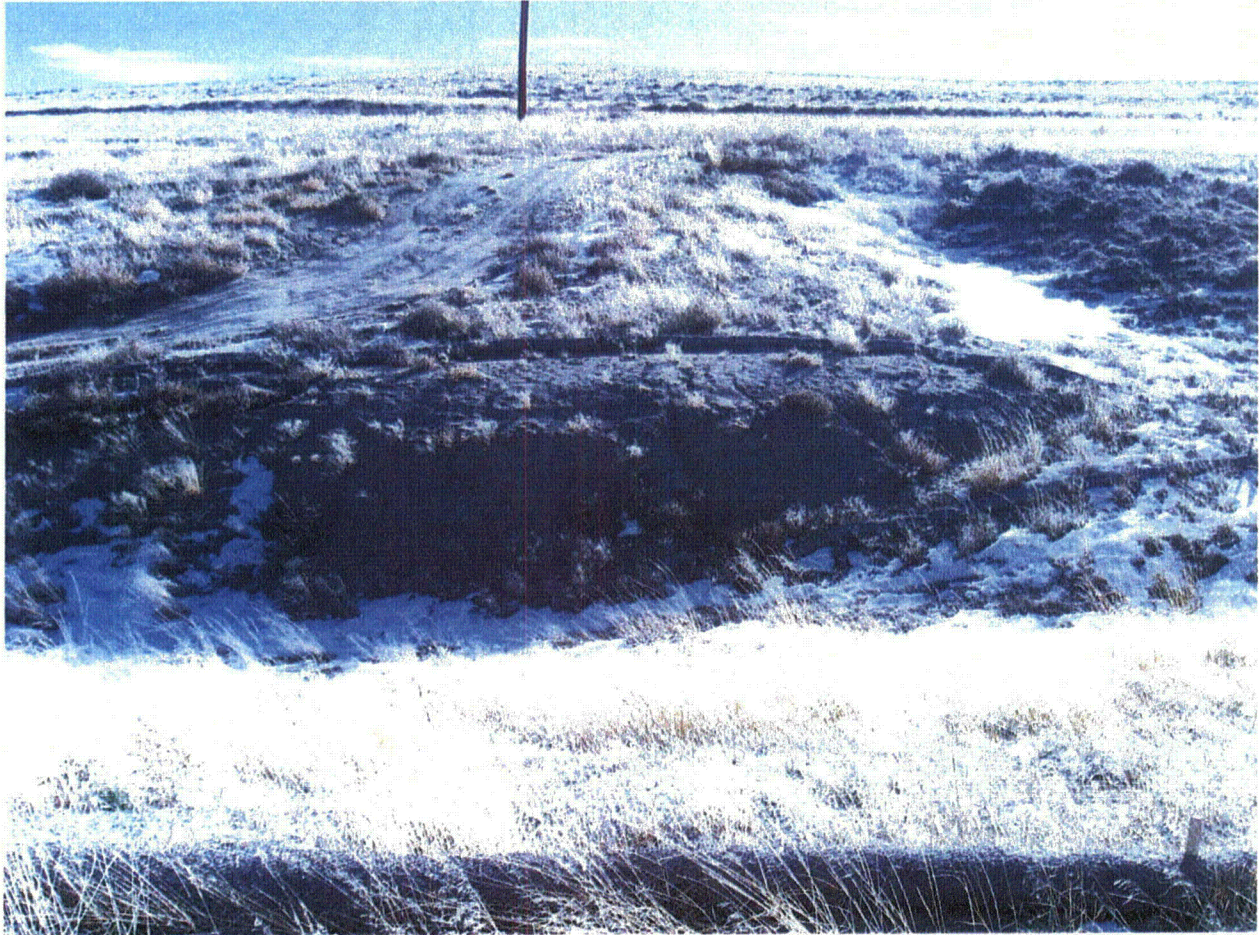
- slopes of drainage are stable with waddles functioning; few sandy exposed areas on south slope could use additional revegetation (**Figure 1**)

- 2 The drainage slopes in MU-9 appear stable and straw waddles have been utilized to protect revegetation. There are barren areas particularly along the south slopes that will likely erode further if additional prevention is not provided such as slope reduction and vegetation. LQD will continue to monitor the drainage for control of sediment into the flow path of the drainage.

Figure 1 South slope of drainage in MU-9; straw waddles used to control sedimentation; steep slope without vegetation likely to continue to erode

There are no compliance items that require immediate action. As mentioned during the inspection, CR should continue to monitor sediment in the drainage in MU-9, particularly on steep slopes without vegetation. It was noted that CR has improved topsoil protection and sediment control practices as well as minimizing the disturbance footprint in new wellfield development areas. This effort is recognized and greatly appreciated.

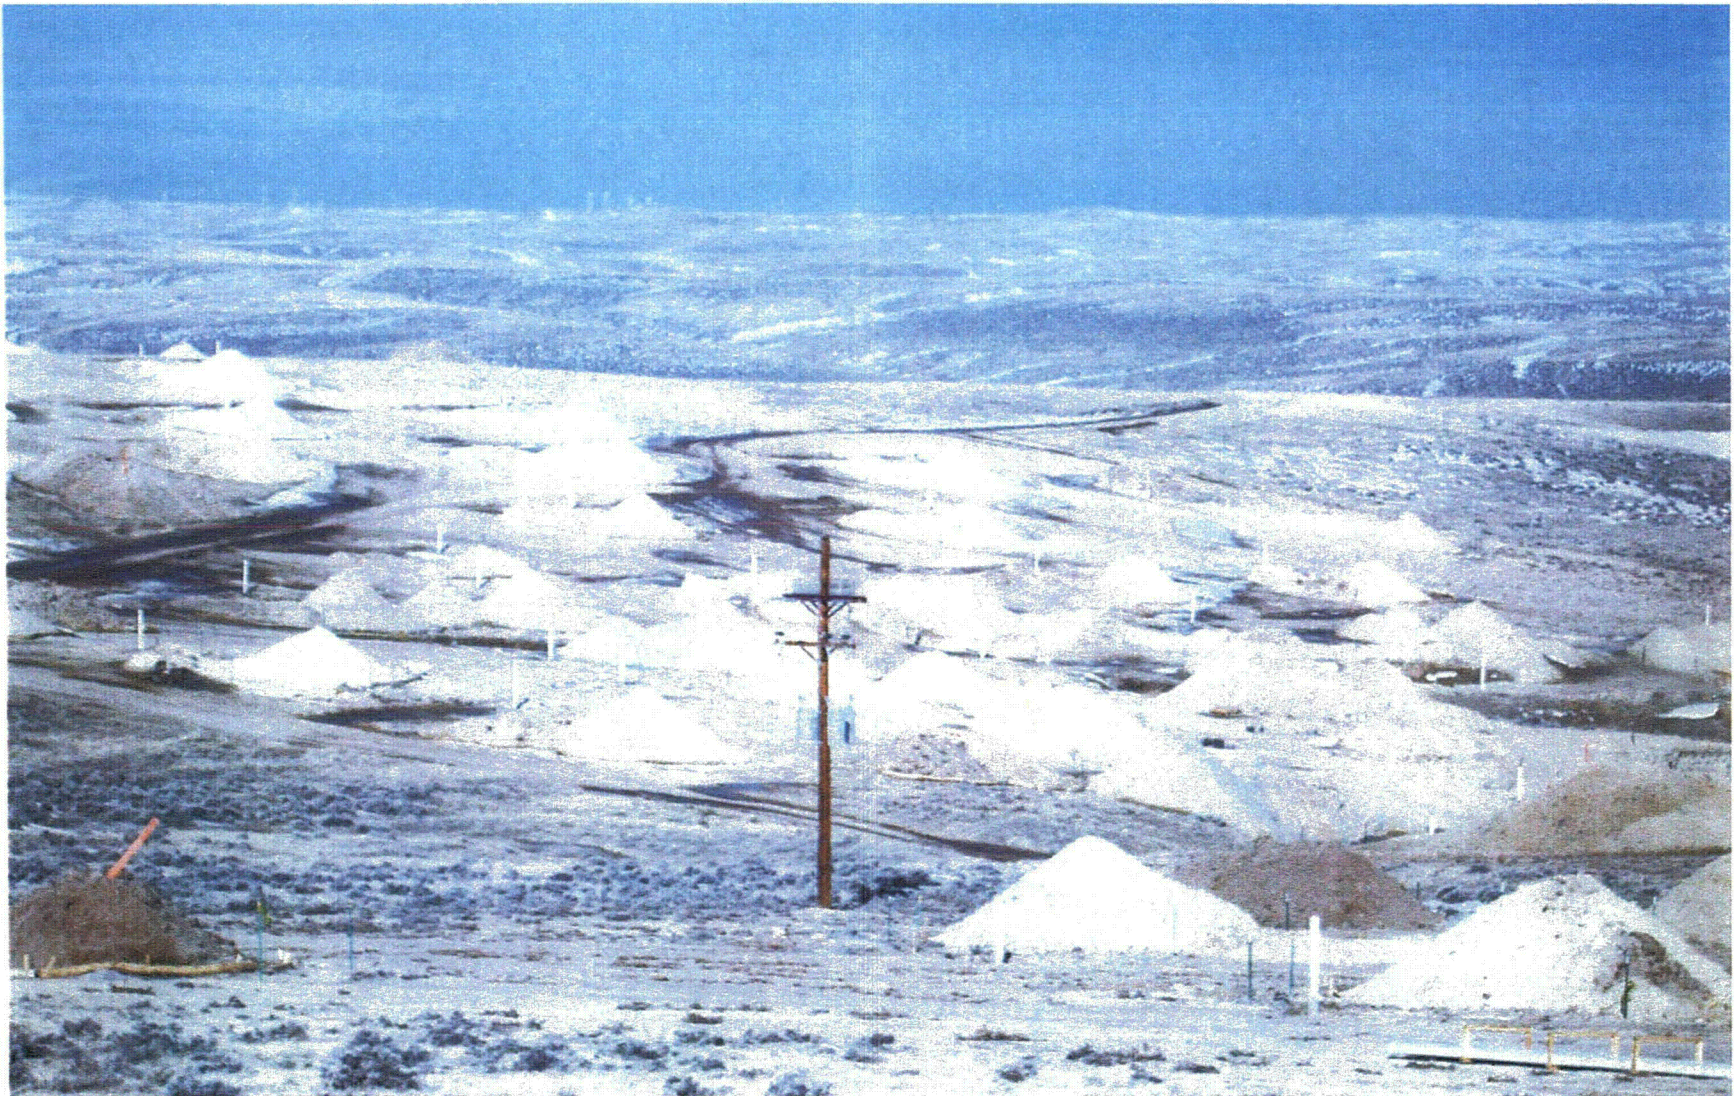
- waiting on pump test approval from LQD;
- wellfield development in progress; topsoil salvage and protection was exceptional with straw waddles at the base of the piles and piles placed away from the activity at the well; drill traffic appeared to be staying on designated pathways with notable undisturbed areas to enhance the revegetation during wellfield reclamation (**Figure 2 & 3**)

- 1 CR is doing a much better job with managing surface disturbance during wellfield development with regard to topsoil salvage and protection and restricting disturbance to pathways to drill sites. The decision by the former LQD Administrator to not require topsoil stripping in wellfield disturbance areas was based on minimizing the disturbance and providing necessary protection from sediment where it is needed. CR is now making this effort as was identified in MU-10. This effort is greatly appreciated.

Figure 2 MU-10 wellfield development; topsoil stockpiles placed away from drilling activities and clearly marked, routes for vehicle use are clear, areas without disturbance can be identified, sediment control placed around stockpiles

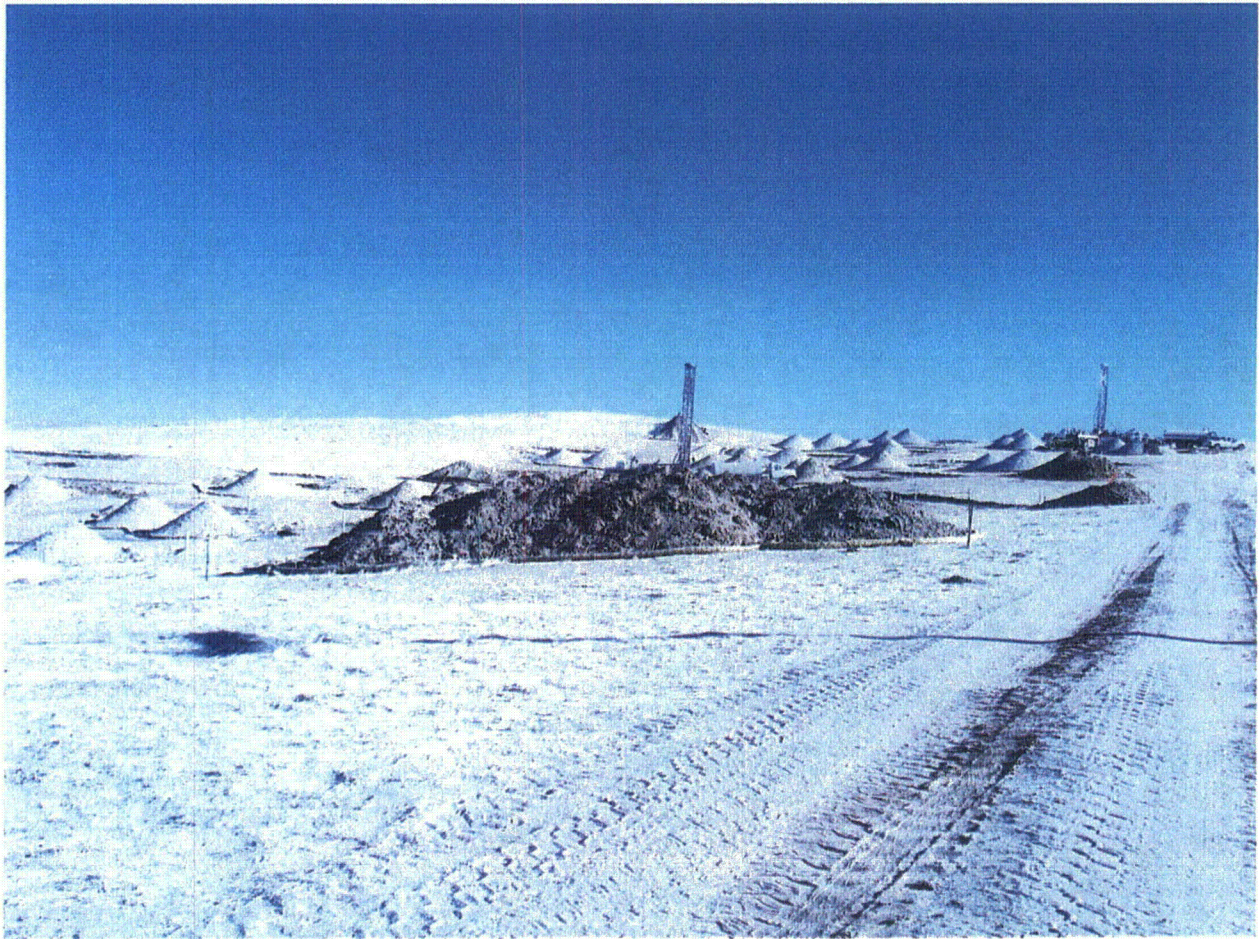
Figure 3 MU-10 development drilling, view of road used to access drill sites, undisturbed area topsoil stockpile with straw wattle protection at base of pile
