One Pager
North Anna Earthquake

Summary of Earthquake Information for the North Anna NPP as of September 9, 2011

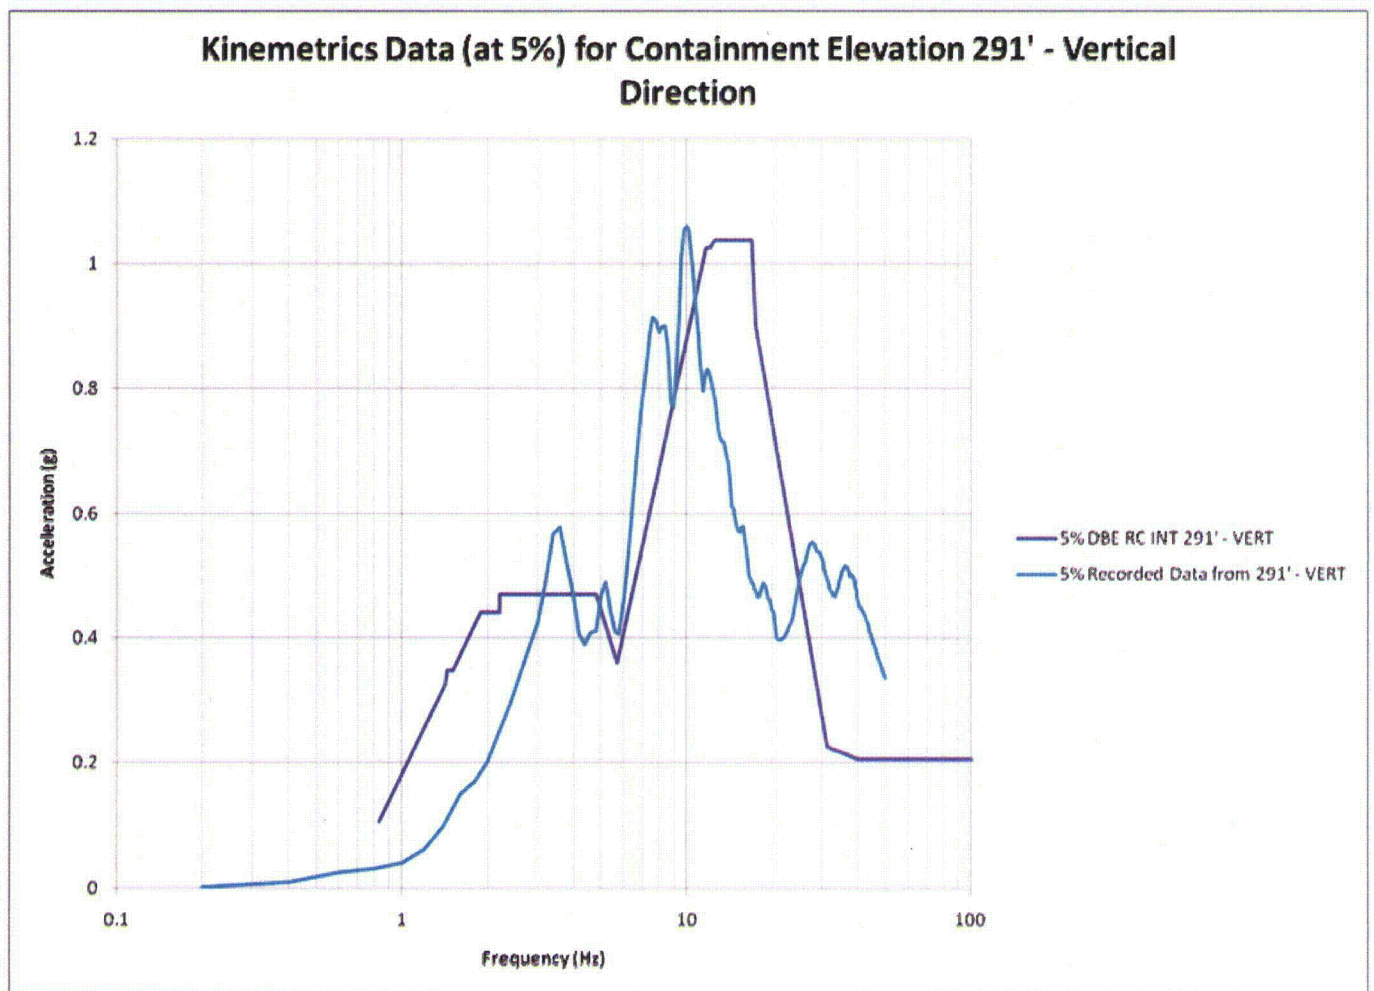
- Preliminary data provided by the licensee indicate that the DBEs at different elevation levels have been exceeded in both the horizontal and vertical directions at different frequencies (see attached sample figure).
- The licensee's inspections have not identified any safety related equipment which failed during the event except for the 2H EDG. When it became evident that the DBE had been exceeded, the licensee declared all the safety related equipment in both units inoperable and took action to place the units in cold shutdown.
- Preliminary data from the licensee's investigation about the 2H EDG failure indicates that a cooling water system gasket may have been installed incorrectly.

The figure above, as submitted by the licensee, compares the observed ground motion in the vertical direction to the exceeded design motion at various frequencies. The blue curve is from the observed readings and the purple curve is the design spectrum at the same elevation level.
