SUBJECT:
Davis-Besse Nuclear Power Station, Unit 1
Docket Number 50-346, License Number NPF-3
Submittal of Shield Building Root Cause Evaluation

Root Cause Analysis Report

Concrete Crack within Shield Building
Temporary Access Opening

CR Number 2011-03346, Dated 10-10-2011

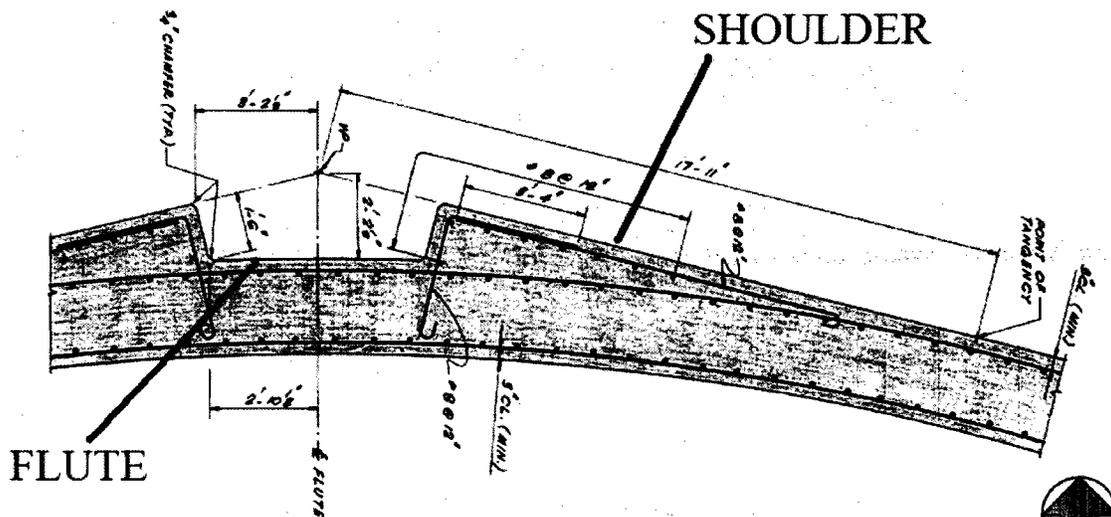
Plan View of Architectural Flute / Shoulders

The design configuration inherent stress concentration at the outer face of structural reinforcing steel behind the thickest section of the architectural flute shoulder enabled the radial stress from the freezing moisture to exceed the tensile strength of the concrete and initiate a crack. Other horizontal (hoop) and vertical stresses that adjoined the outer face of structural reinforcing steel underneath the architectural flute shoulder region enabled the laminar crack created by freezing moisture to propagate along the outer face of structural reinforcing steel.

The design configuration did not include radial reinforcing steel ties or stirrups at intermediate spacing between each end of the architectural flute shoulder reinforcing steel connection with the structural reinforcing steel which enabled the laminar crack created by freezing moisture to propagate.

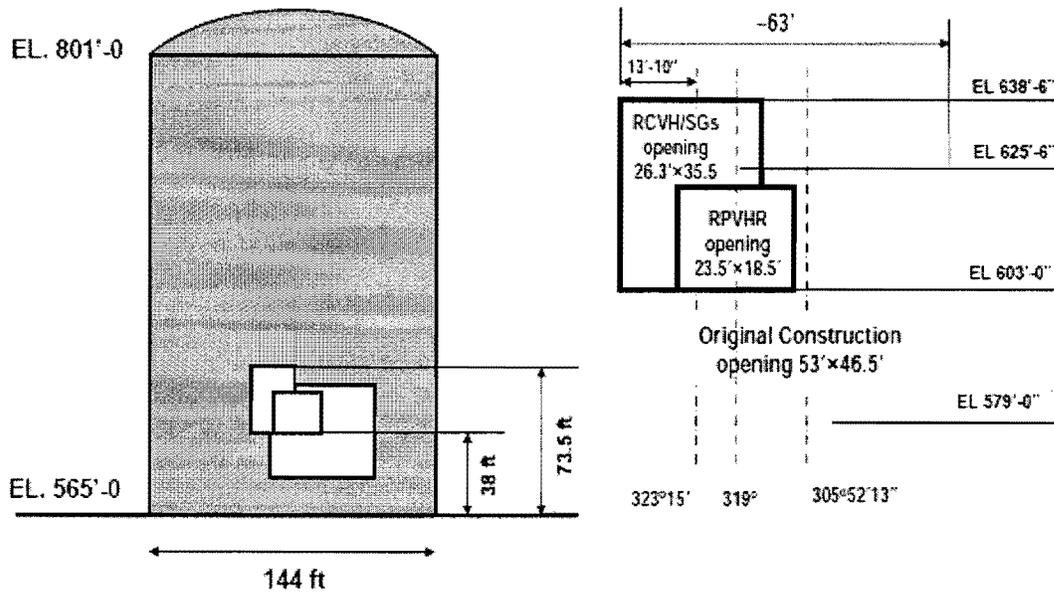
Elevation View of Shield Building / Construction Opening & Temporary Access Openings

A temporary access opening approximately 25 feet 6 inches wide and 35 feet 6 inches high centered at approximately azimuth 323 degrees was cut through the shield building wall during the 17 Mid-cycle outage at DBNPS [Reference 10.1.3 & 10.1.4]. The left side of the temporary access opening was cut near the thickest section of the architectural flute shoulder located on the north-northwest side of the shield building between elevations 603 feet and 638 feet six inches. The temporary access opening through the shield building wall was necessary for installation of a replacement reactor pressure vessel head. The existing reactor pressure vessel head was installed in 2002 through a temporary access opening located within the boundary of the original construction opening. The current temporary access opening extended past the edge of the original construction opening into part of the previously undisturbed shield building wall.

The known extent of condition at the time of problem discovery was a concrete crack in the shield building wall that was visible on the entire 35 feet height of the temporary access opening left face. The crack was adjacent to the outer face of structural reinforcing steel, and it extended approximately eight feet into the left-top and approximately four feet into the left-bottom region of the temporary access opening progressing from the outer face of structural reinforcing steel towards the architectural flute reinforcing steel. The crack at the left-top of the temporary access opening continued to the exterior surface at the edge of the opening and extended about two and a half feet vertically upwards on the exterior surface of the shield building concrete [Reference 10.1.7]. The crack width was initially indeterminate, due to the effect of the hydrodemolition process, resulting in disintegrating the concrete aggregate and cement paste at the crack location. The hydrodemolition process was incomplete at the time of crack discovery and had been stopped to allow removal of the outer face of structural reinforcing steel.

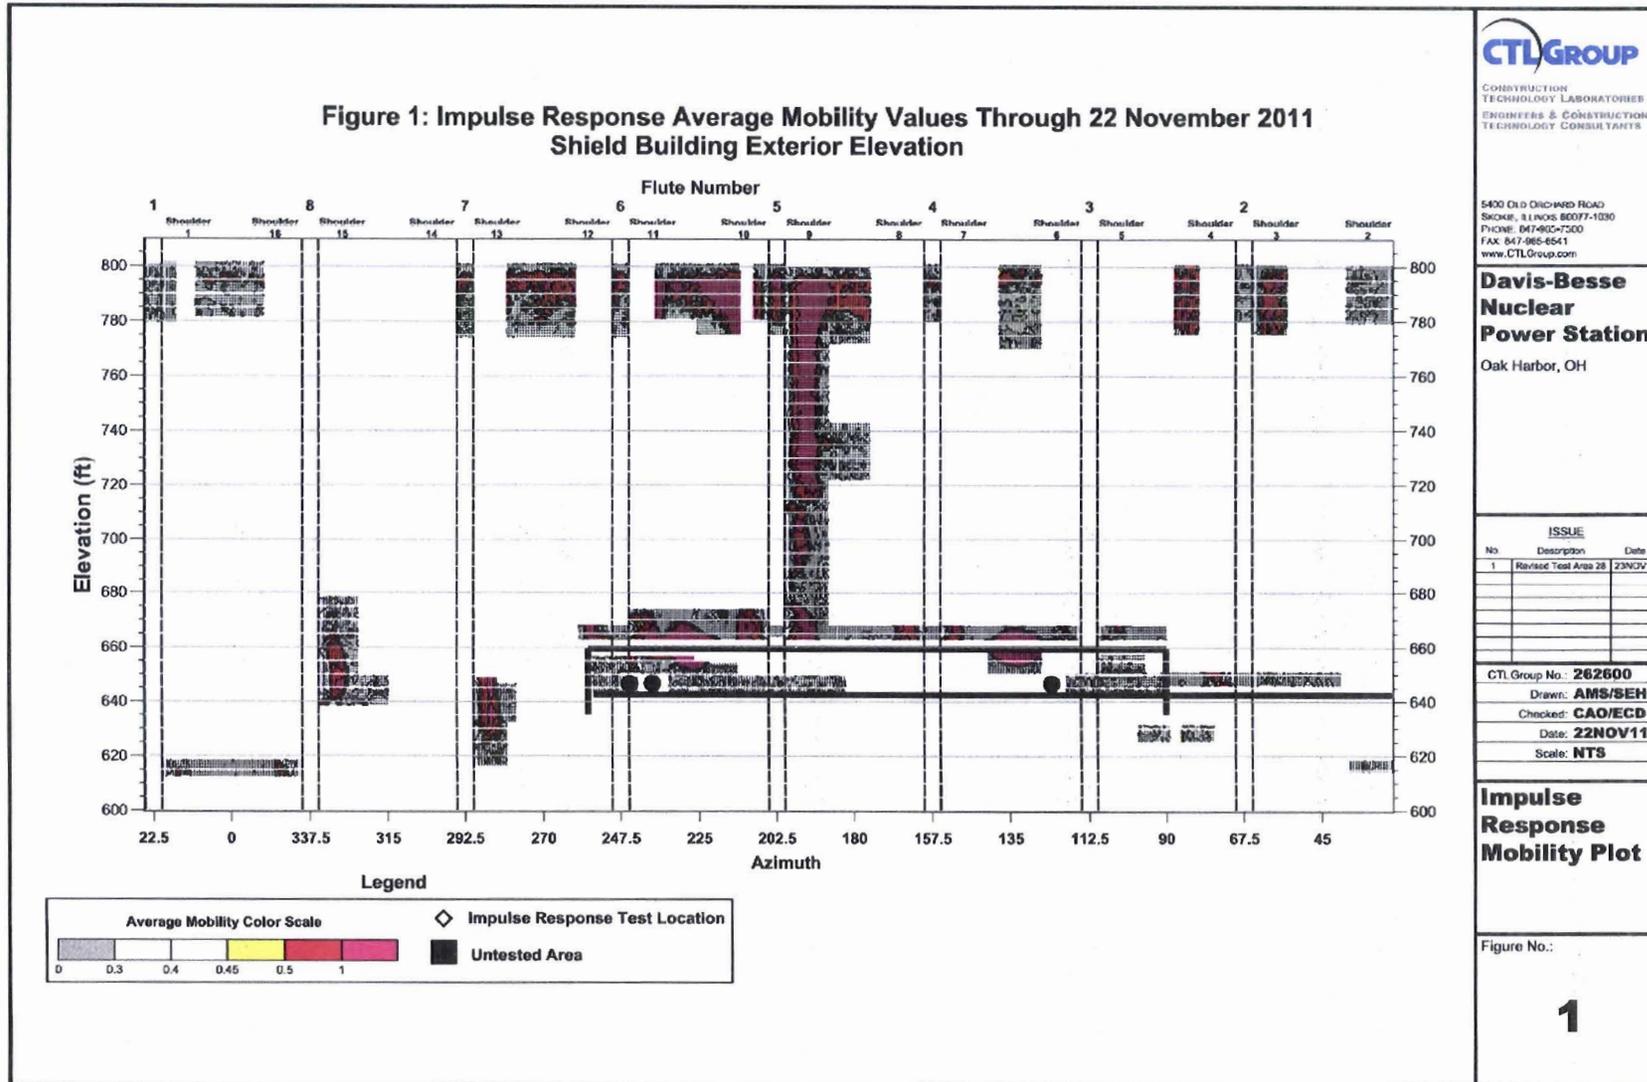
Attachment 2, Shield Building Impulse Response Average Mobility Values

Fifteen of the sixteen shoulders were inspected using the Impulse Response mapping. Results indicate that all 15 shoulders inspected had indications of laminar cracking. The cracks were well confined in the shoulder areas between the ends of the horizontal reinforcing steel. The southwestern exposure of the shield building wall was observed to have the most extensive concrete cracking.

Impulse Response mapping identified a region of laminar cracking adjacent to the shoulder areas near the top 20 feet of the shield building. This area coincides with a higher density of reinforcing steel (#11 horizontal bars at 6" c-c).

Impulse Response mapping also identified a region of laminar cracking adjacent to the main steam line construction blackout for penetration #39 and #40, located above and below the Auxiliary Building roof line. This crack is also located in an area of higher density horizontal reinforcing steel.
