THE UNIVERSITY OF TEXAS AT AUSTIN

Nuclear Engineering Teaching Laboratory · <http://www.me.utexas.edu/~nuclear/index.php/netl>
1 University Station, R9000 · Austin, Texas · 78712 · (512) 232-5370 · Fax (512) 471-4589

Subject: Docket 50-602, License no. R-129 Licensee Event Report 47625 Corrected
Followup Report

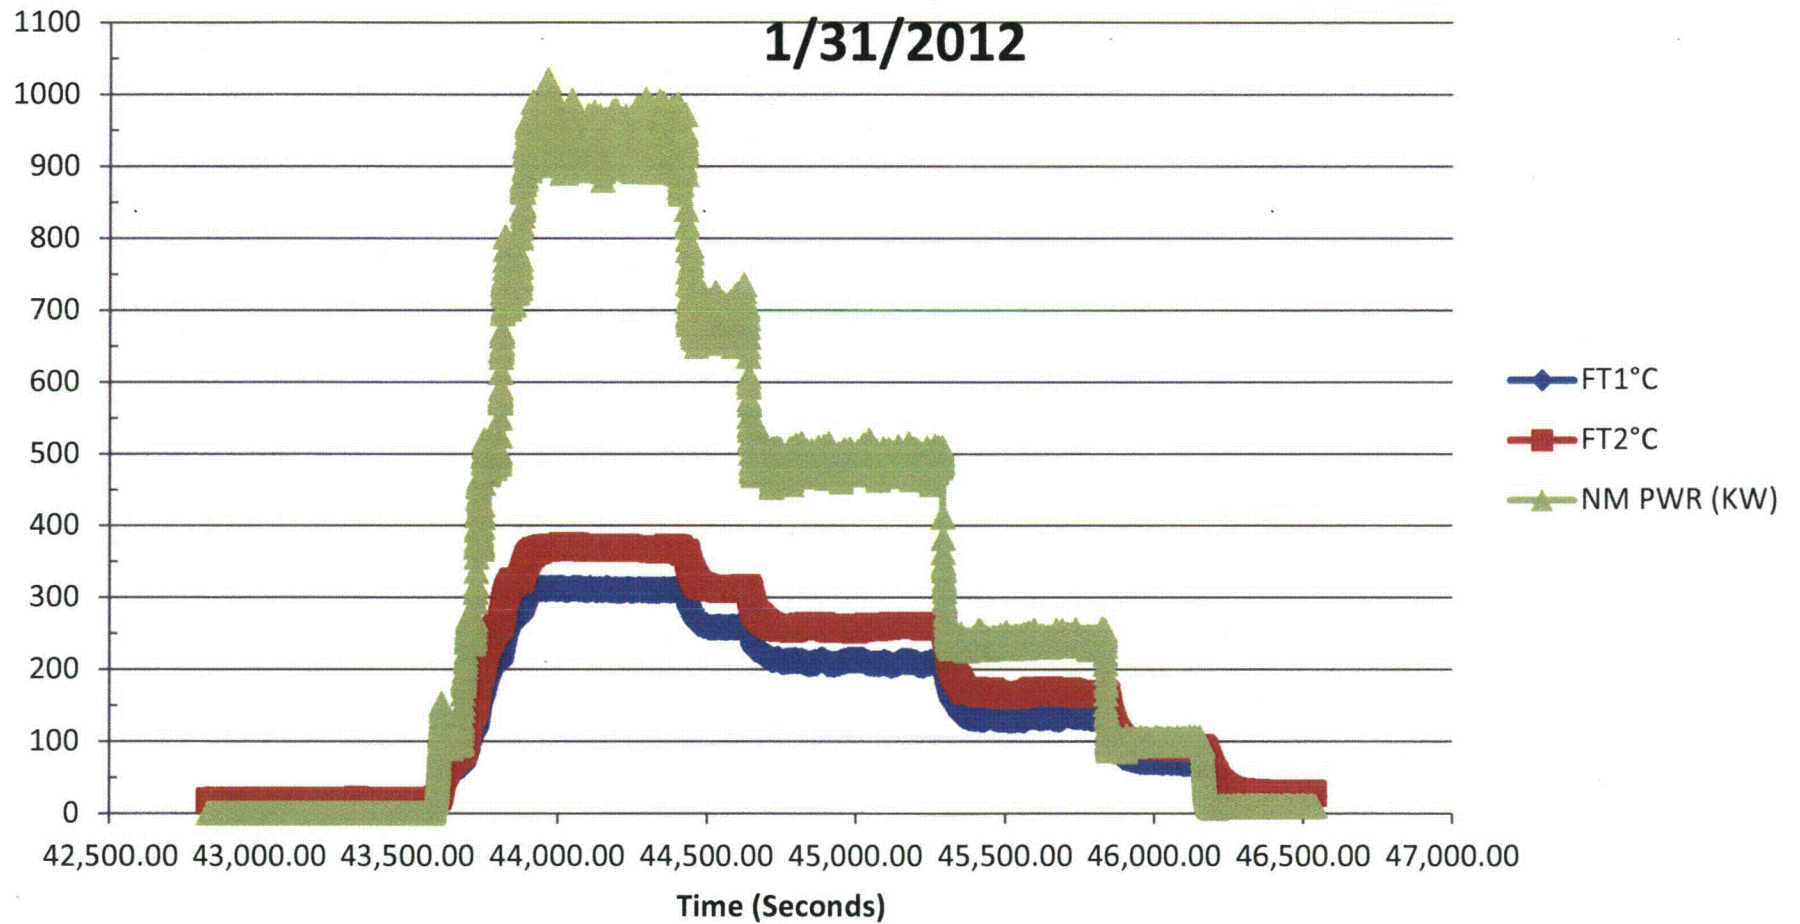
Pwr & FT vs Time with repaired TC

Resistance checks were completed on January 31, 2012. Testing indicated the short circuit was resolved. The thermocouple is considered restored to service, pending routine calibration checks conducted in accordance with approved operating/maintenance procedures.
