Subject: 10CFR21 Reporting of Defects and Non-Compliance -
Engine Systems, Inc. Report No. 10CFR21-0105, Rev. 1

Report No. 10CFR21-0105

10CFR21 REPORTING OF DEFECTS AND NON-COMPLIANCE

COMPONENT: Subcover Assembly, P/N 1A-7846

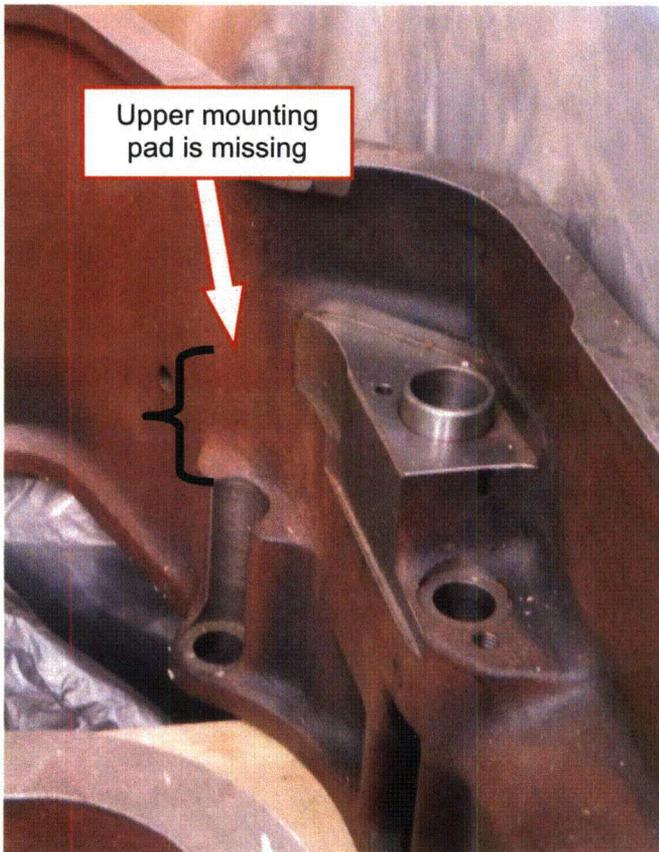
Engine Systems Inc. (ESI) began a 10CFR21 evaluation on 12/20/11 upon notification of an issue with four subcover assemblies at Perry Nuclear Plant. It was reported that Perry was performing a maintenance activity whereby they were replacing four cylinder head subcover assemblies on their Enterprise diesel engine. During installation, it was noted that qty 2 of the 11 bolt holes were missing an upper mounting pad. This was visually apparent once the customer attempted to install the bolts, which have a 6" length. The two areas missing the upper landing pad did not have an area for the underside of the bolt head to rest upon. See photos 1 and 2 below showing an incorrect vs. correct subcover.

**Photo 1: Subcover Returned by Perry
(Incorrect)**

Customers may elect to justify use of a shorter bolt to facilitate installation of in-stock covers. Otherwise it is ESI's recommendation that customers return the subcovers for replacement.

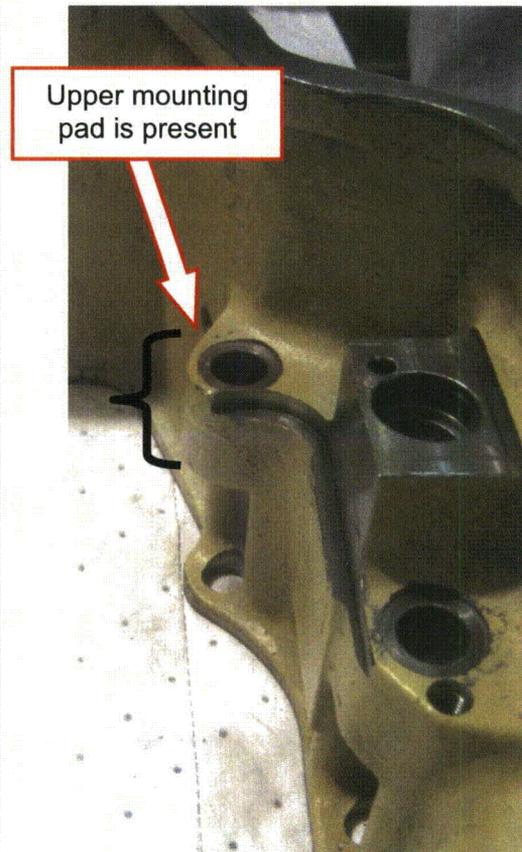
**Photo 2: Previously Installed Subcover
(Correct)**

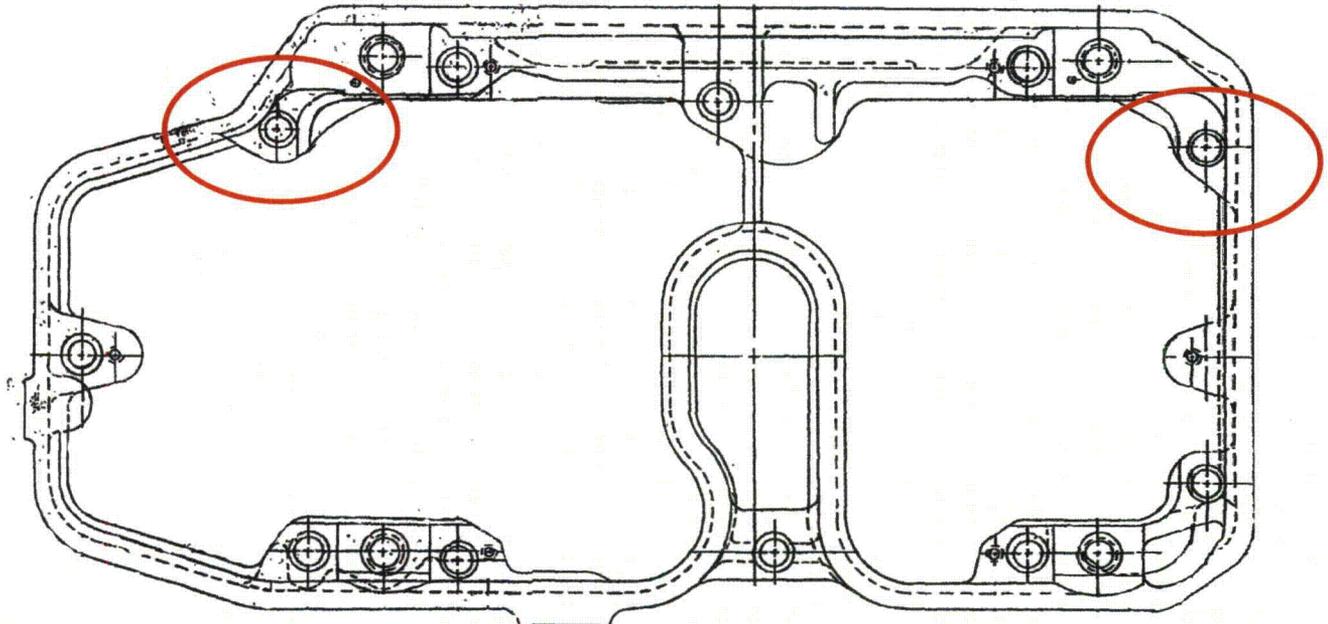
Figure 1: Overhead View of Subcover

Figure 1 and photo 3 below show the positions within the subcover where the pads are missing.

Lack of the mounting pads alone will not result in a failure, however if a customer attempts to install the subcover without recognizing the missing material, there is the possibility that two of the eleven hold down bolts will provide no clamping function. This may result in loosening of the subcover mounting which could allow the cover to separate from the cylinder head.

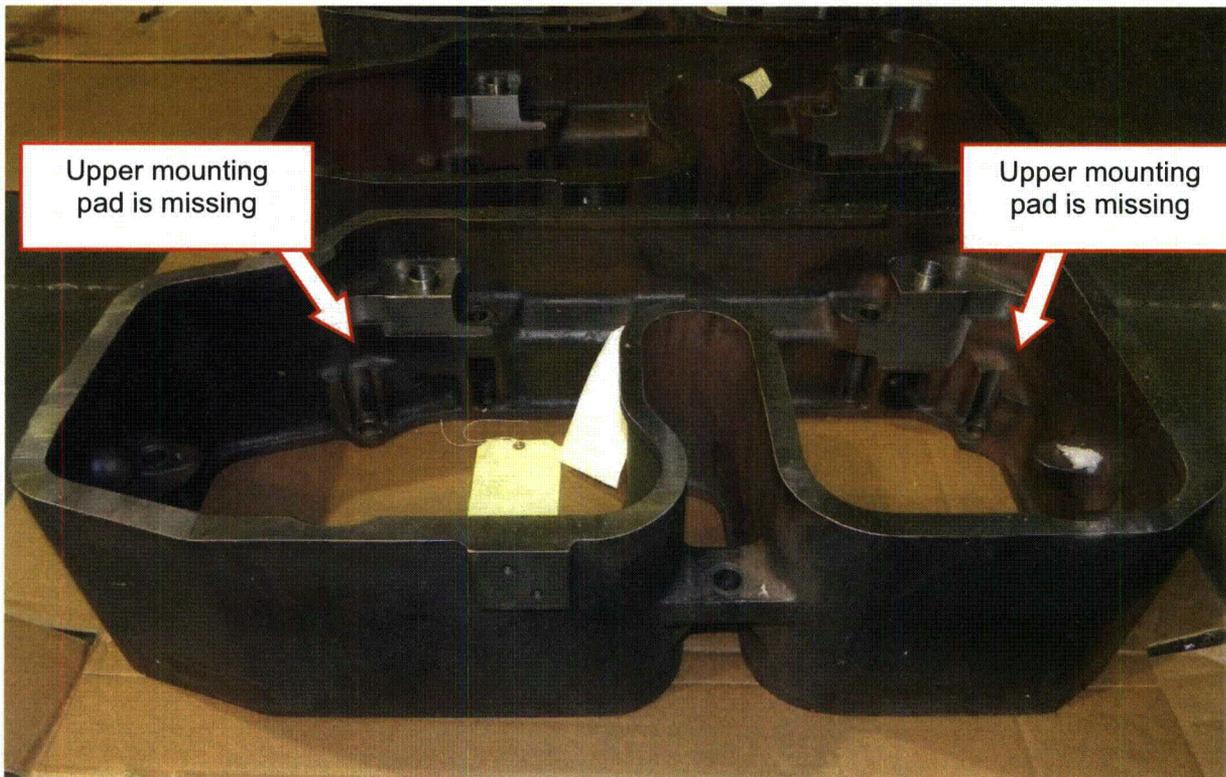
Photo 3: Locations of Missing Landing Pads

The root cause analysis determined that the cause of this issue was that the pattern for the casting is missing the portions that would ultimately form this upper mounting pad. In addition, the machining drawing was unclear in showing these locations. As a result, ESI's inspections did not specifically check for these locations and the non-conforming subcovers were shipped to the customer.

The pattern is now being corrected to ensure the presence of the upper mounting pads. Also, ESI's dedication report is being revised to add specific checks to inspect for the presence of these pads. This will be completed prior to any future shipments of this item.
