Subject: FW: DB Shield Building Investigation and Technical Summary Report
Sent Date: 11/17/2011 7:32:54 PM
Received Date: 11/17/2011 7:33:02 PM
From: Sanchez Santiago, Elba

November 17, 2011 Rev 0

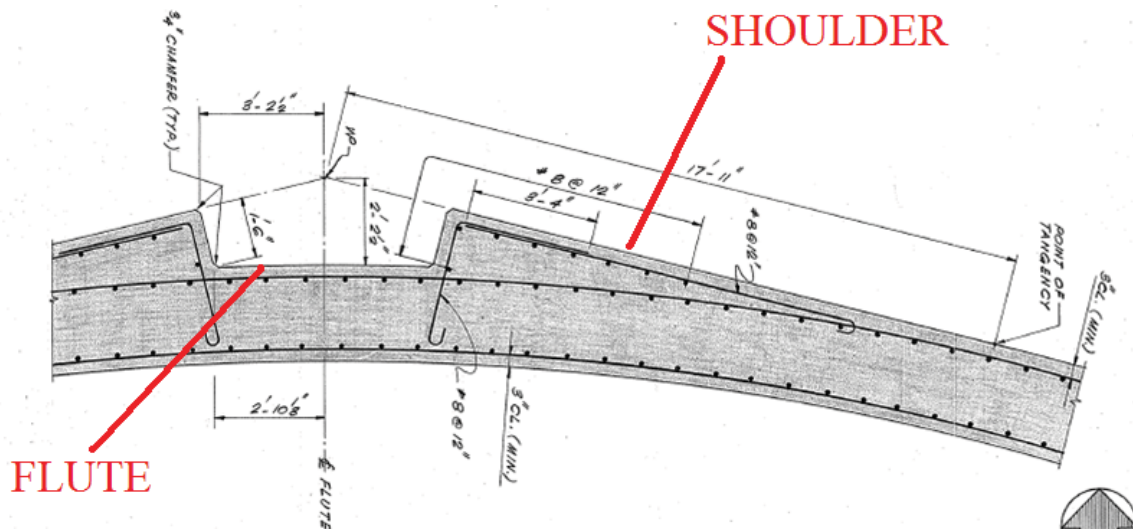
Figure 01 – Flute / Shoulder Geometry

The Shield Building is a safety related free standing cylindrical shell structure with eight (8) “architectural flute areas” as identified on DBNPS Drawing C-0110 (Ref. 8). During further discussions within this document, each “fluted area” will be addressed as two built up, or thickened “shoulders.” The groove between the shoulders will be addressed as the “flute.”

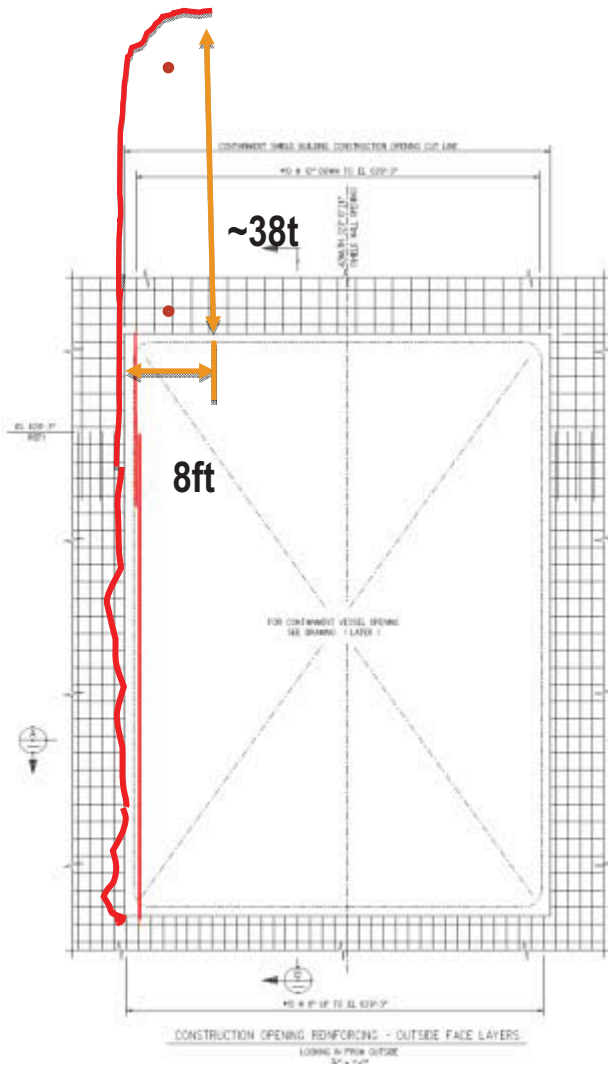
Figure 02 – Extent of Condition at Construction Opening

The condition was initially identified on October 10 when cracking was reported along the left side of the new construction opening in the Shield Building during hydro-demolition. A problem Solving and Decision Making Team (PSDM) team was formed using FENOC personal supported by industry experts from Bechtel and Sargent & Lundy. The team's decision was to "chip back" along the cracked areas and observe the indication. No indications were found on the left side or the bottom after chipping but chipping on the top revealed the crack extended beyond the construction opening.

The initial IR testing (Ref. 38, page 461) above the construction opening indicated that the crack appeared to extend approximately 38 feet above the construction opening (to elevation 676). Four core bores were taken above the opening to validate the IR results. These core bores indicated a crack existed near the outer reinforcement mat. A core bore was also used to confirm the absence of the cracking approximately 38 feet above the construction opening. Figure 02 depicts the region of laminar cracking that was identified in the area above the construction opening.

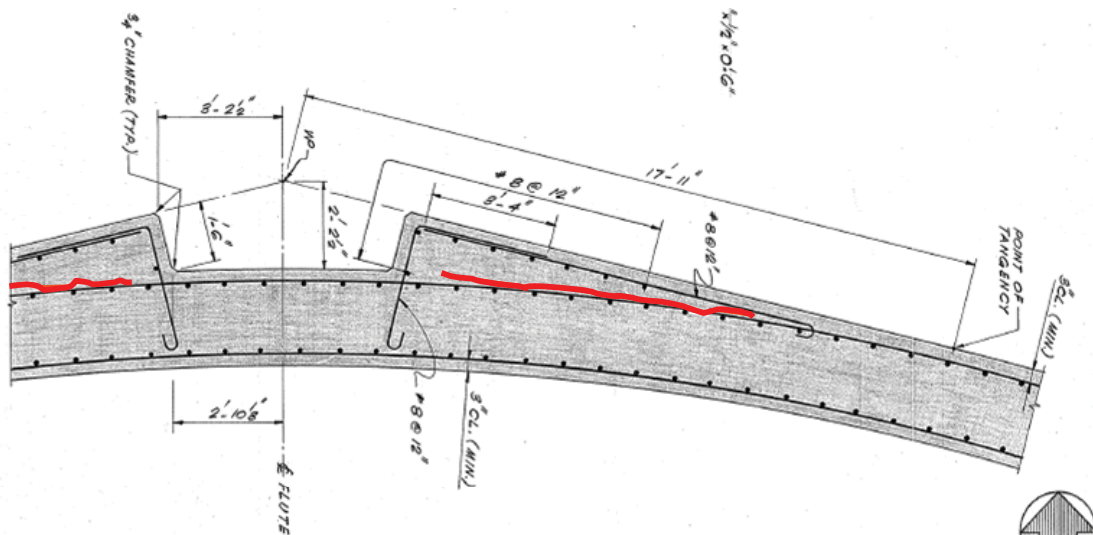
Figure 03 – Extent of Cracking in Flute Shoulder Regions

Additional IR testing was performed on a total of 15 of the 16 flute shoulders (the 16th flute Shoulder as not accessible due to the location of the start-up transformer). The results indicated that the cracking in the shoulders was a generic issue unrelated to the hydro demolition. Core bores were taken on 12 shoulders to confirm the boundaries of the cracking and to characterize the cracks. The boundaries of the cracking were confirmed by nine pairs of core bores performed to validate the IR results on flute shoulders 3, 4, 5, 6, 7, 8, 9, 10 and 12. This demonstrated that the IR results were very accurate at predicting delaminated areas of the flute and shell depths and supported the previous observation that the cracks are confined within the reinforcing steel of the shoulder area, see Figure 04.

- The cracks are generally confined within the reinforcing steel of the shoulder area.
- Cracking may exist at all elevations in the flute shoulder areas.
- The cracks are very tight, less than 0.01 inches.
- The cracks are near the outer reinforcement mat.

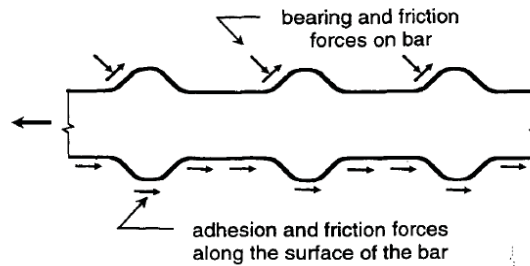
Figure 04 – Reinforcement Load Transfer Mechanism

Bond strength on reinforcement bar in the presence of a known crack is not available. This parameter does not lend itself to calculational methods and is typically established by testing. However, an evaluation can be provided which looks at the actual loading and margins in the structure and compares this to available literature for bonding mechanisms. This evaluation depends primarily on the fact that the loading in the reinforcement mat is subject to very low stresses when compared to allowable values. In some cases, such as the top of the structure, the level of loading shown in the calculations is predominantly driven by environmental effects. If the structure is not capable of handling the imposed loading, visible degradation on the surface would be evident. Because of the calculated low stress levels in the reinforcement under the design basis loads it is expected to have a negligible effect with transfer of force into concrete in the presence of a tight laminar crack.

The development length or lap splice length is a ACI Code value (in inches) used to ensure that the tensile forces from one reinforcing steel bar can be adequately transferred through the concrete to the adjacent reinforcing steel bar. Development and splice lengths per the ACI Code for ultimate strength design were originally developed to achieve strengths beyond the reinforcing steel bar yield. The calculated reinforcing stresses are far below code allowable values (32% for the most limiting load case for vertical reinforcing steel) and therefore full development length or splice length of the reinforcing steel bars is not required for actual load transfer. A reinforcement bar with excessive development overlap which is loaded at less than 50% load presents substantially less challenge to the bonding.

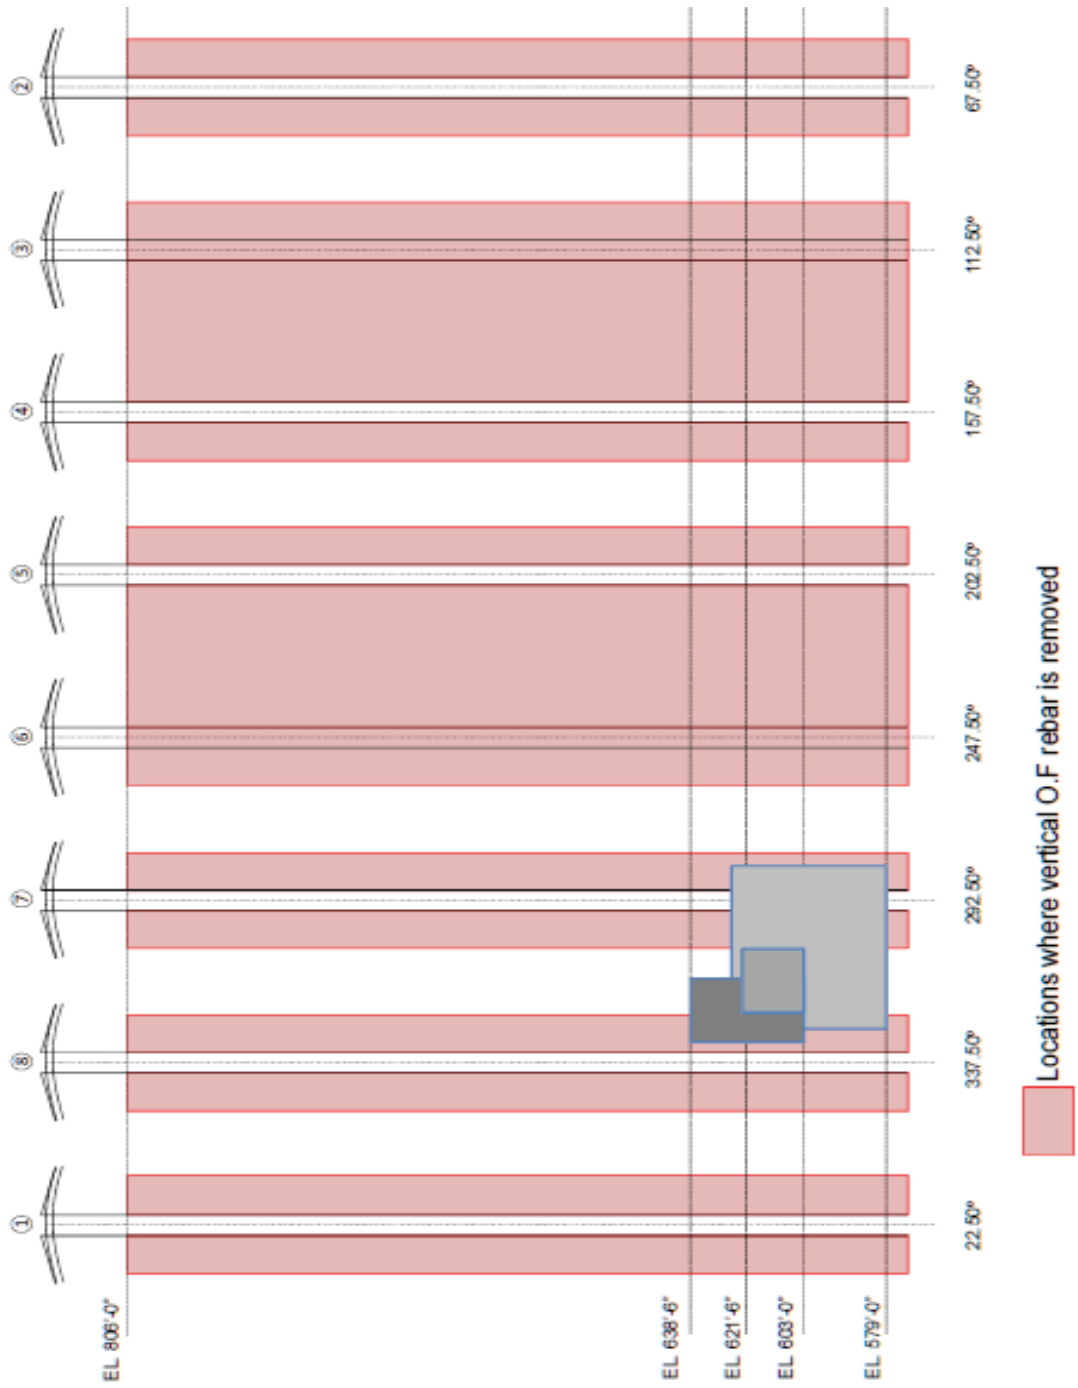
Figure 05 – Location where vertical O.F. rebar is removed – Part 1 of 2

It was conservatively assumed that the outside face vertical rebars with a 27' wide strip, from bottom to top (EL.565' to EL.809.5'), at each flute shoulder location are not effective. It is also assumed the outside face vertical rebars with 30' wide strip, from bottom to top (EL.565' to EL.809.5'), at two main steam penetration locations are not effective (Figure 05).

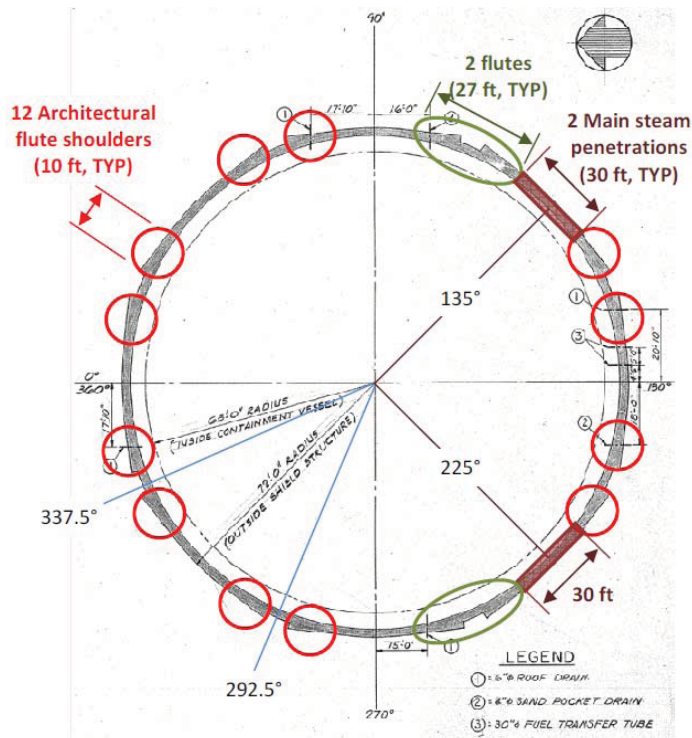
Figure 06 – Location where vertical O.F. rebar is removed – Part 2 of 2

Since this is an interim condition, non-linear finite element analysis was deemed as acceptable and was performed for the controlling load combination D+E'. It was found that plastic behaviors are very limited to no more than 2 elements at the opening corners, while all other reinforcing bars are within the elastic range. The maximum rebar ductility ratio at the corners is less than the acceptable ductility ratio (Refer to Calculation C-CSS-099.20-045, Rev.0, Sect. 7.9, and (Ref.28)).
