South Texas Project
Unit 2
Docket No. STN 50-499
Request for Relief from ASME Boiler and Pressure Vessel Code,
Section XI Requirements for the Essential Cooling Water System
(Relief Request RR-ENG-3-08)

**SOUTH TEXAS PROJECT
UNIT 2
REQUEST FOR RELIEF FROM ASME BOILER AND PRESSURE VESSEL CODE,
SECTION XI REQUIREMENTS FOR THE ESSENTIAL COOLING WATER SYSTEM
(RR-ENG-3-08)**

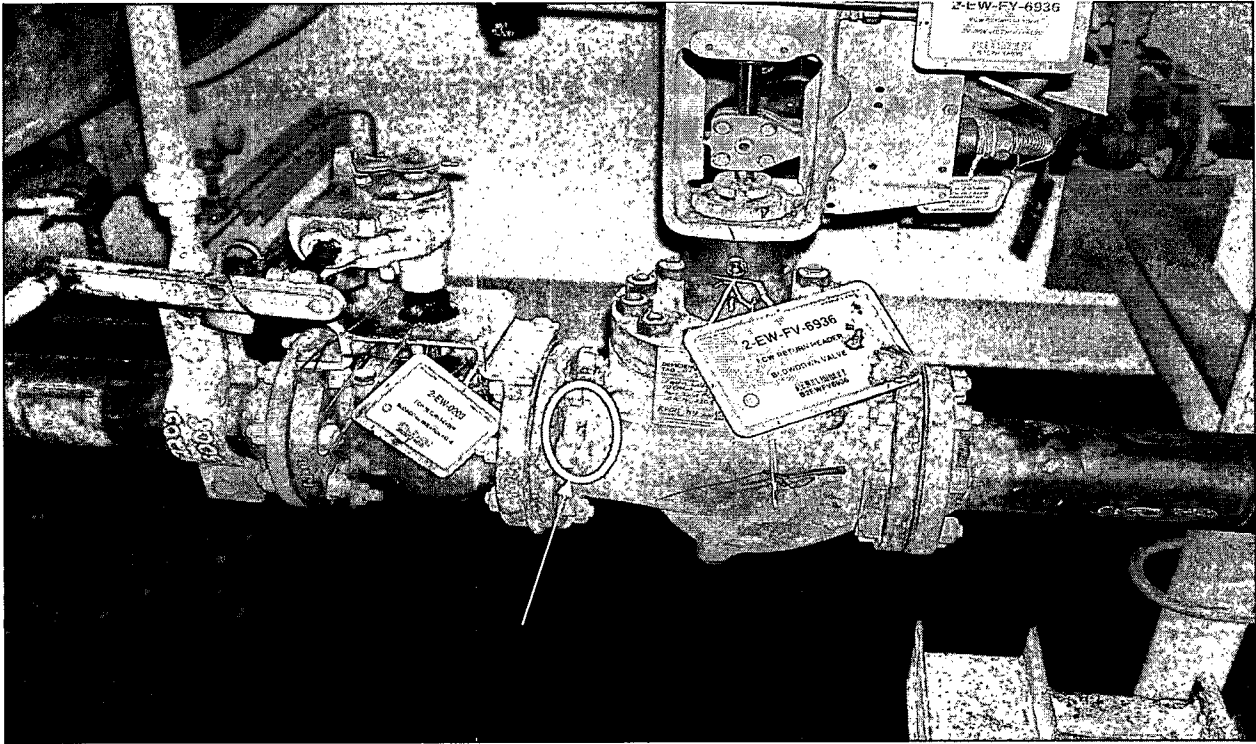
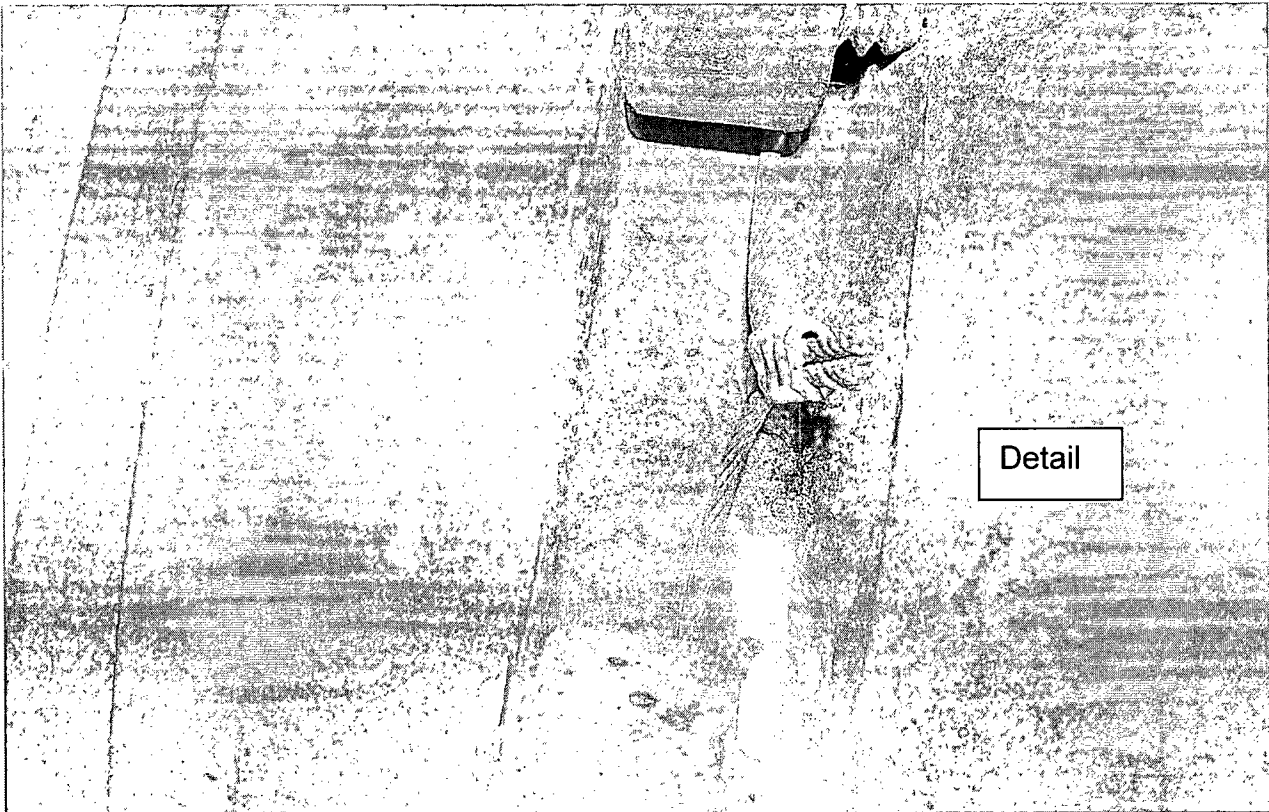
FIGURE 3: DEALLOYED AREA AT 10 O'CLOCK POSITION (2-EW-FV-6936)

Two indications of through-wall dealloying were identified on the inlet flange of cast aluminum-bronze ECW valve 2-EW-FV-6936 on July 28, 2011. The valve minimum wall thickness in the affected area is $\frac{1}{4}$ - inch. Residue deposits indicating dealloying were found at the 10 o'clock (Figure 3) and 2 o'clock (Figure 4) positions (looking upstream from the valve inlet). Prior to cleaning, each indication was less than 1/2-inch in diameter. Cleaning reduced each indication to less than 1/8-inch in diameter. Subsequent inspection on November 30, 2011, found additional residue at the 2 o'clock position with little apparent change at the 10 o'clock position. Visual examination found no cracks, and there is no measurable leakage.

The root cause of dealloying is a combination of corrosion and stress. The dealloying process normally initiates from a crevice such as the area behind a backing ring, a fabrication-induced flaw, or a casting flaw. Dealloying in this case is believed to be similar to dealloying seen in other susceptible aluminum-bronze components. The process by which dealloying of aluminum-bronze occurs is described in previous communications with the NRC (Reference 8.1).

These flaws are to be repaired by replacing the degraded valve bodies. Replacement of the affected valves at this time is not possible because the necessary parts are not available. Valve replacement will follow receipt of the replacement parts. Approval of this relief request will allow deferral of code repair of flaws until after Unit 2 is returned to service, currently scheduled for mid-April 2012. Time required to obtain the parts precludes resolution of the flaws prior to the planned Unit 2 startup date. Delaying unit restart until completion of repairs would constitute a hardship without a compensating increase in the level of quality and safety.

- Perform monthly walkdowns of the affected valves to detect changes in size of the discolored area or leakage until a code repair is performed. Structural integrity and the monitoring frequency are re-evaluated if significant changes in the condition of the dealloyed area are found during this monitoring. (See commitment in Attachment 2.) There is no measurable leakage at this time.

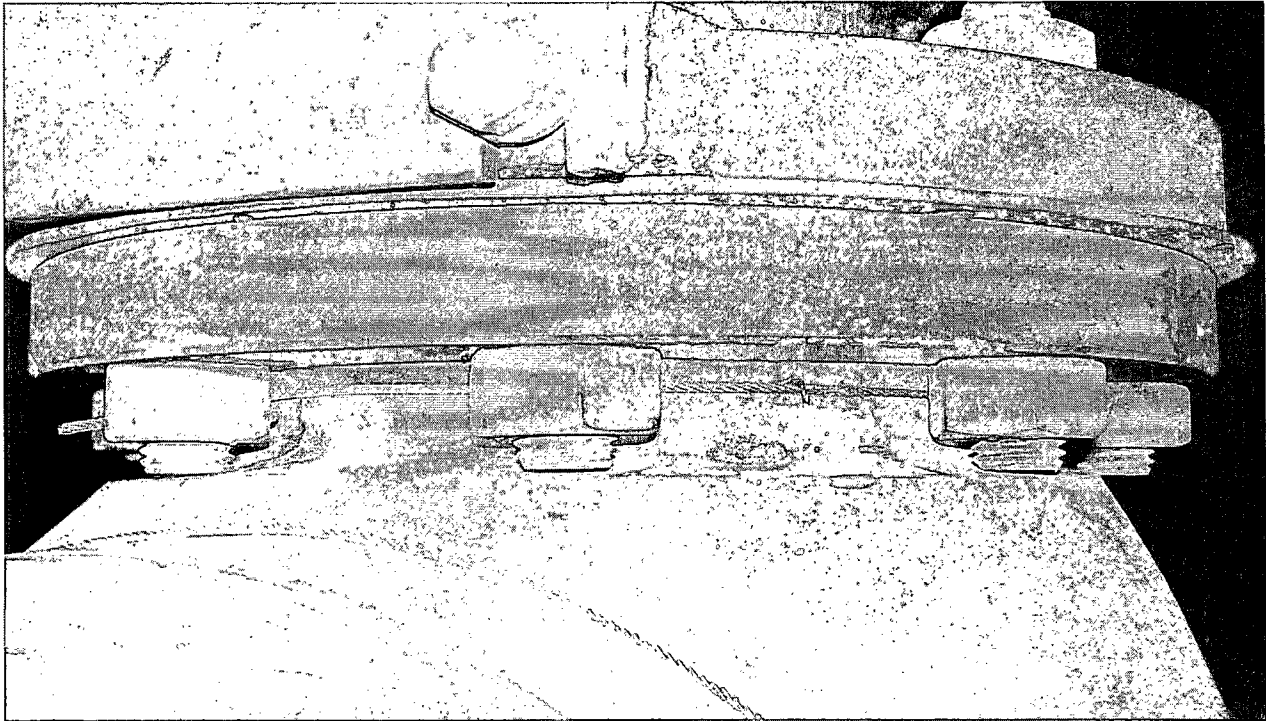
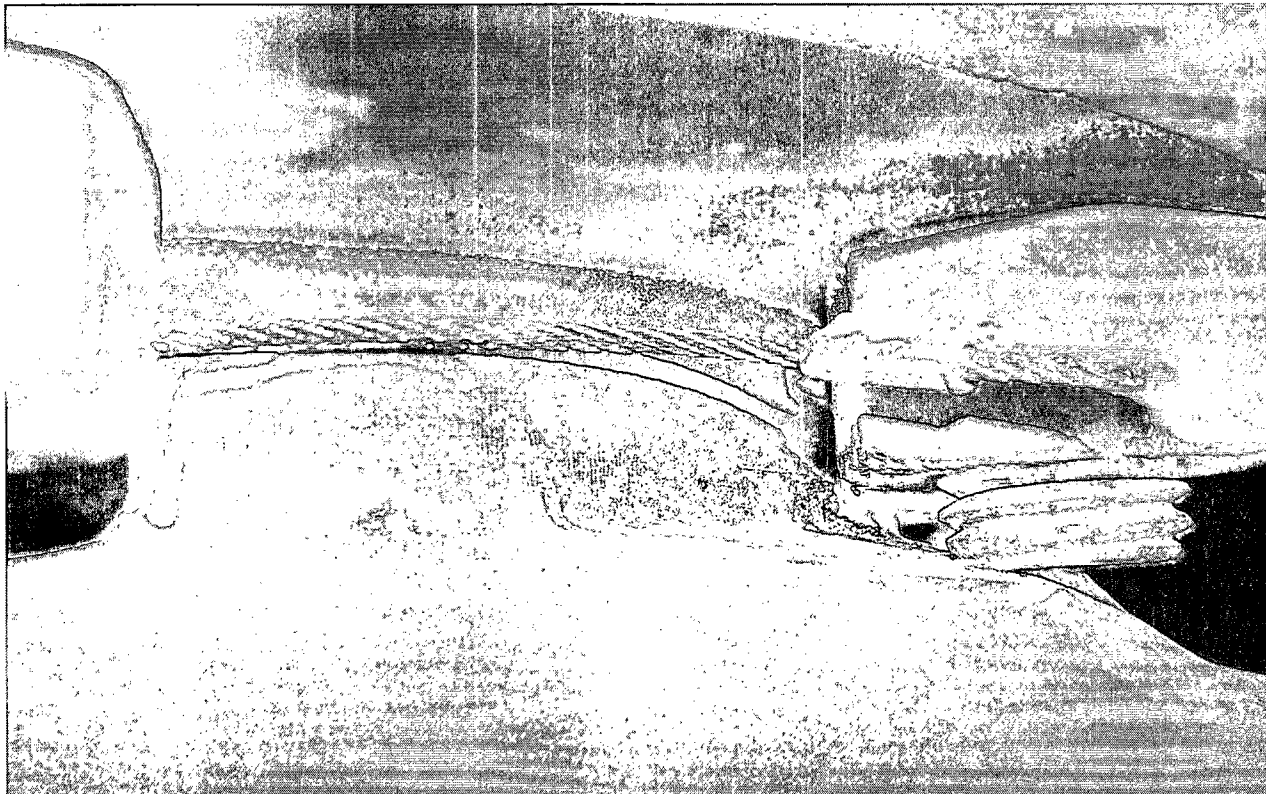
FIGURE 5: ADDITIONAL AREAS OF DEALLOYING (2-EW-FV-6936)

The November 30, 2011, inspection identified an additional three dealloying indications on the same valve body. The indications are on the inlet flange of 2-EW-FV-6936 between the 11 o'clock and 1 o'clock positions (between the first two indications). See Figure 5. Prior to cleaning, the indications were approximately 1/8 - inch in diameter. Visual examination found no cracks, and there is no measurable leakage.

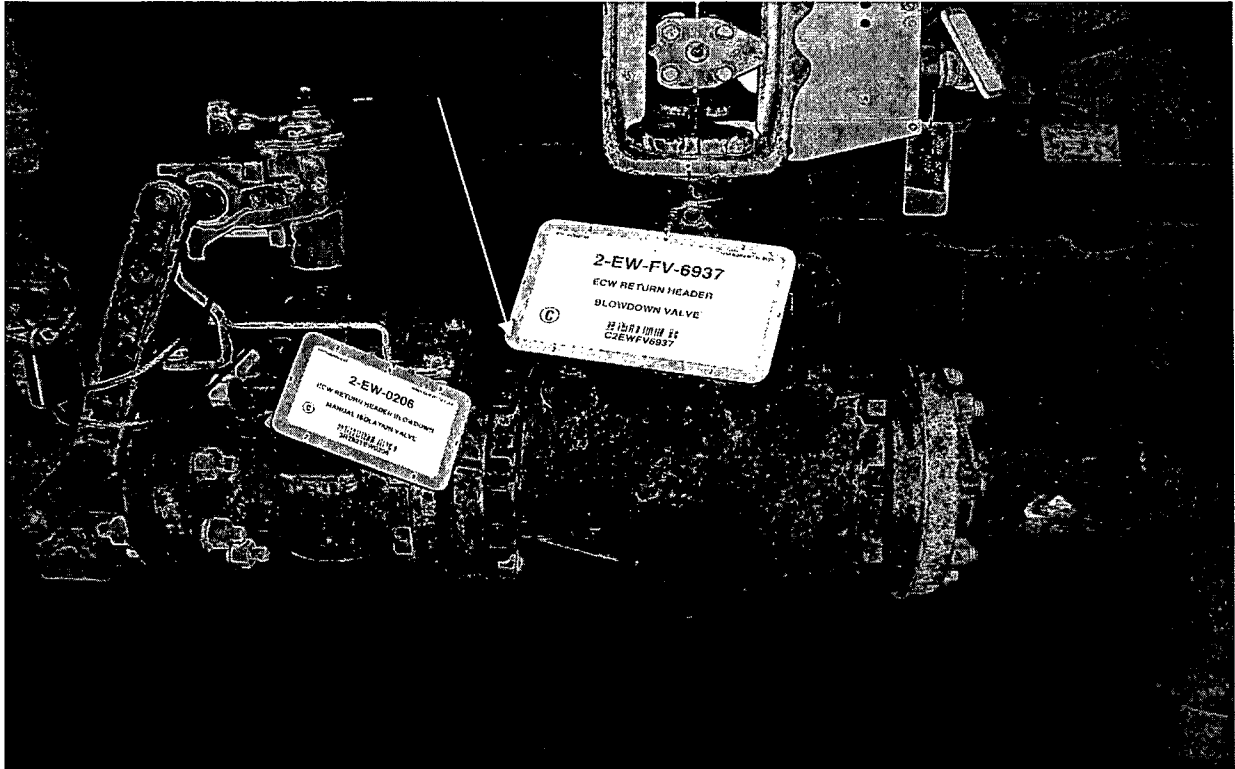
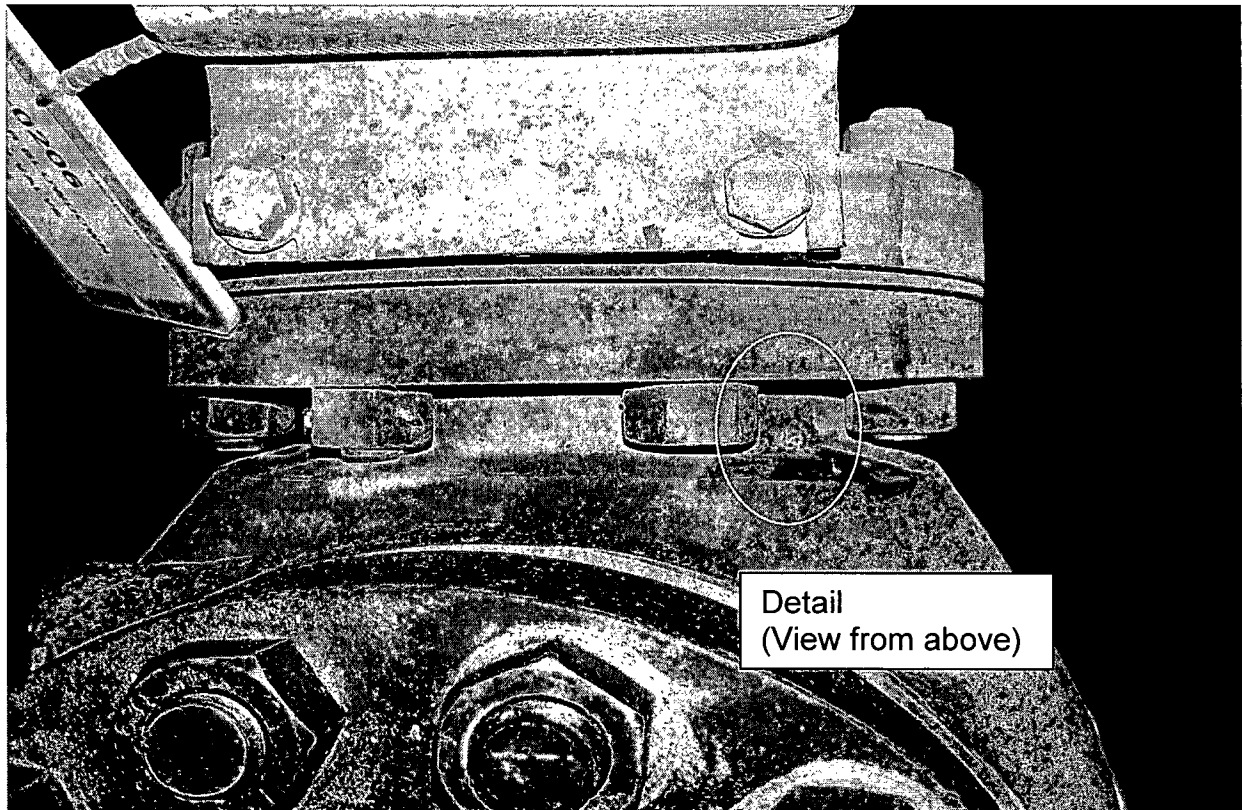
FIGURE 6: DEALLOYED AREA AT 2 O'CLOCK POSITION (2-EW-FV-6937)

A dealloying indication on valve 2-EW-FV-6937 was found on January 9, 2012. The valve minimum wall thickness in the affected area is $\frac{1}{4}$ - inch. Dealloying at the 2 o'clock position was identified as a spot less than 1/8 - inch in diameter

surrounded by multiple pinpoint of secondary indications. See Figure 6. This may be indicative of a dealloyed volume of piping material with a surface area 1 - inch by 1-1/2 inch. Visual examination found no cracks, and there is no measurable leakage.
