# Byron Station Single Phase Failure

NRC Meeting  
March 22, 2012

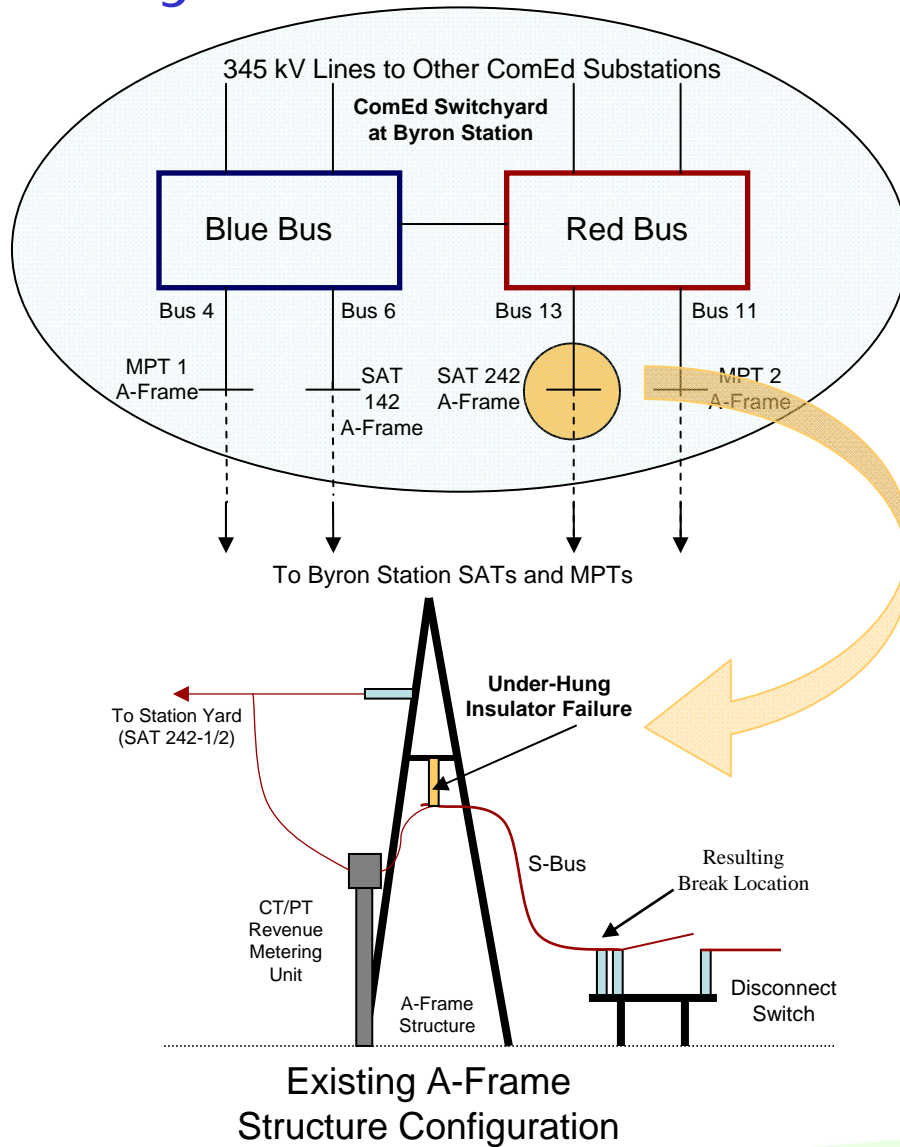
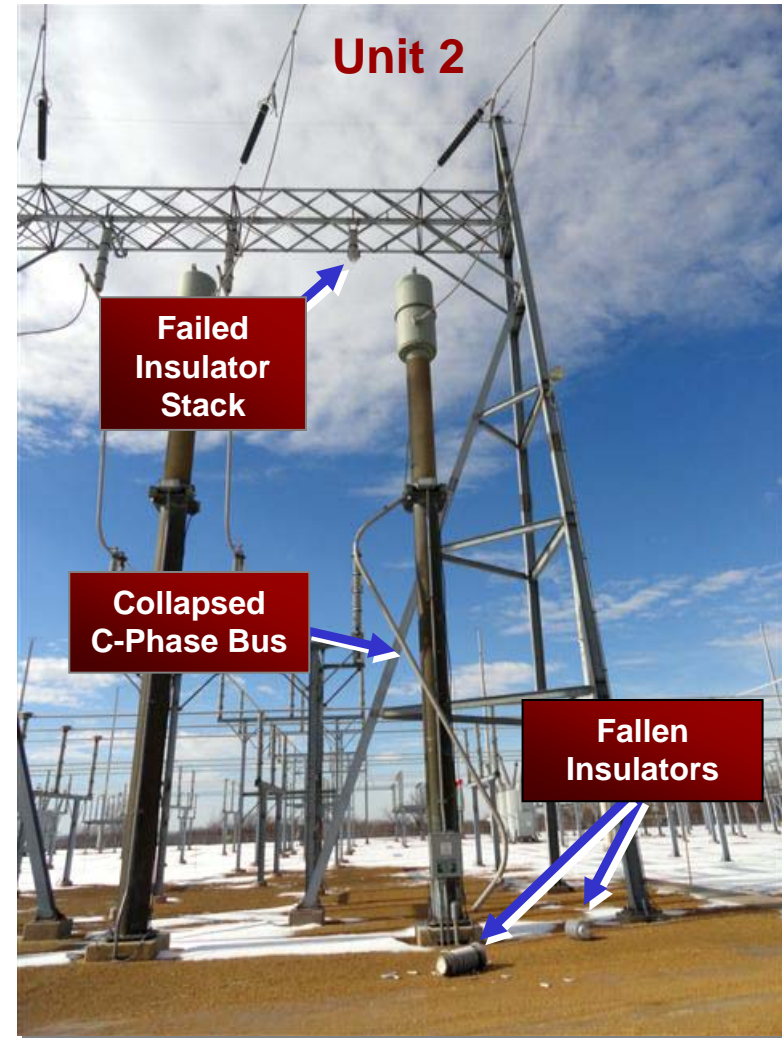
# Byron Unit 2 Insulator Failure

- ✓ January 30, 2012
- ✓ Mechanical failure of 345 kV under-hung porcelain insulator on SAT A-frame structure
- ✓ Open phase condition (primary grounded)
- ✓ LOOP
- ✓ Unusual Event
- ✓ Reactor trip
- ✓ Manual separation of ESF buses

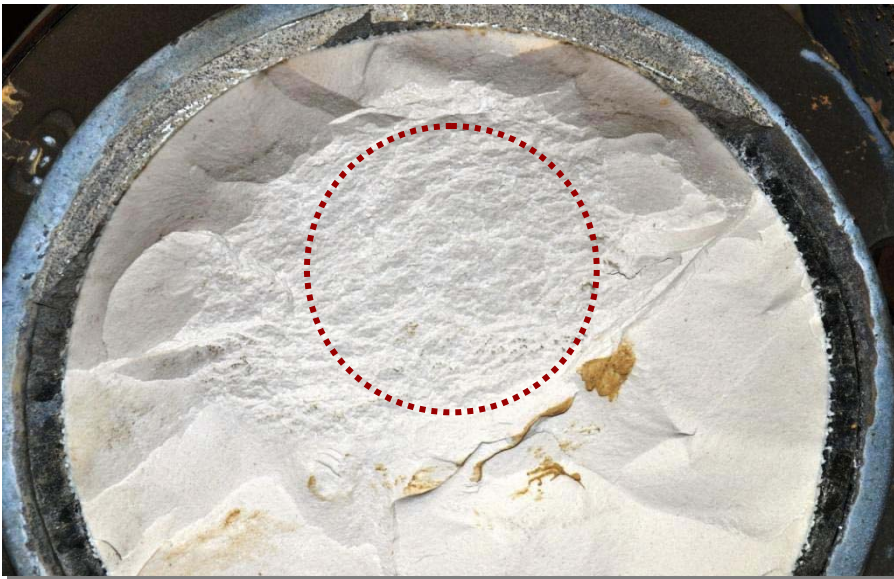
**Unit 2 Failed Insulator**

- ✓ Failure of Unit 2 'C' Phase insulator resulted in an open circuit and voltage imbalance (high impedance ground on high side of SAT, open phase on the 345 kV side of disconnect)
  - Did not result in a fault that actuated the existing protective relay scheme
- ✓ Voltage imbalance propagated through the SATs to the ESF buses
  - Under voltage or degraded voltage relays did not initiate an EDG start signal because the relays sensed adequate voltage between 'A' and 'B' Phases

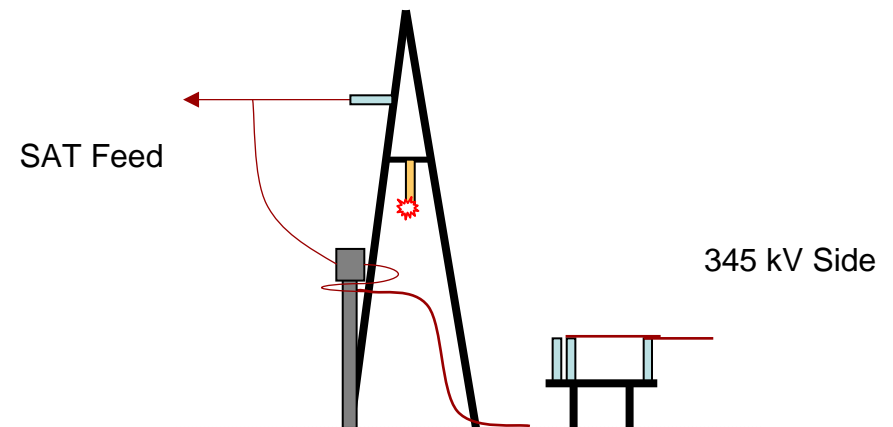
## Impact of Open Phase

- ✓ Due to ground, significant voltage imbalance
  - 4.16 kV safety bus per unit (pu) voltage
    - $V_{ab}$  1.0142 pu (on a 4160 V base)
    - $V_{bc}$  0.5912 pu (lasted 12 seconds, then cleared)
    - $V_{ca}$  0.5870 pu
