Byron Station Single Phase Failure

NRC Meeting
March 22, 2012

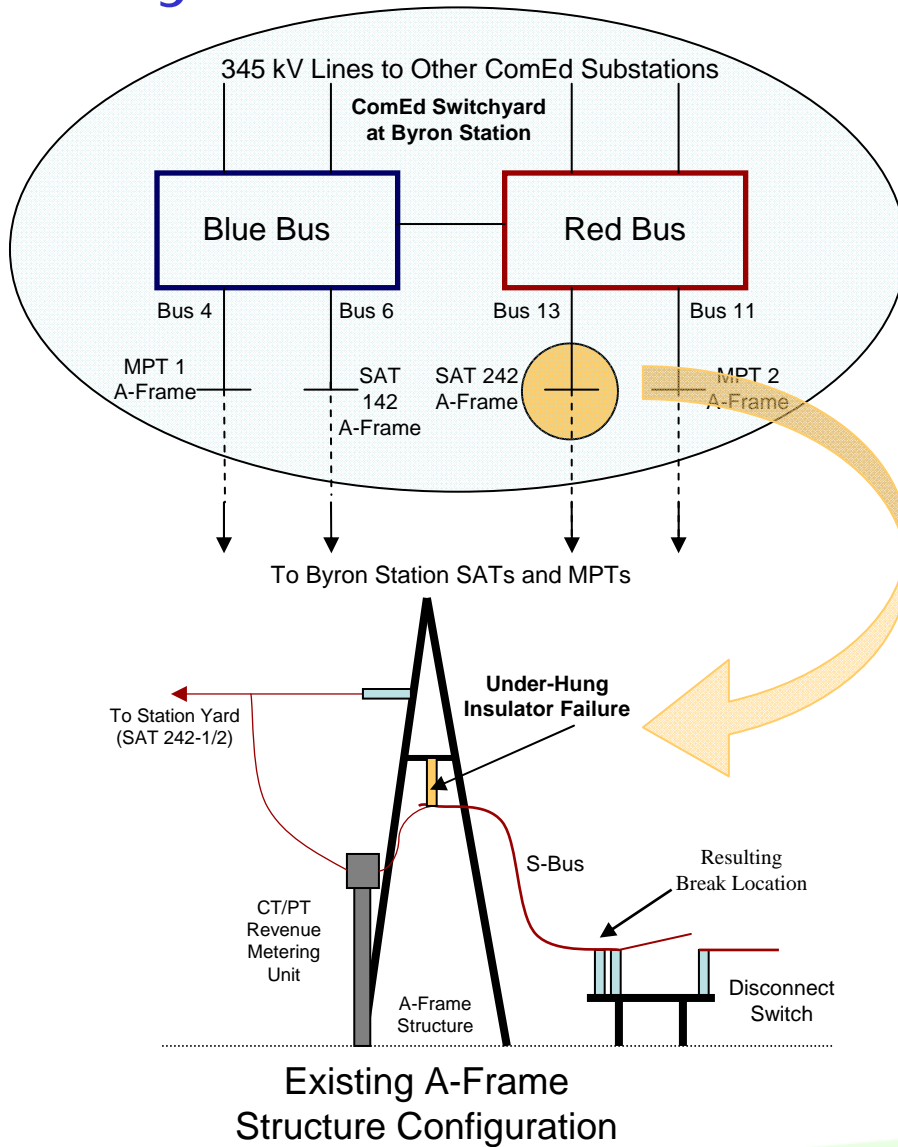
Byron Unit 2 Insulator Failure

- ✓ January 30, 2012
- ✓ Mechanical failure of 345 kV under-hung porcelain insulator on SAT A-frame structure
- ✓ Open phase condition (primary grounded)
- ✓ LOOP
- ✓ Unusual Event
- ✓ Reactor trip
- ✓ Manual separation of ESF buses
