Entergy Operations, Indian Point Energy Center, Unit 2

Root Cause Evaluation Report

IP2 Turbine Trip/Reactor Trip Due to 21 Main Transformer Fault

CR-IP2-2010-6801; Event Date: 11-07-2010

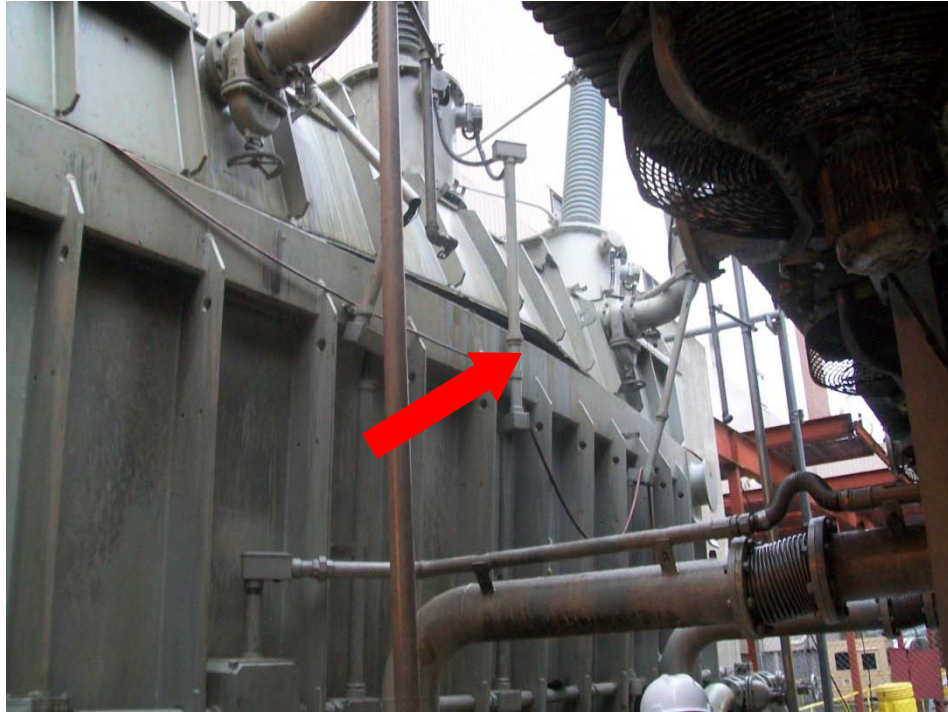
Fig. 4: Site conditions following the 21MT tank rupture

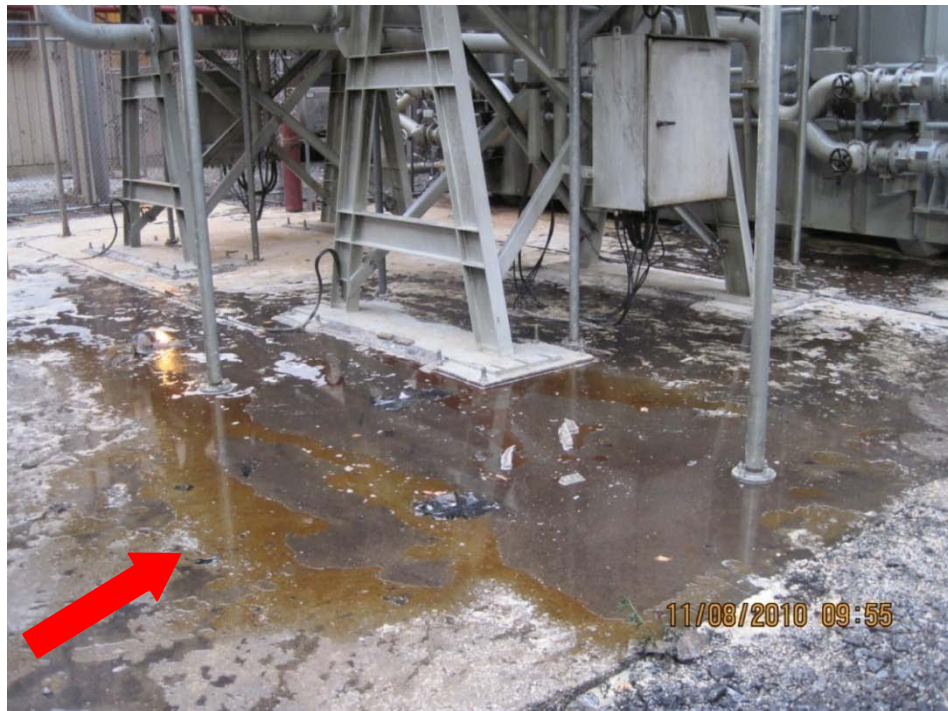
Following the failure of 21 Main Transformer, oil (from 21 Main Transformer) mixed with water from the fire deluge system, overflowed the transformer’s containment structure and penetrated the east wall of the Turbine Building. This oil/water mixture flowed onto the 15 ft elevation of the Turbine Building, near the 6.9 KV switchgear, and into the 5 ft elevation. All Turbine Building sump pumps were immediately secured, and cleanup activities of the oil/water mixture commenced. The discharge canal was monitored for any signs of oil or oil sheen. Initially, there was no oil detected in the discharge canal or the river. On 11/8/10, an oil film was observed on the water in the discharge canal. The oil was observed along the entire discharge canal and the visible portion of the outfall. No means to quantify the oil was available. No means was available to determine whether or not oil was being transferred to the Hudson River from the discharge canal. The oil was reported to station management. The New York State DEC was informed of the spill of transformer oil that may have been the source of oil in the canal. The oil sheen in the discharge canal was contained. Clean Harbors and Miller Environmental were called in to assist in the containment and cleanup of the oil.

Fig. 5: Oil released following the 21MT tank rupture

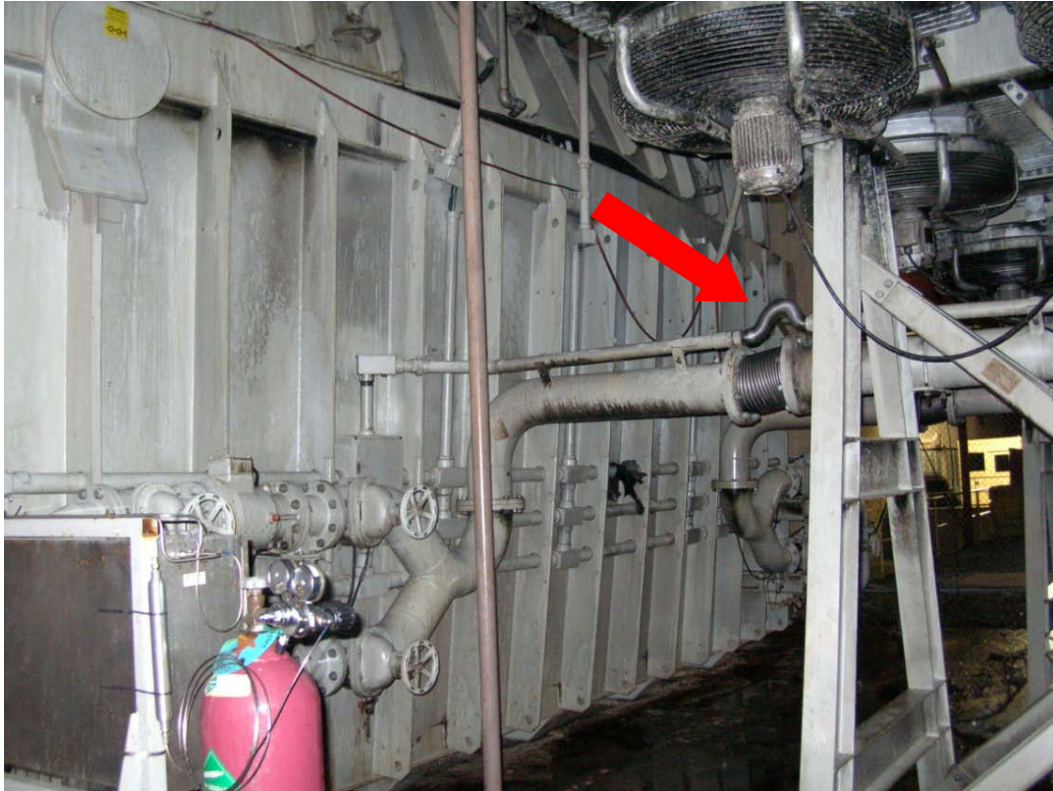
Fig. 6: Photo of external appearance of 21MT taken by IPEC personnel the night of the fault. Red arrow points to deformed conduit from force of explosion.

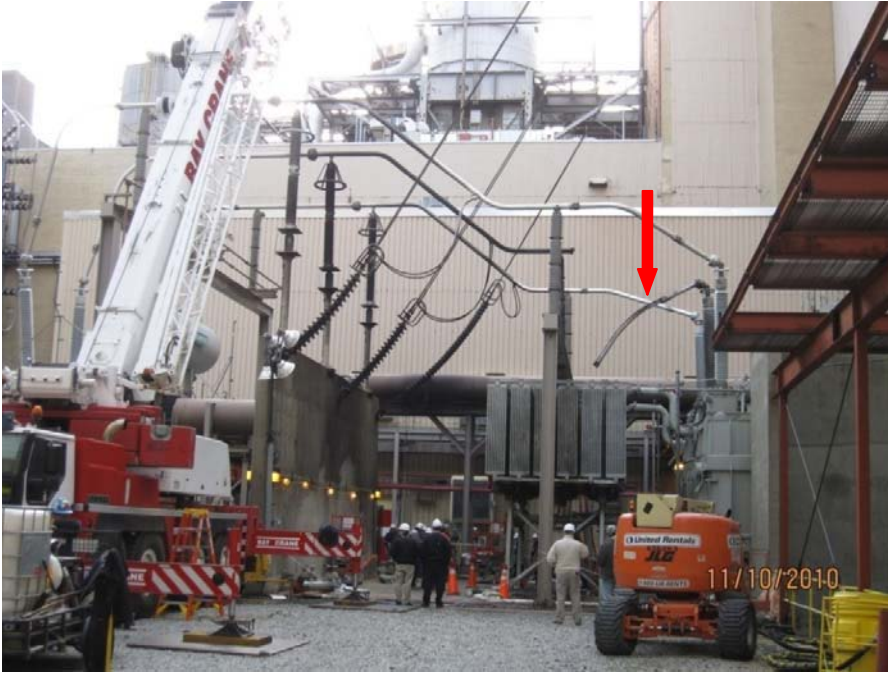
Fire brigade felt and heard second explosion in transformer yard while mobilizing equipment. Simultaneously, the CCR felt a large concussion. Visual inspection after the second explosion noted that the B-Phase W95 feeder bus section from 21 Main Transformer was broken away and resting over the radiator.
- 1849 Alert Emergency declared – EAL 8.2.3 (21 Main Transformer explosion).
- 1900 Entered 2-POP-3.2, “Plant Recovery from Trip, Hot Standby”

Fig. 7: Rigging crews on-site to disassemble 21MT. Red arrow points to fractured HV feeder bus section.

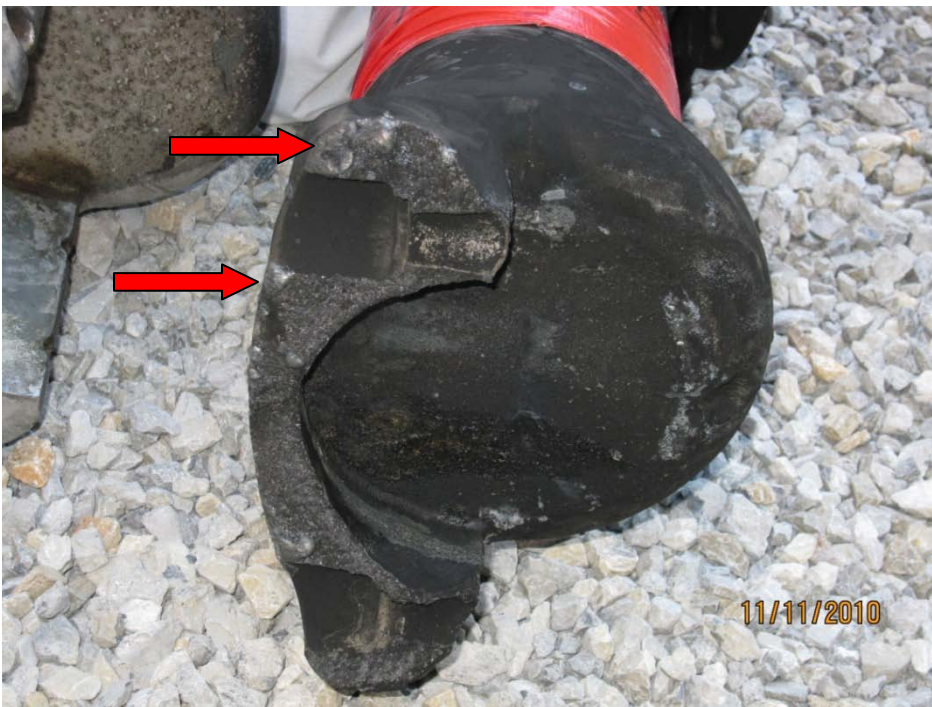
Fig. 8: Fracture surface of “B” phase HV feeder bus section showing localized melting

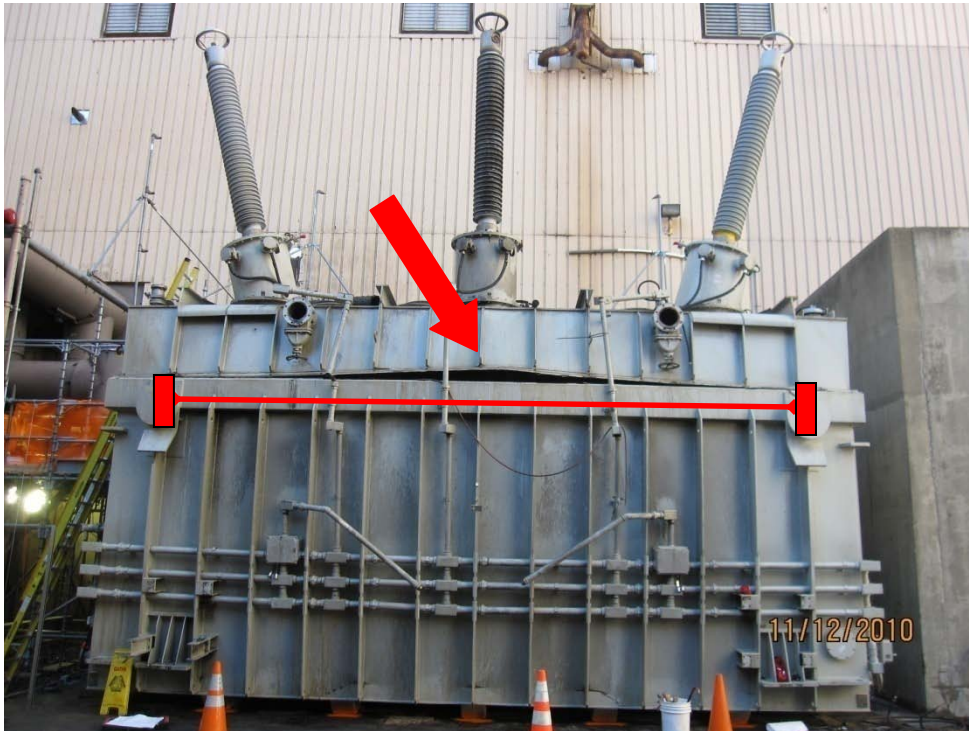
The transformer experienced a rapid increase in pressure due to the failure of the 'B' phase high voltage bushing. This sudden increase caused the tank to fail. Combustible gases, from arcing, built up in the transformer as the insulating oil leaked from the tank breach. After several more minutes, enough oxygen combined with the hot gases causing a secondary explosion. A cooling valve cracked 360° resulting in most of the oil draining from the tank. See Attachment III for photos of damage to bushings and ruptured transformer tank.

Fig. 9: View of 21MT tank structure after removal of radiators. The red line is approximately the extent of the burst weld seam.

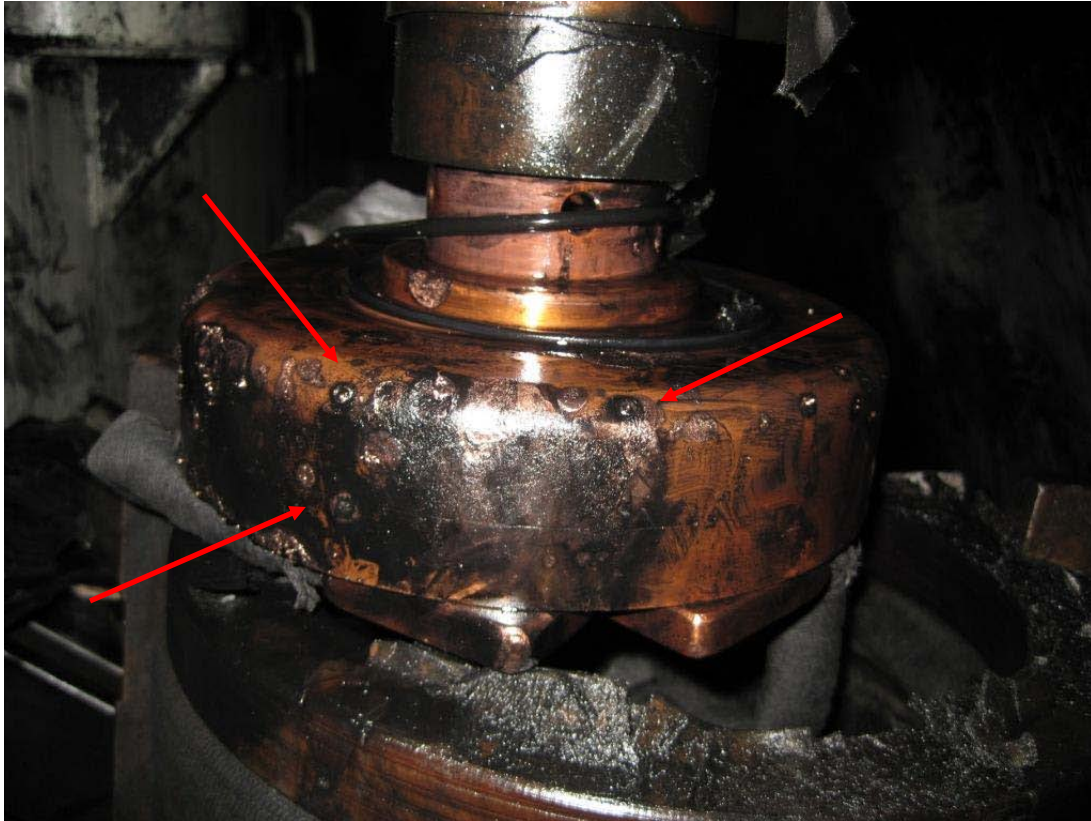
The 'A' phase bushing sustained little visible damage. The corona shield winding was in good condition with no evidence of arcing and all connections were intact. There was arcing noted on the base of the conductor, however, this is an expected response as the dielectric properties of the oil medium were compromised due to the failure of the 'B' phase bushing.

Fig. 11: Numerous arc strikes observed at the bottom terminal of the "B" phase bushing

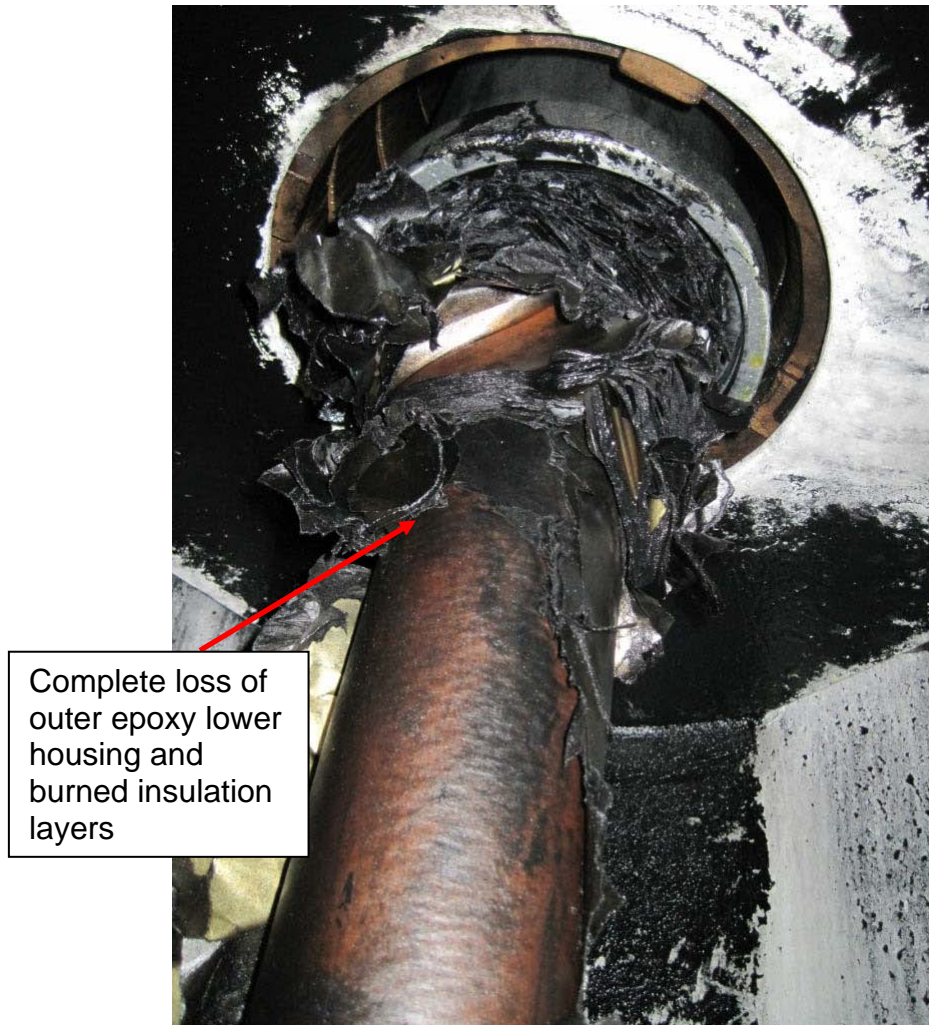
The inboard end (oil side) of the 'B' phase high voltage bushing was found severely damaged. The inboard end housing (epoxy-resin insulator) was found completely shattered and ejected from the bushing with pieces both inside and outside of the main tank. Most of the conductive and insulating paper was torn, unraveled, removed from the bushing conductor and scattered throughout the transformer internals and outside of the transformer. Excessive arc striking was noticed at the bushing bottom terminal and on the transformer main tank wall and turret. The arc strike out of the bushing has been located at the highest section of the bushing conductor at the top of the turret. A hole through the center conductor of the bushing was observed. The bushing lower corona shield was found shifted downward, exposing the bushing bottom terminal. The corona shield winding was in good condition with no evidence of arcing and all connections were intact. The shield support bracing was broken due to the shockwave from the initial explosion, which caused the shield to shift / drop down. The porcelain insulator of the bushing external to the top of the transformer tank was intact.

Fig. 12: Failure of the “B” phase bushing insulating material

Action Completed: This Trench bushing was replaced in 3R16 with an ABB bushing under WO 267273, EC 27984.

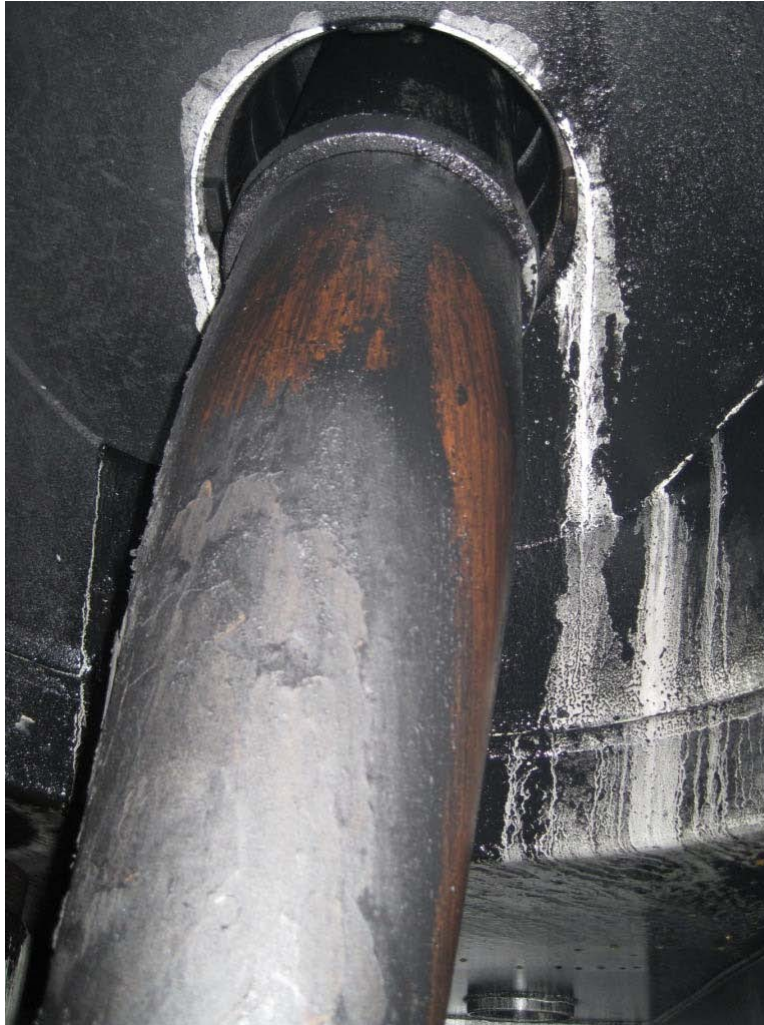
Fig. 13: Condition of the "A" phase HV bushing

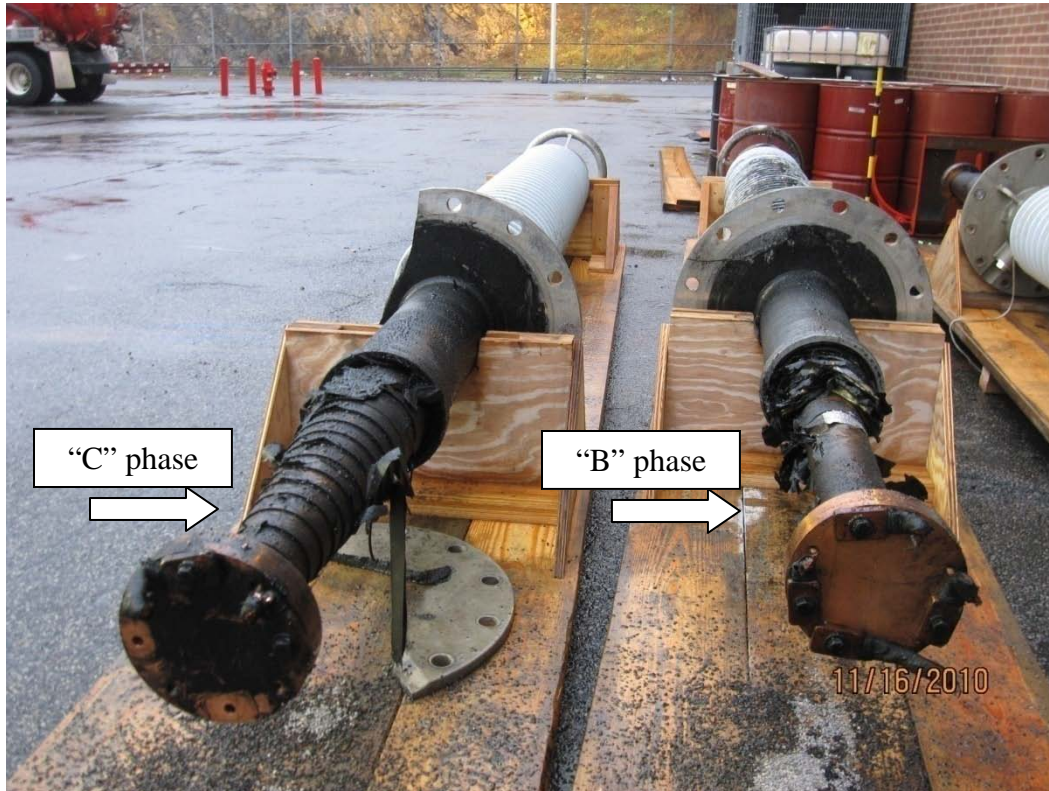
The 'C' phase high voltage bushing sustained some damage but not as severe as the 'B' phase. The epoxy-resin was shattered off of the bushing. Most of the insulating paper was found intact still on the bushing conductor. The corona shield was slightly shifted downward due to some damage to the shield bracing. The bottom terminal of the bushing was exposed. The shield winding was in good condition with no evidence of arcing and all connections were intact. The damage to the 'C' phase high voltage bushing appears to have been caused by the shock wave from the failure of the 'B' phase high voltage bushing.

Fig. 14: Extent of damage to "B" phase and "C" phase HV bushings after removal from transformer

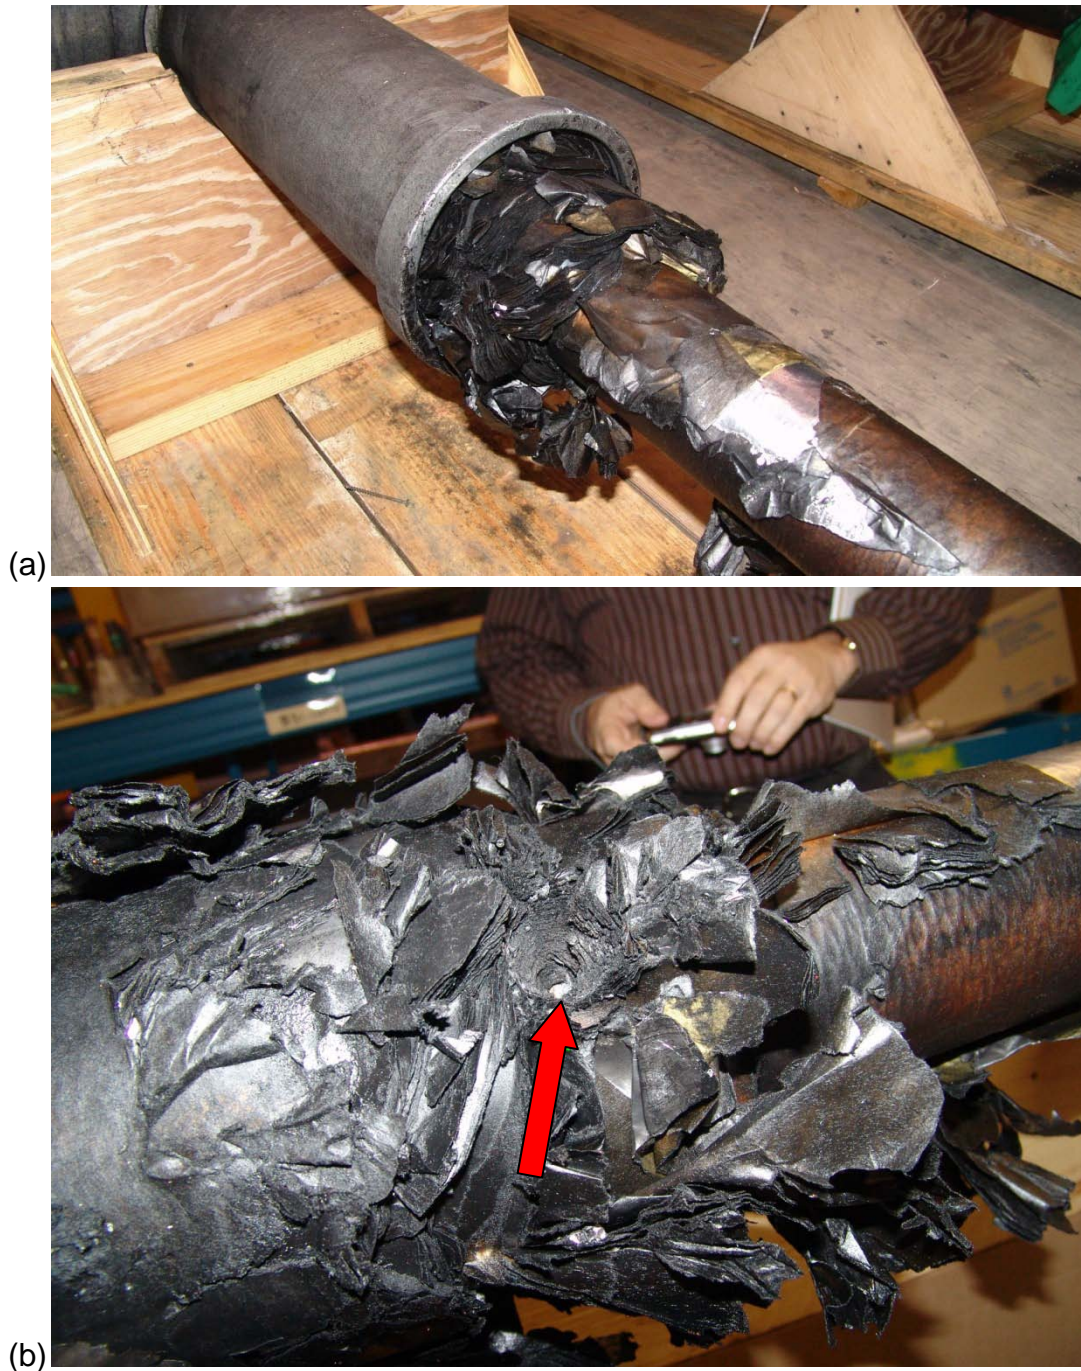
The teardown of the failed ‘B’ phase bushing from 21 Main Transformer revealed a puncture hole in the inboard end of the bushing that radiated outward to the bushings ground flange. When the bushing was unwound electrical treeing was observed in the paper at the high stress edges of the foil layers.

Fig. 17:(a) Overview of "B" phase bushing at Ajax Trench manufacturing facility. (b) Outer surface of radial puncture in "B" phase bushing capacitor.

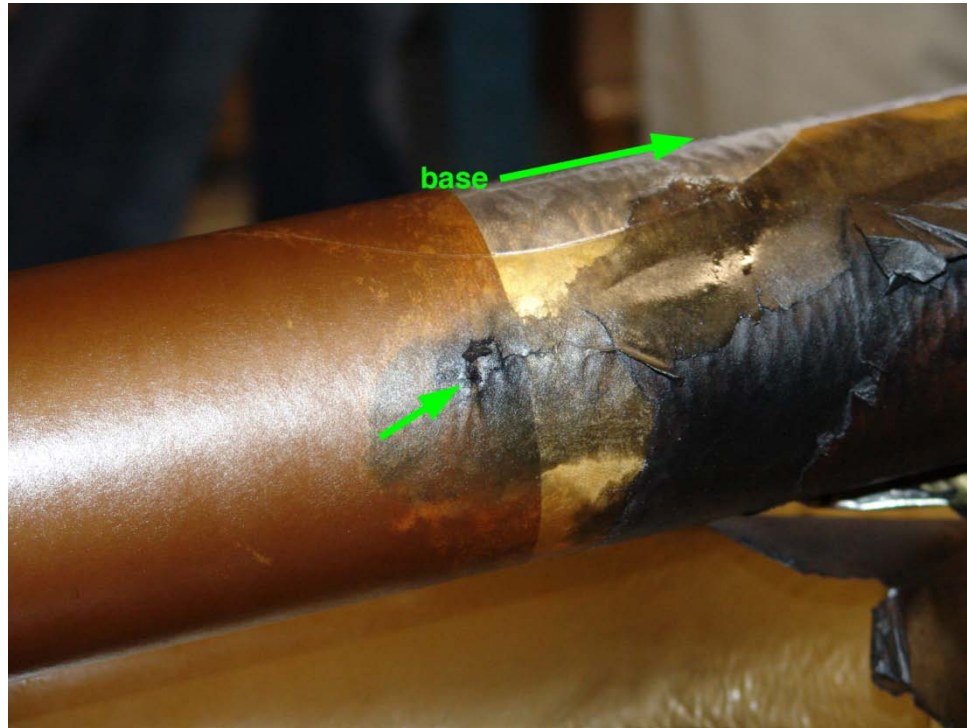
Fig. 18: Radial puncture initiation site in layer 20 or 21 of failed "B" phase bushing

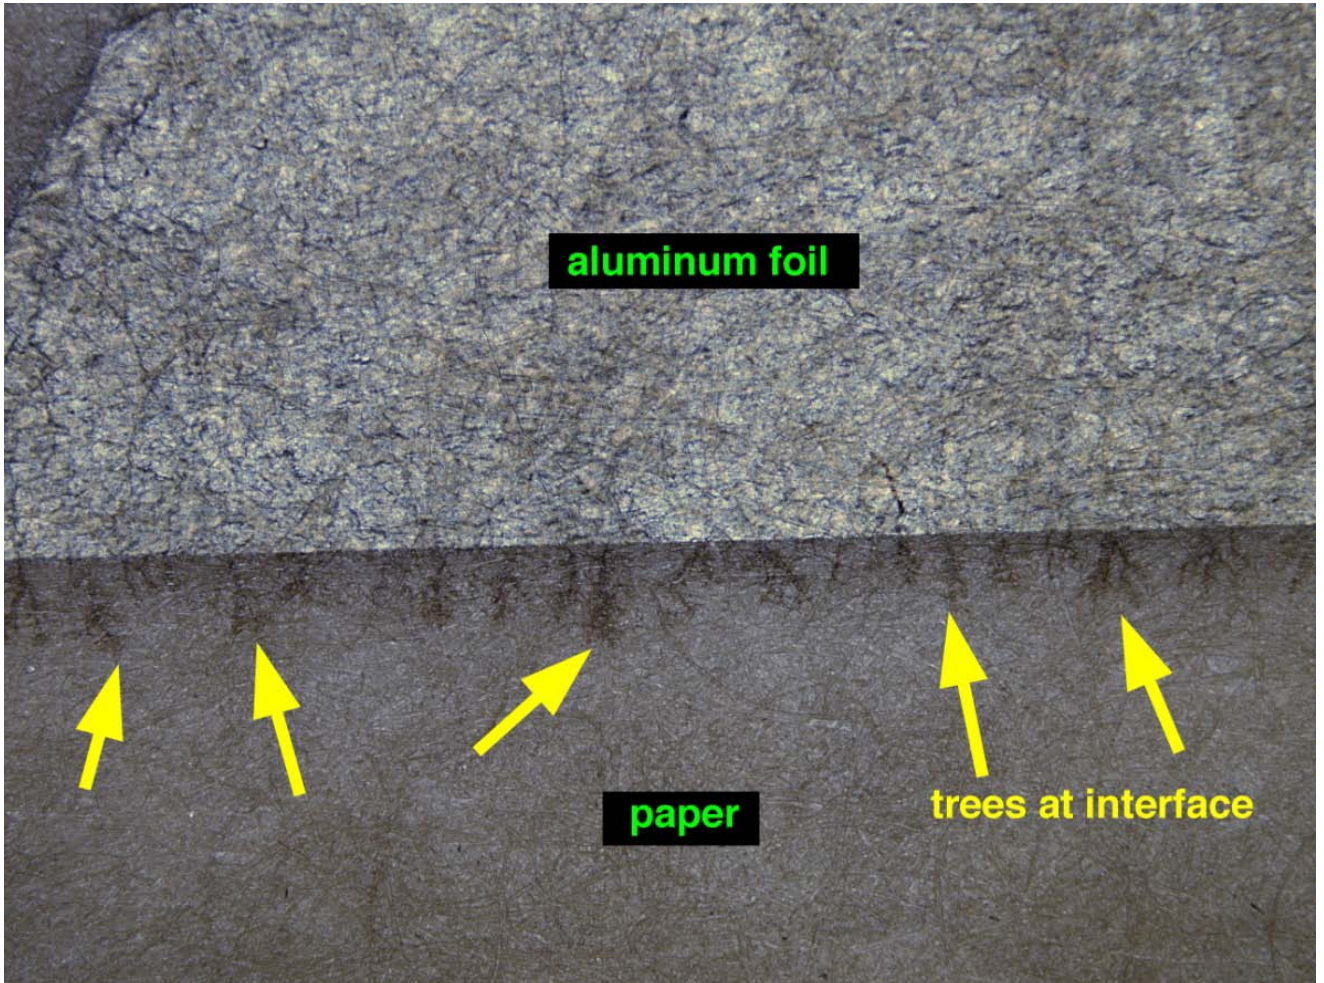
When the other two bushings from 21 Main Transformer (MT) were unwound the same electrical treeing phenomenon was also observed.

Fig. 19: Trees observed at paper/foil interface in “C”phase bushing

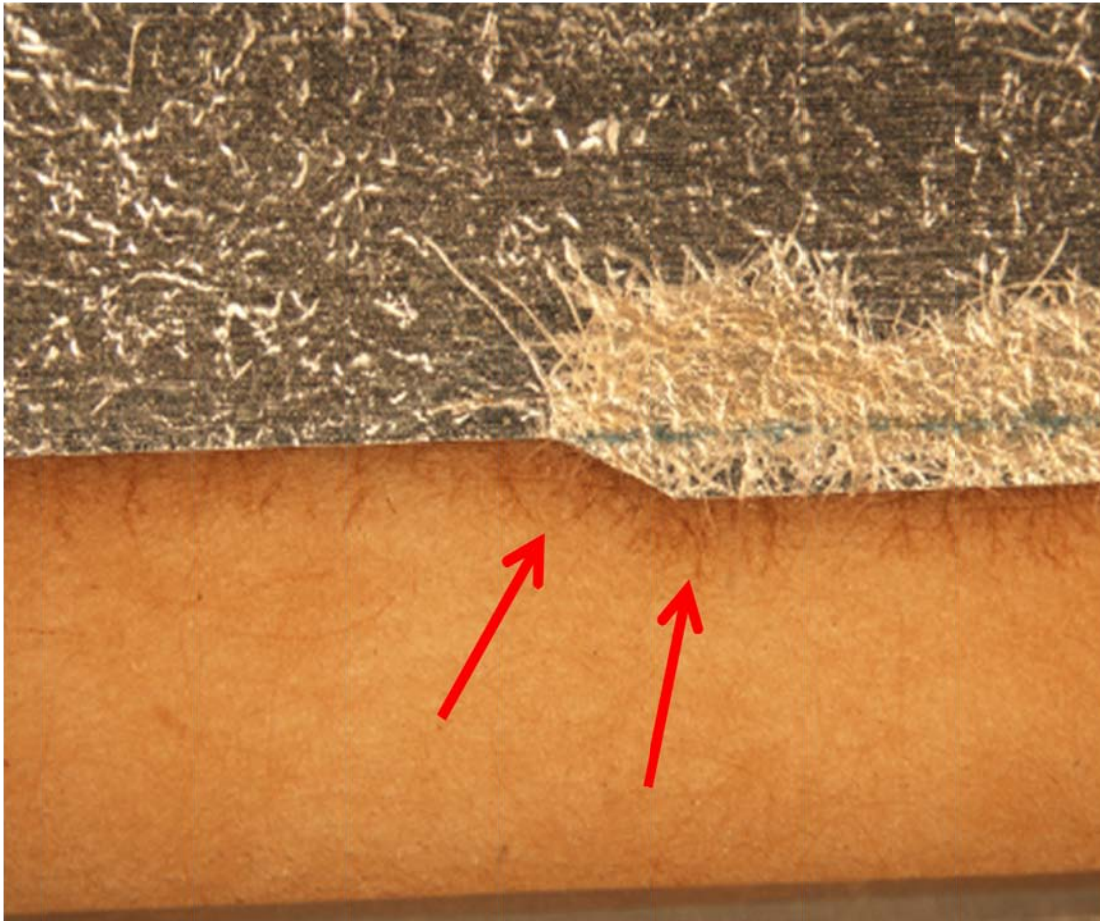
Electrical treeing compromises the axial and radial breakdown strength of the paper layers since these are three-dimensional structures. As the insulation quality breaks down, the electrical withstand strength decreases between adjacent paper layers. At some point, dielectric breakdown between layers will occur. Breakdown between layers results in an avalanche condition wherein full-scale breakdown progresses rapidly and without significant warning.

It appears that the electrical treeing is being caused by the manufacturing/design of the foil edges. The foil edges are cut with a device similar to a standard office paper cutter. This results in “sharp” edges that do not control the electrical stresses at the foil/paper interface. These stresses cause the electrical treeing in the paper. The analysis of the paper, foil and oil did not reveal any other anomalies that would have lead to the treeing.

Fig. 27: Evidence of electrical treeing in paper insulation removed from “B” phase bushing

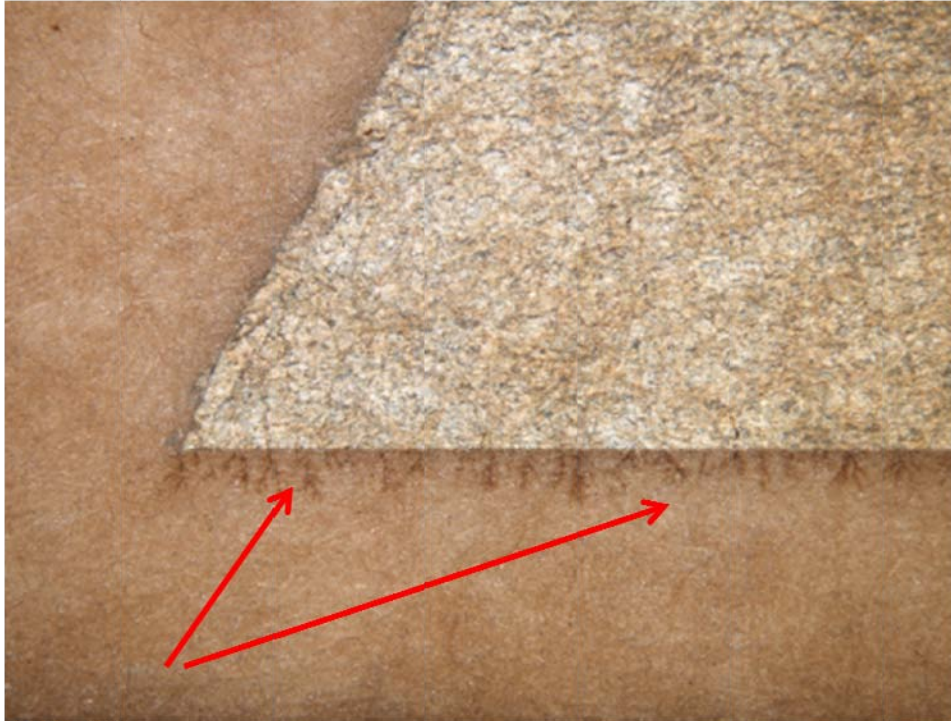
Fig. 30: Electrical treeing observed in “C” phase bushing only at electrically-stressed edge
