Exelon Generation Company, LLC www.exeloncorp.com
Byron Station
4450 North German Church Road
Byron, IL 61010-9794

Subject: Licensee Event Report 2012-001-00, "Unit 2 Loss of Normal Offsite Power and Reactor Trip and Unit 1 Loss of Normal Offsite Power Due to Failure of System Auxiliary Transformer Inverted Insulators"

4. TITLE
Unit 2 Loss of Normal Offsite Power and Reactor Trip and Unit 1 Loss of Normal Offsite Power Due to Failure of System Auxiliary Transformer Inverted Insulators

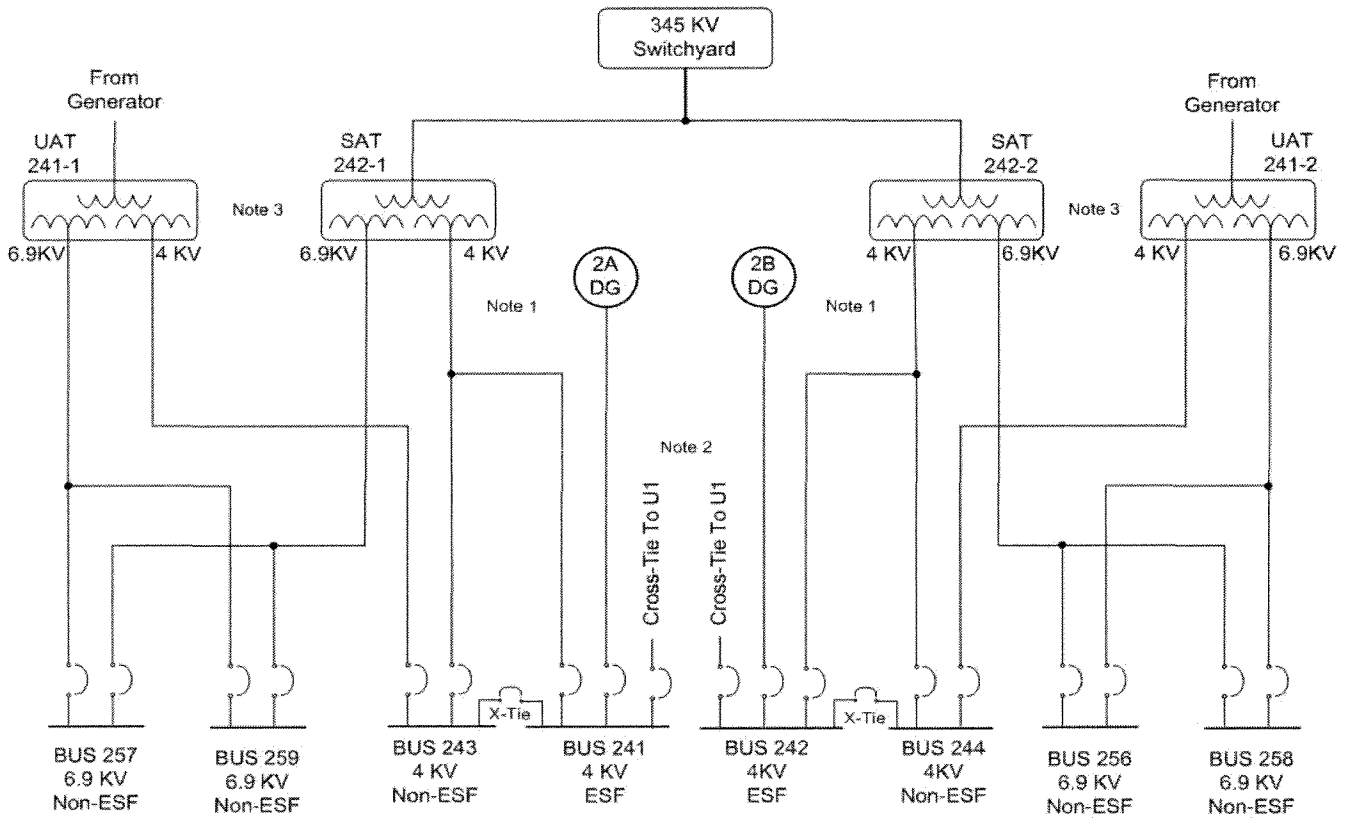
Figure 1

Unit 1 and Unit 2 AC Electrical Power Design Summary (see figure 1)

The Unit 1 and Unit 2 AC electrical system consists of two 4.16 kilovolt (kV) Engineered Safety Features (ESF) buses, four nonsafety-related 6.9 kV buses and two nonsafety-related 4.16 kV buses. The two 4.16 kV ESF buses and two of the nonsafety-related 6.9 kV buses normally are supplied by one of the two System Auxiliary Transformers (SATs) [EB] connected through one 345 kV offsite circuit. The remaining two nonsafety-related 6.9 kV station buses and two nonsafety-related 4.16 kV station buses normally are supplied by one of two Unit Auxiliary Transformers (UATs) [EL] when the main generator is online. The four Reactor Coolant Pumps (RCPs) are powered by the four 6.9 kV buses. Each 4.16 kV ESF bus has a dedicated standby emergency Diesel Generator (DG) [EK].

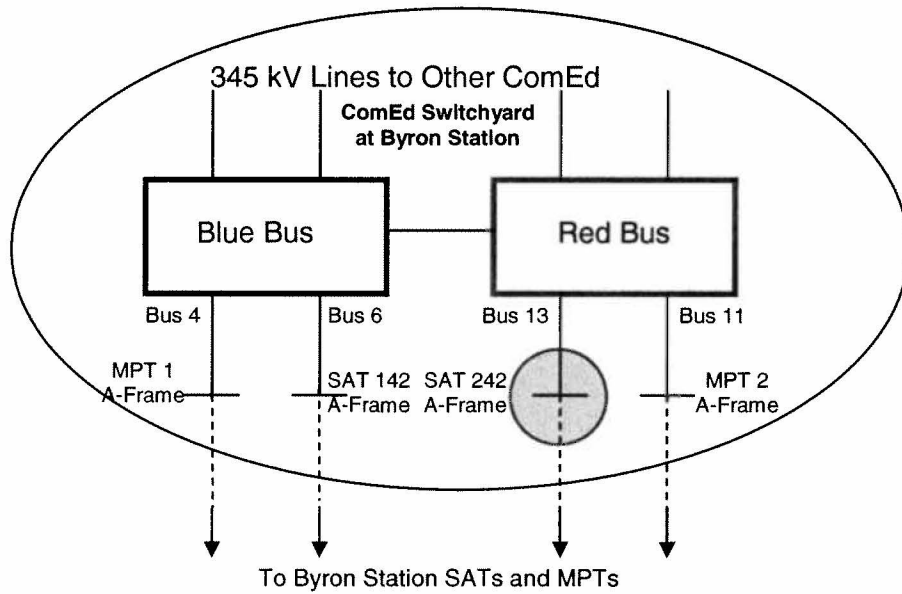
Figure 2

On January 30, 2012, at 1001:54 hours, a mechanical failure of a 345 kV under hung porcelain insulator on the SAT 242-1/2 A-Frame structure in the switchyard resulted in an open phase non-faulted condition on the SAT 242-1/2 C phase S-Bus lead between the A-Frame structure support insulator and the 345 kV Bus 13 disconnect switch (See figure 2). When the insulator failed, the S-bus fell causing both a mechanical and electrical failure at the terminal pad of the Bus 13 disconnect switch. The nature of the failure resulted in a sustained open phase event to the SAT 242-1/2 and a low level ground fault occurred on the SAT 242-1/2 side of the open phase.
