ENTERGY	ENGINEERING STANDARD	EN-EP-S-002-MULTI	REV. 0
	Buried Piping and Tanks General Visual Inspection	PAGE 12 OF 12

ATTACHMENT 7.1

Piping / Tank IP3 AFW/Cond Return to CST (8-inch Line 1080) (Ref. WO # 279578-03) INSPECTION DATE: 12/9/2011

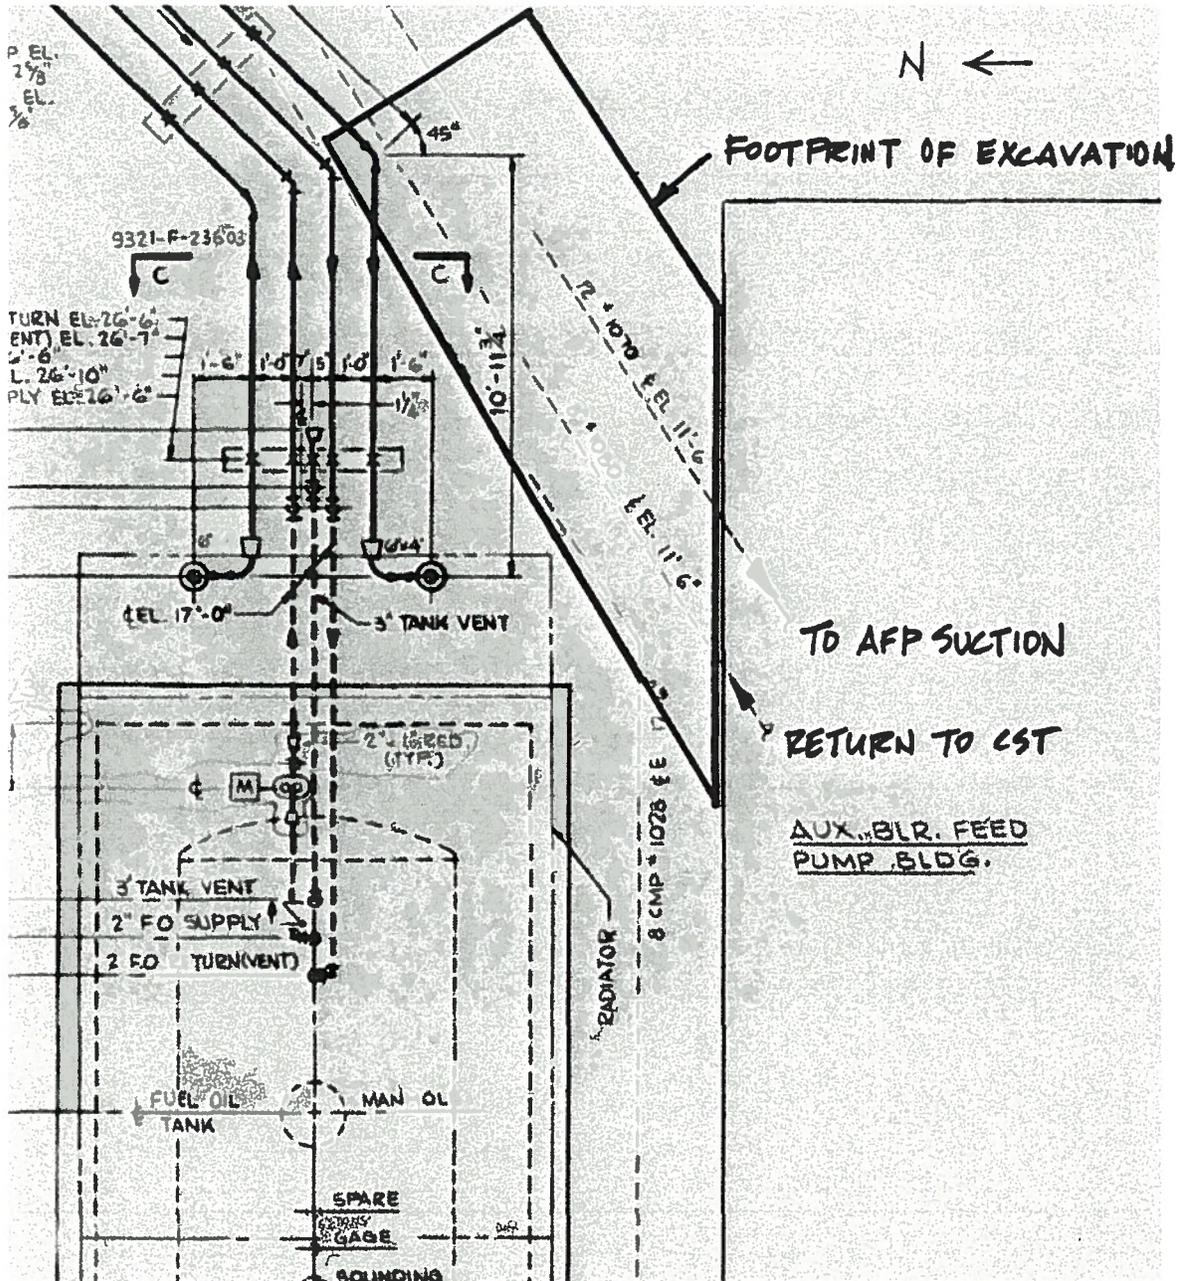
Ref. Drawing 9321-F-23593  
 IP3 Yard / NE corner of AFP Bldg  
 WO # 279578 - Excavation/Inspection of Cond/AFW Lines 1070 & 1080

COMMENTS (Inspector): This inspection is a visual inspection of the As-Found condition of the pipe coating. The portion of Line 1080 inspected under this task is shown on the attached dwg. 9321-F-23593 excerpt (attached). The results of this inspection will be evaluated together with the results of direct UT and guided wave ultrasonic inspections, which will be performed under separate tasks.

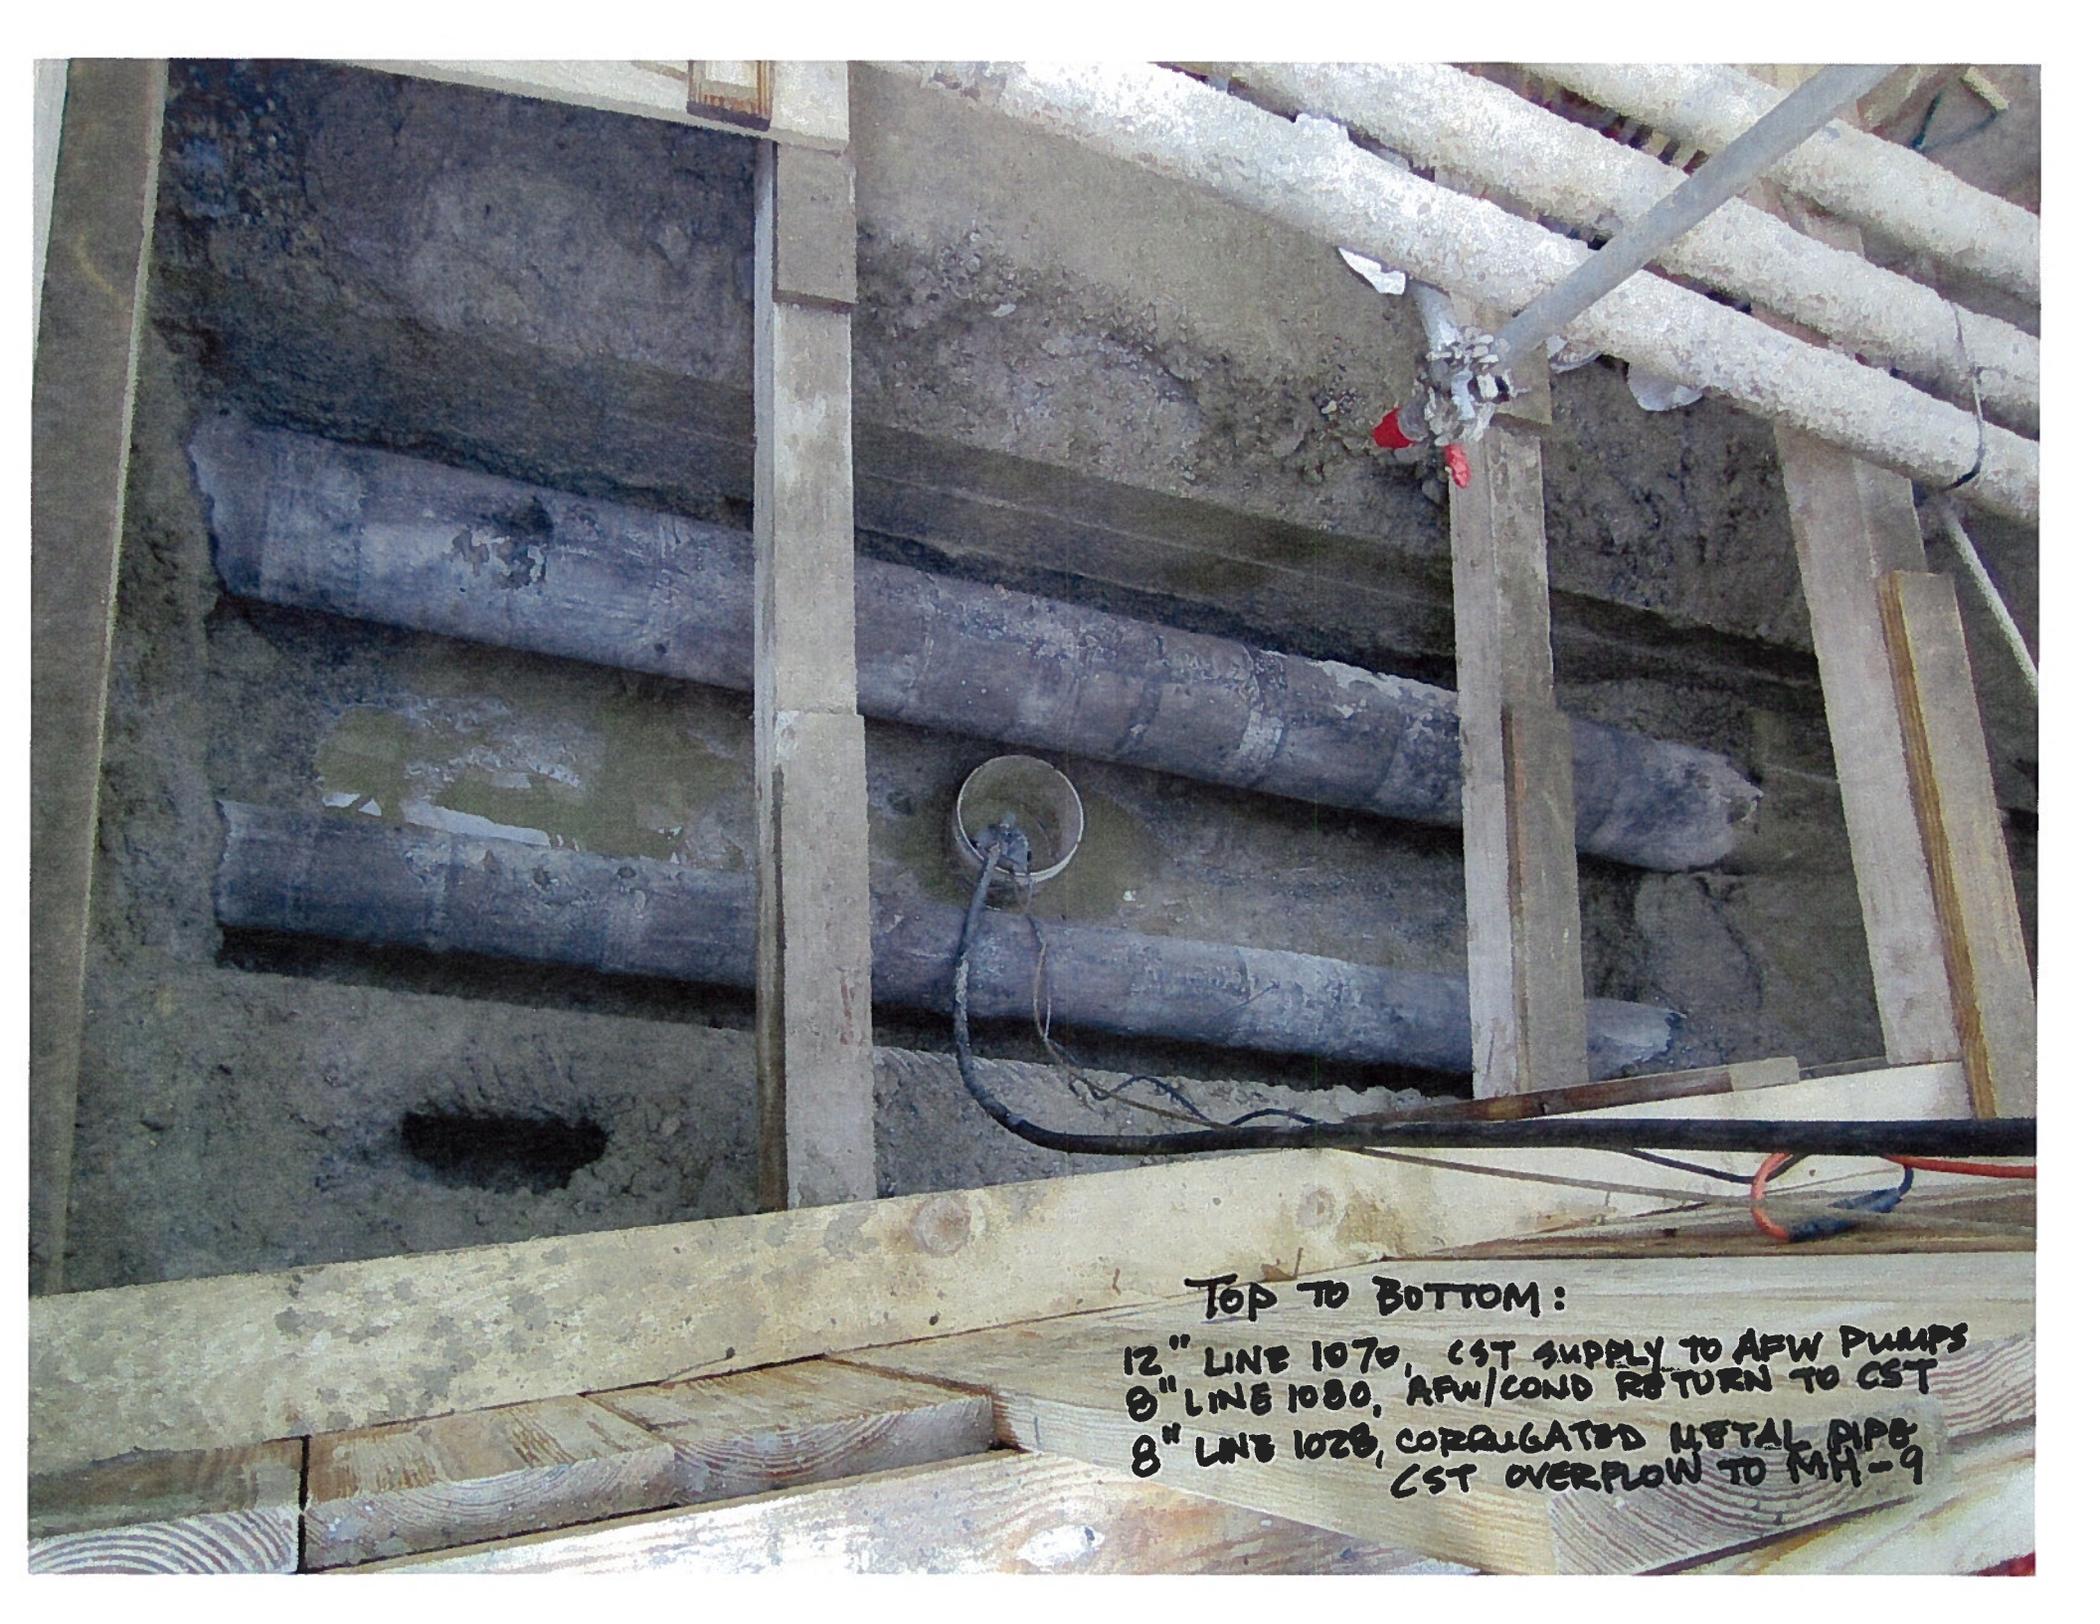
**TOP TO BOTTOM:**

12" LINE 1070, CST SUPPLY TO APW PUMPS  
8" LINE 1080, APW/COND RETURN TO CST  
8" LINE 1028, CORRUGATED METAL PIPE  
CST OVERFLOW TO MH-9

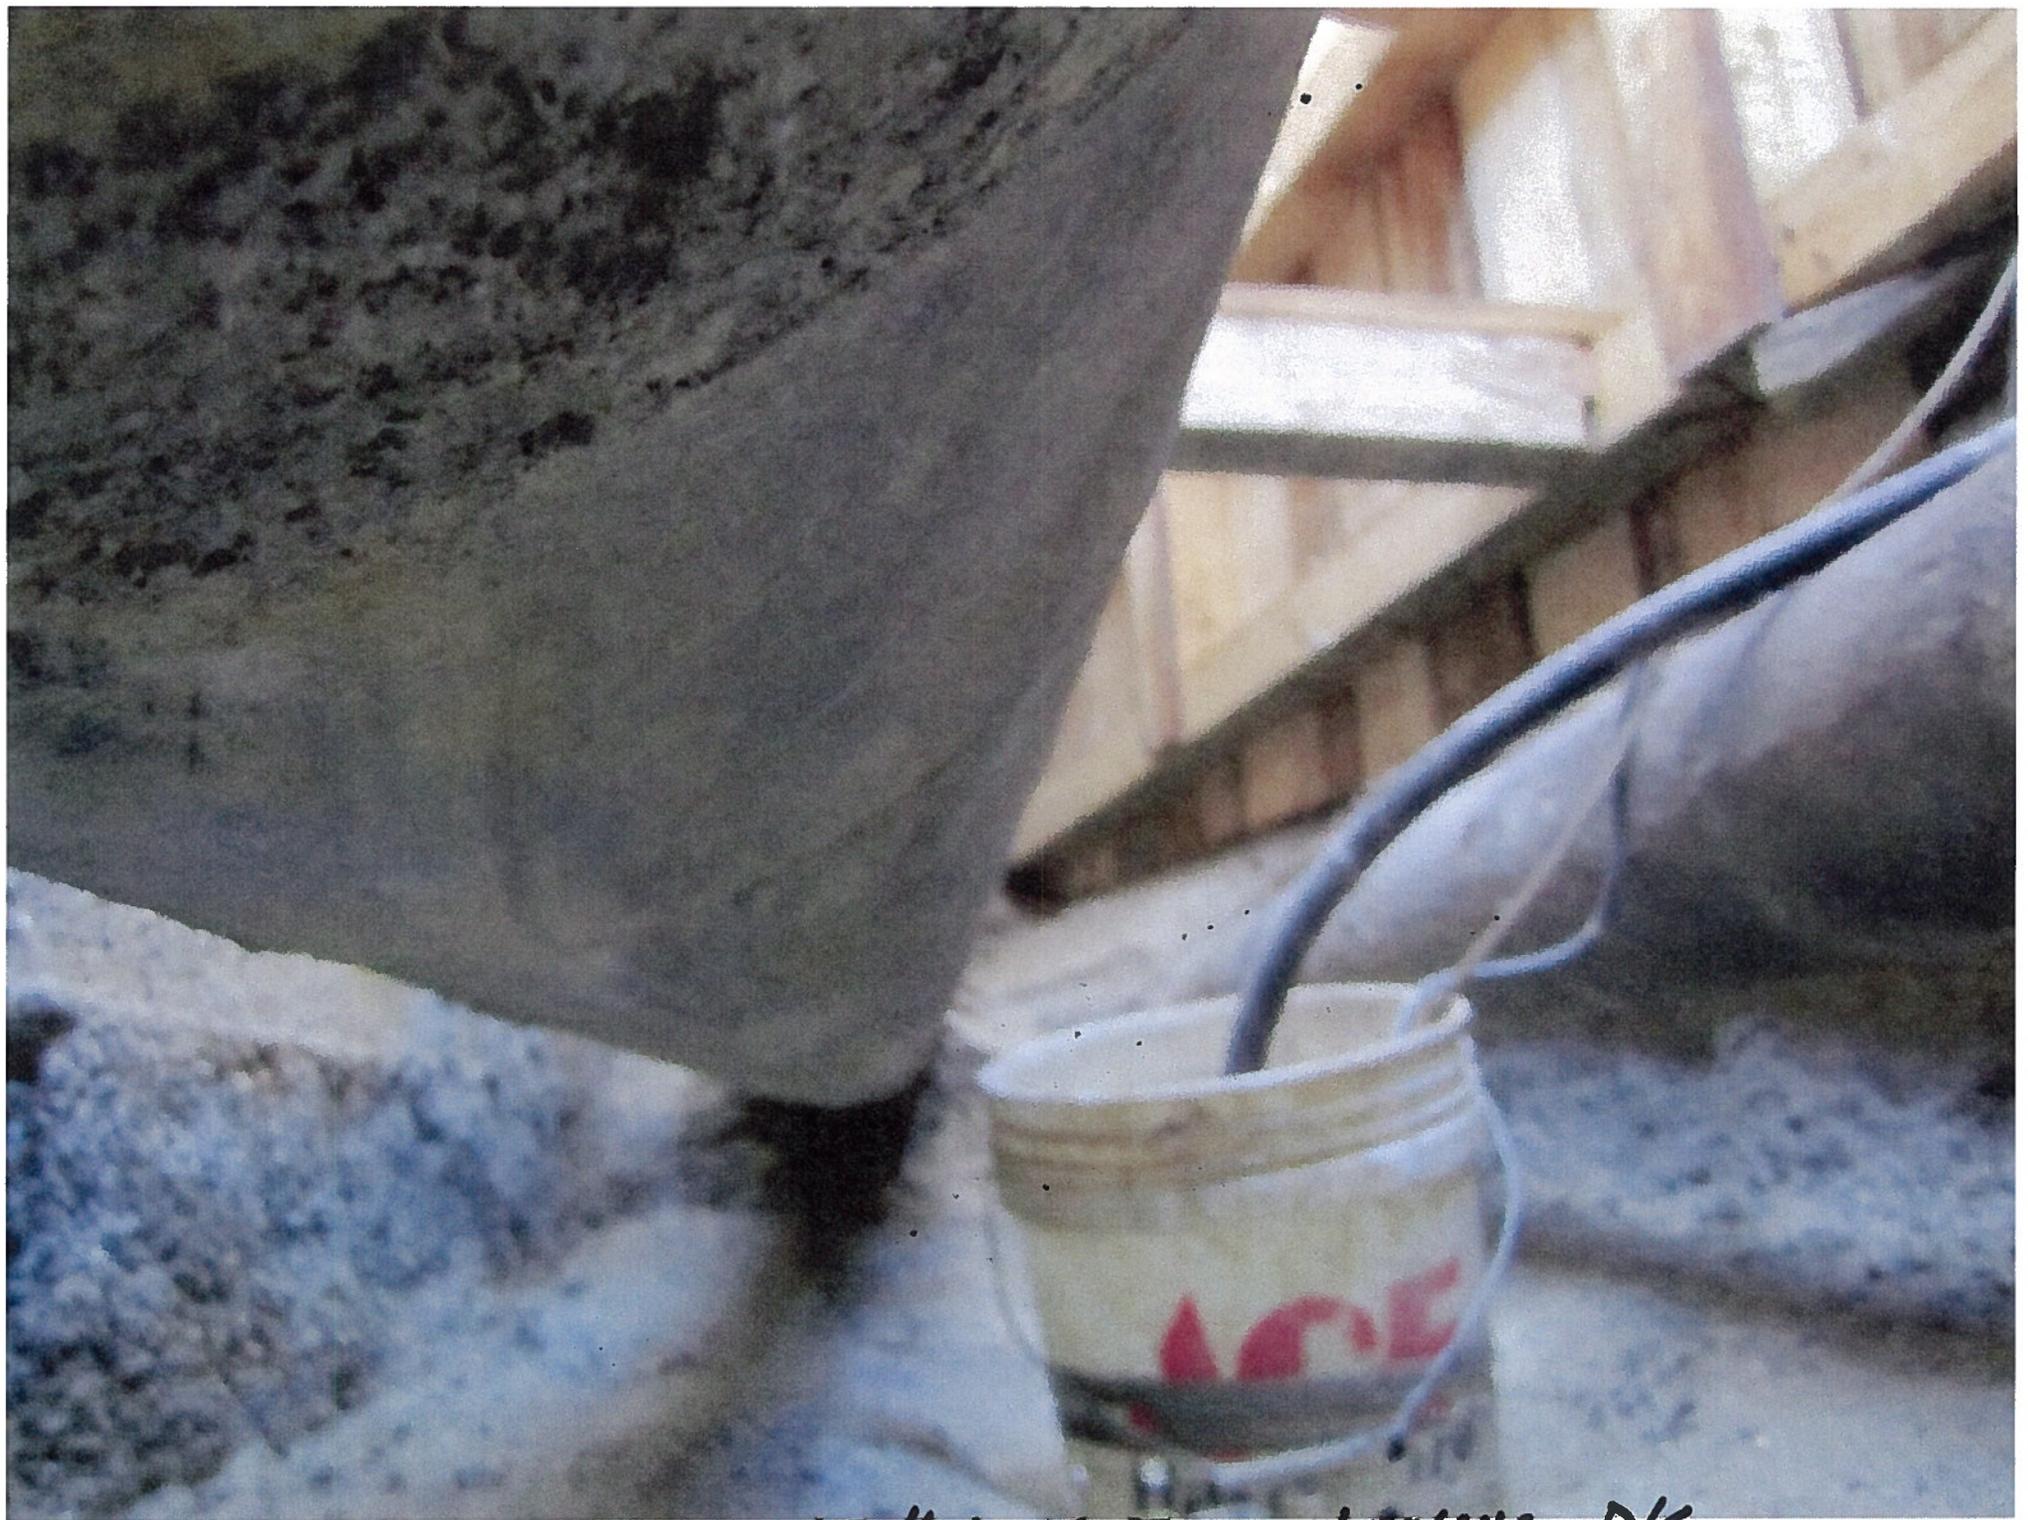
17" LINE TO - LOOKING D/S

↑ TO AFW PUMPS

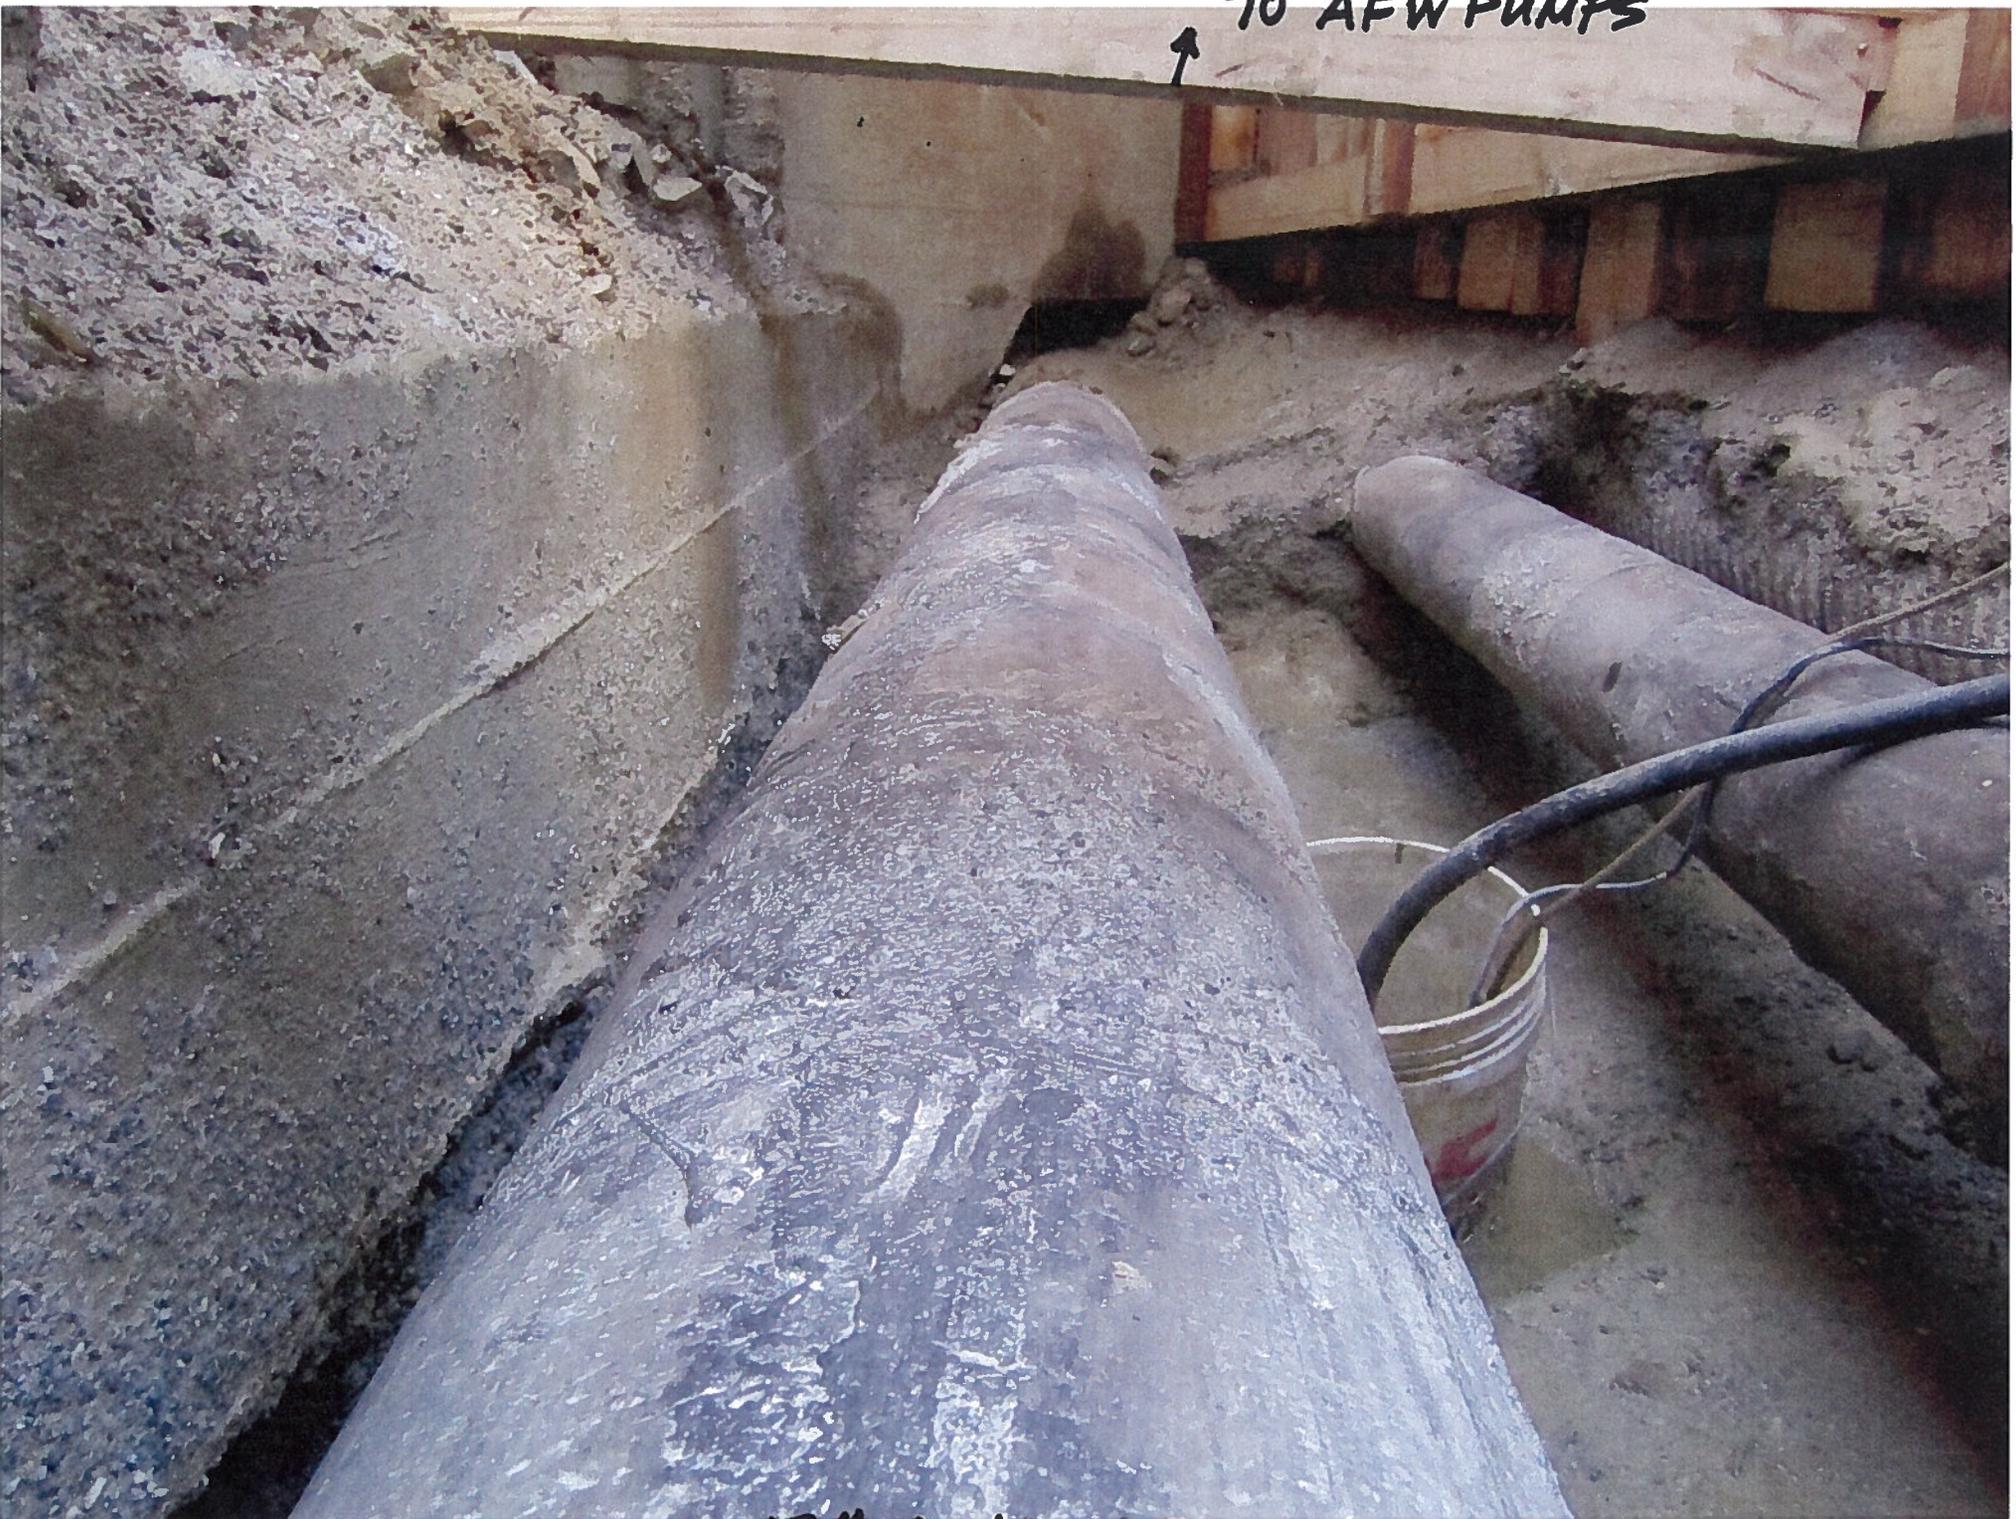
12" LINE 1070

↑ TO EST

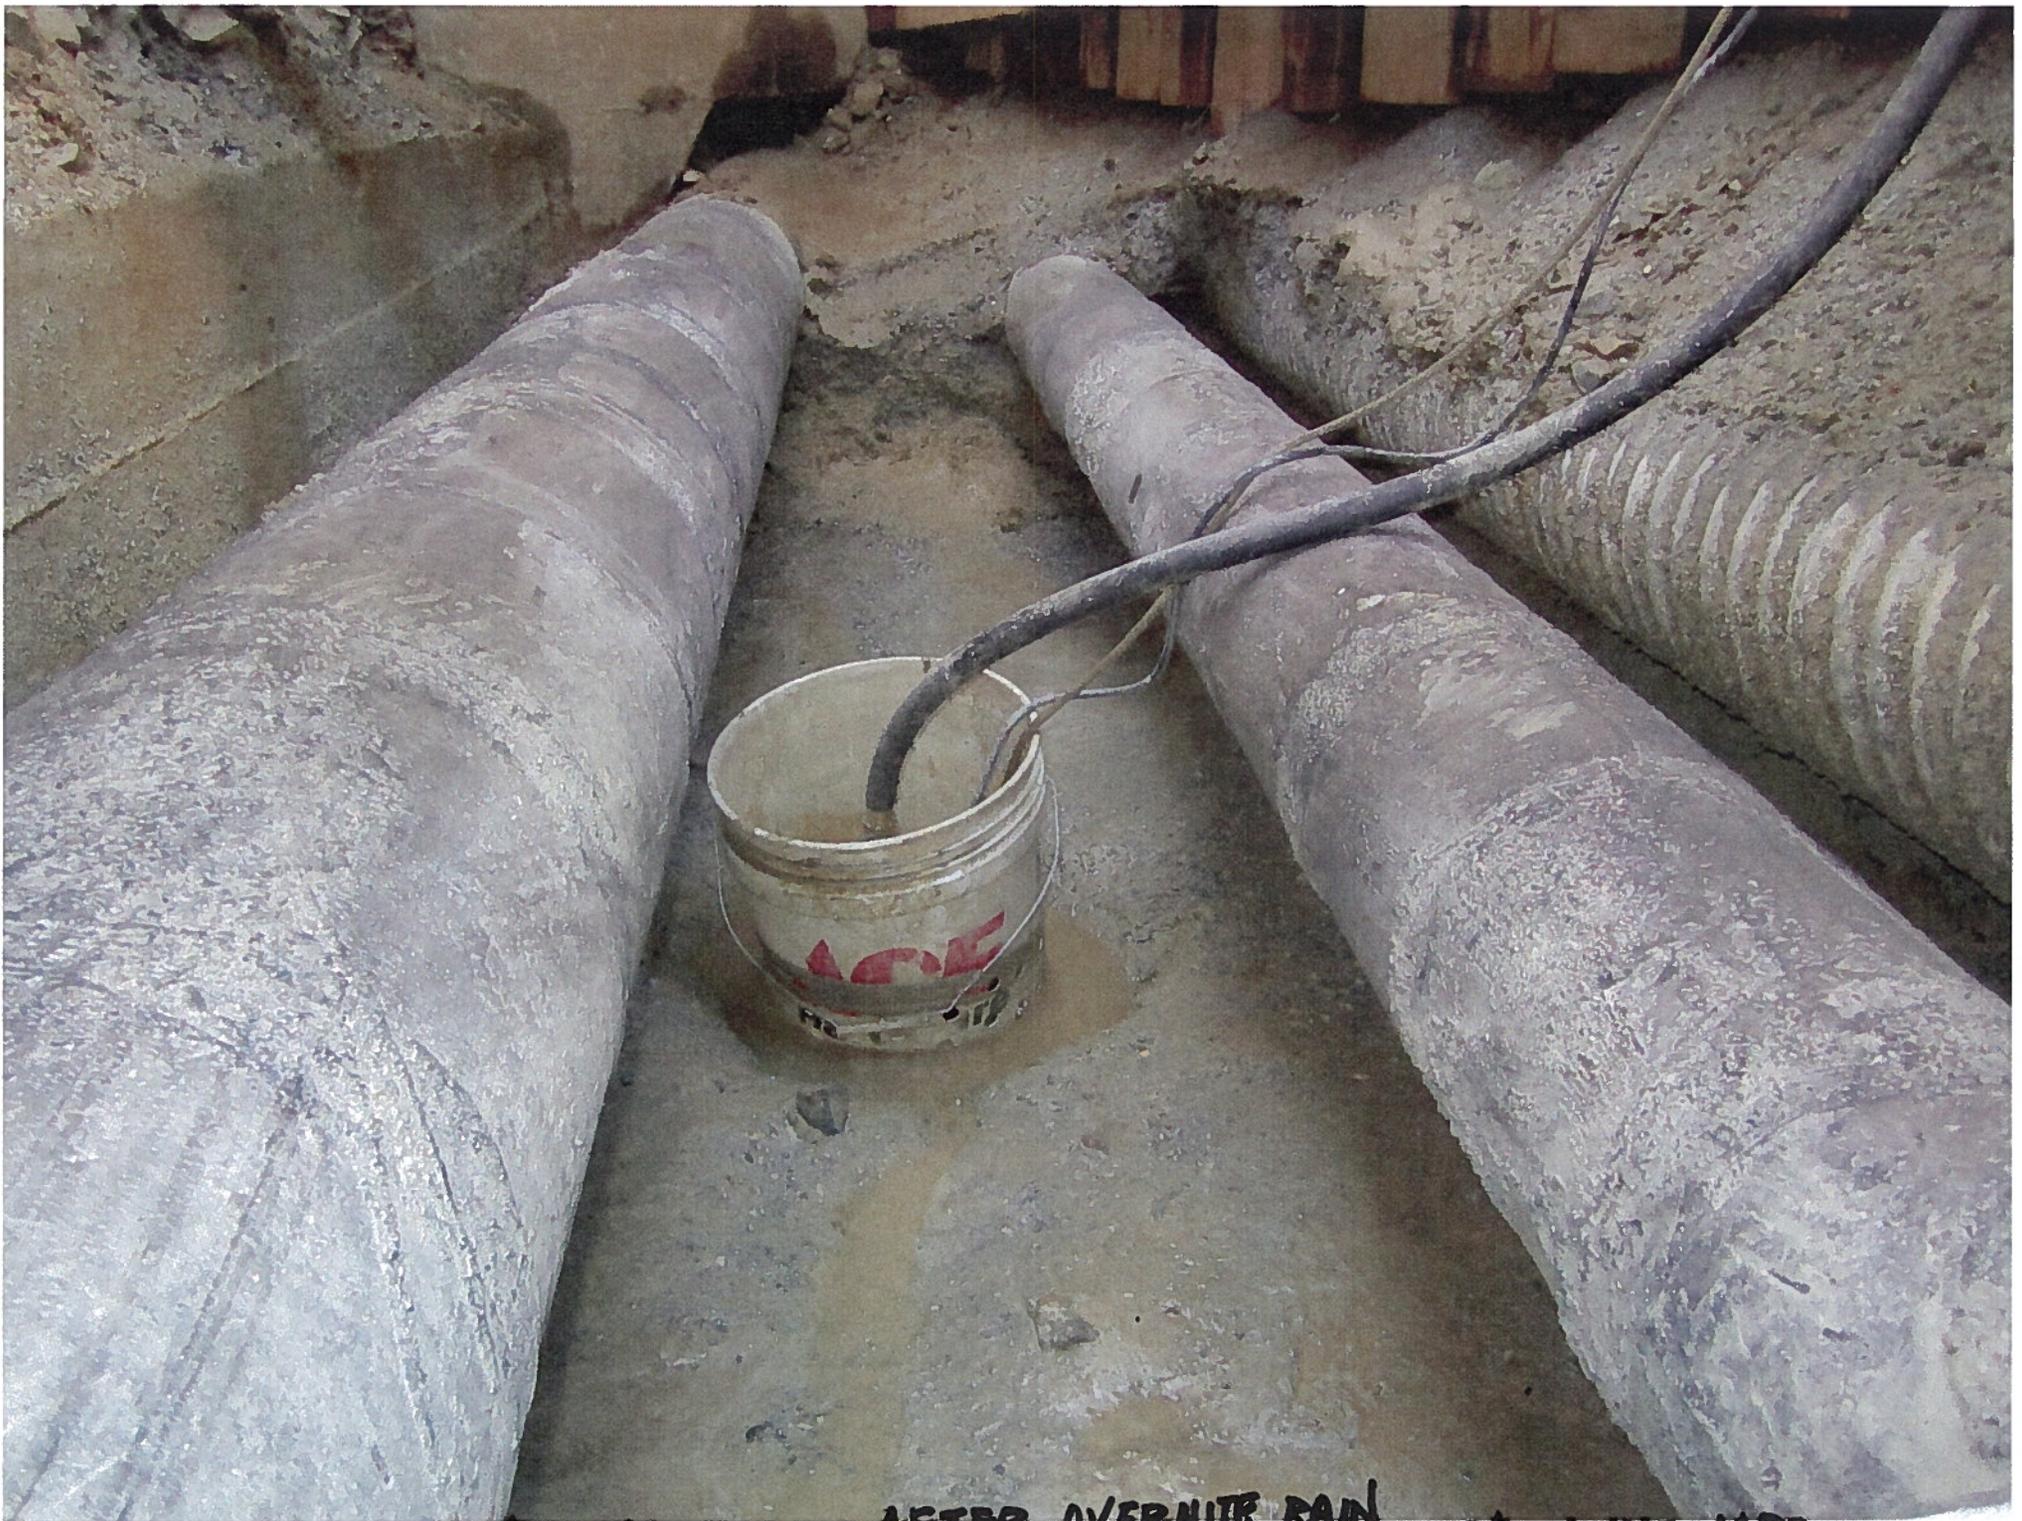
15" LINE 1070 AFTER OVERNITE RAIN 6" LINE 1050
