INSPECTION CHECKLIST

Piping / Tank 120' EL. (approx. grade) 10-inch City Water Line from Catskill Water Supply
 ELEVATION: 120' EL. (approx. grade) LOCATION DWG: 9321-F-41933, zone D-5 INSPECTION DATE: 10/29/09
 INSPECTOR: J. Peterson

COMMENTS (Inspector): 10-inch city water line from the City Water Storage Tank was inspected at excavated location. Line runs approximately parallel with the 16-inch city water line (also excavation under the same modification, EC 13314). Approx. 8 foot length of pipe inspected.

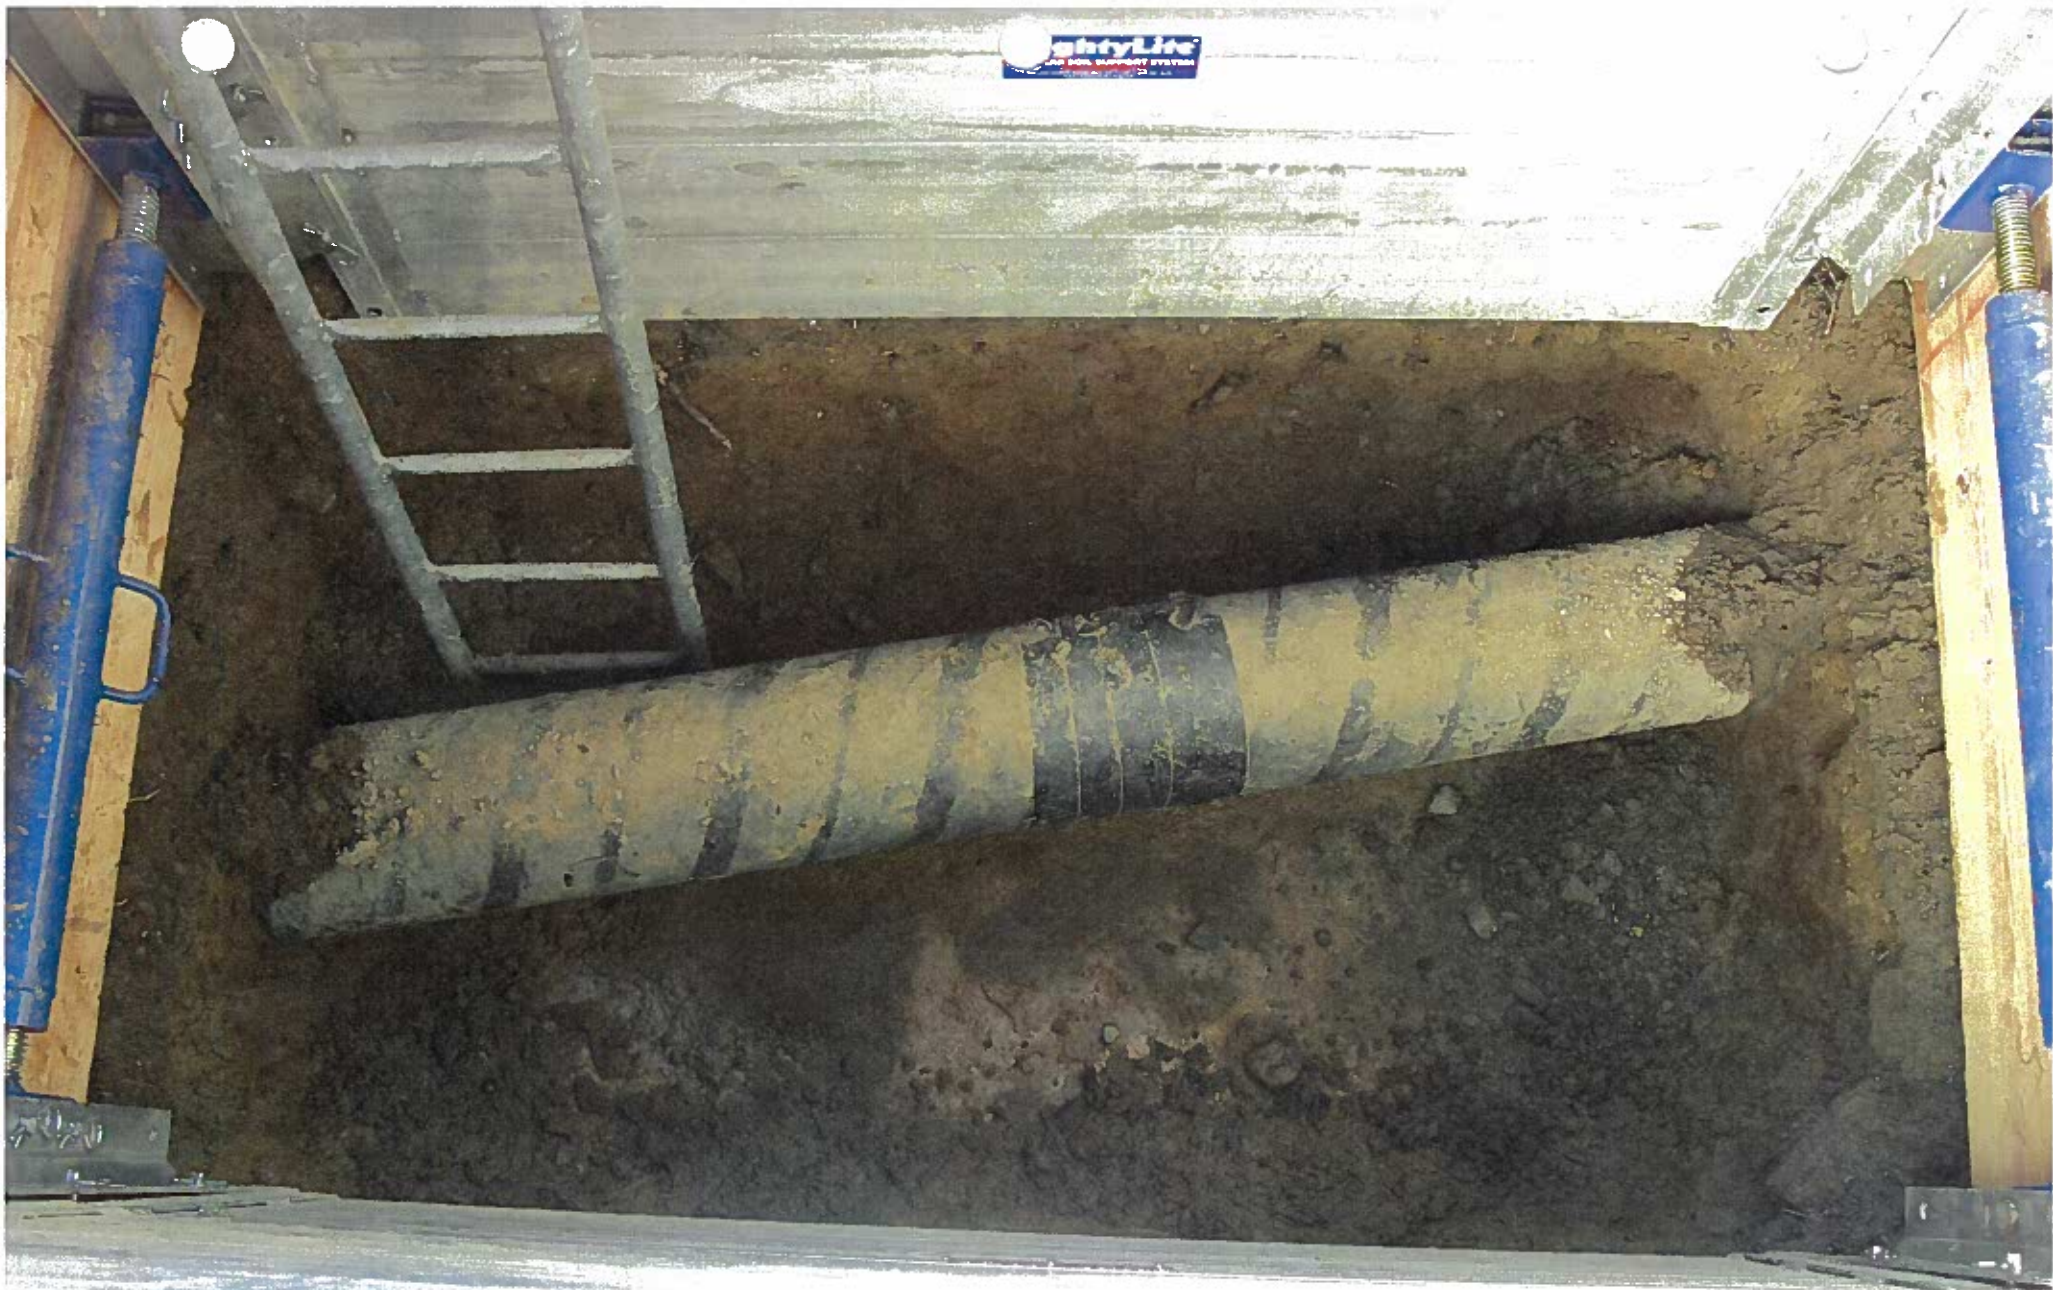
10/29/09 INSPECTION
10" CITY WATER LINE

GENERAL APPEARANCE (Inspector): Exterior pipe coating found in good condition, with no observable discontinuities, peeling, blistering, separation, embrittlement, flaking, etc. Coating also having good adhesion to the pipe with no bubbled spots (i.e., gaps between pipe and coating). See attached photo documentation and Notes. Photo included of the backfill material, showing absence of any large rocks, or foreign material.

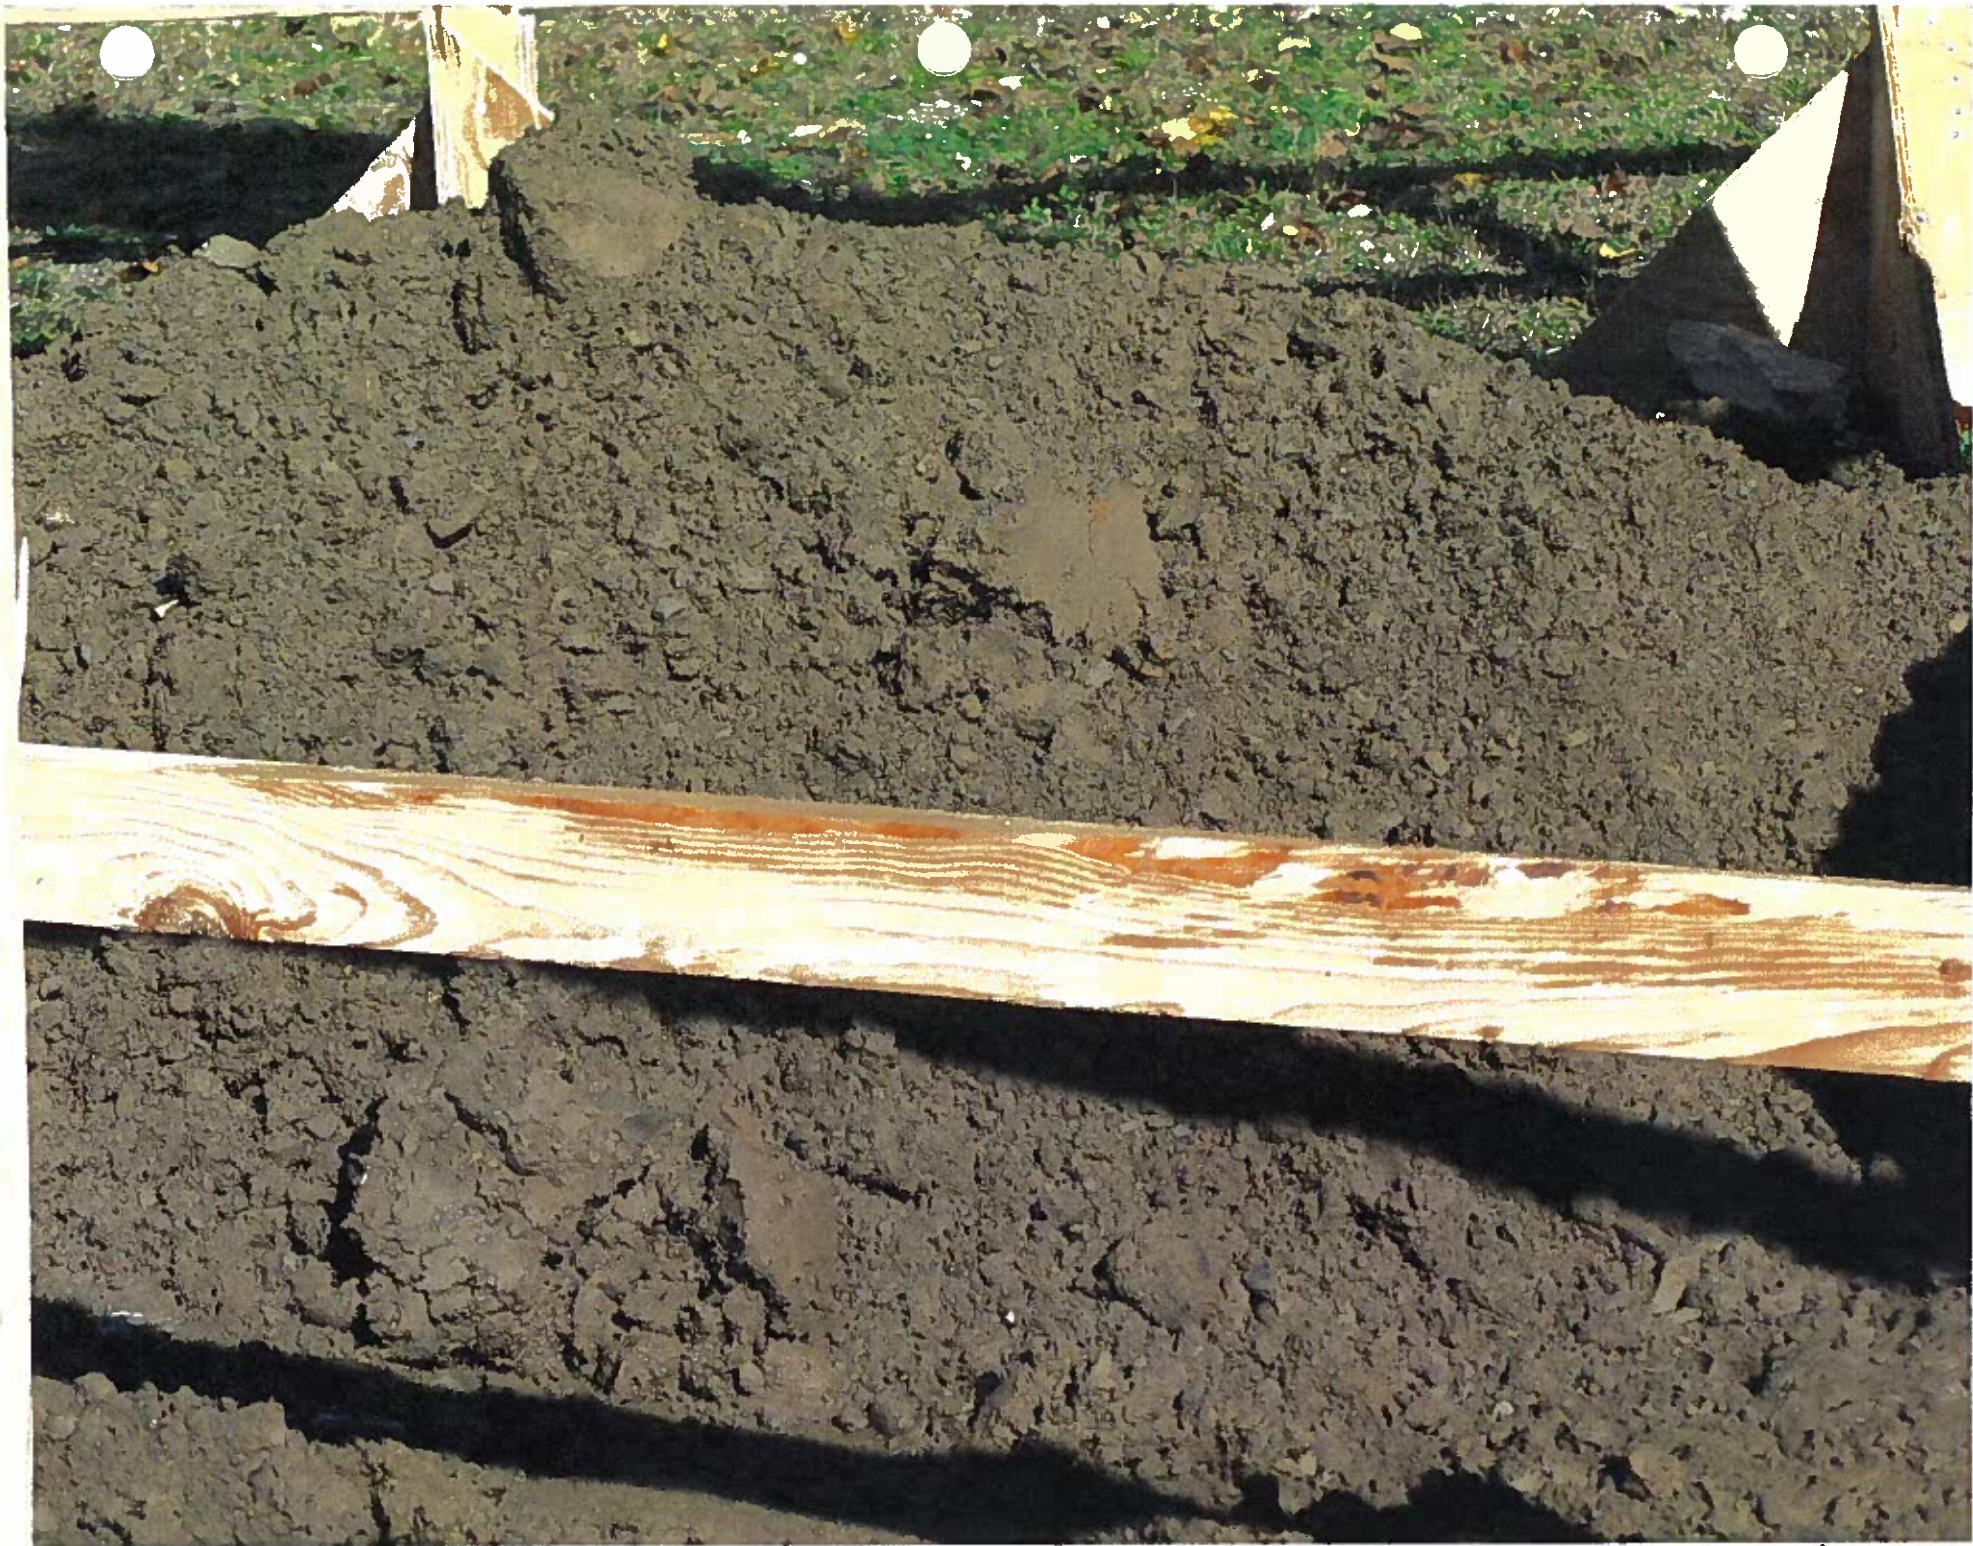
Bedrock surface in cross-section
