ENTERGY	ENGINEERING STANDARD	EN-EP-S-002-MULTI	REV. 0
	Buried Piping and Tanks General Visual Inspection	PAGE 12 OF 12

INSPECTION CHECKLIST

Piping / Tank IP3 CST Supply to AFW Pumps (12-inch Line 1070) (Ref. WO # 279578-03) INSPECTION DATE: 12/9/2011

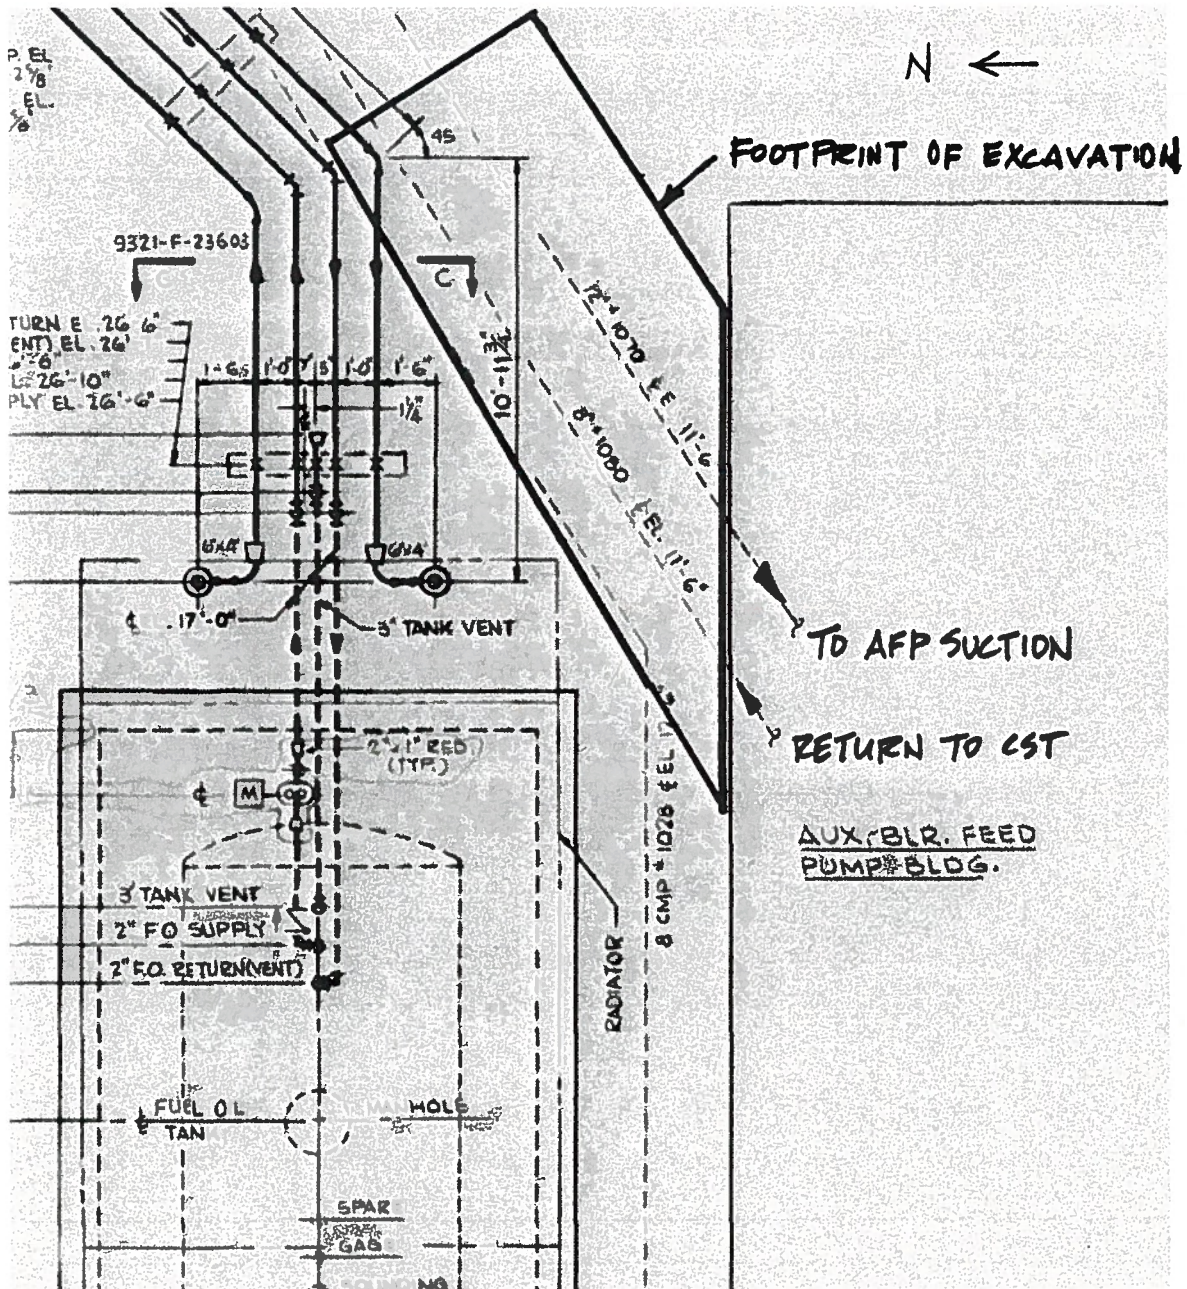
Ref. Drawing 9321-F-23593

IP3 Yard / NE corner of AFP Bldg

WO # 279578 - Excavation/Inspection of Cond/AFW Lines 1070 & 1080

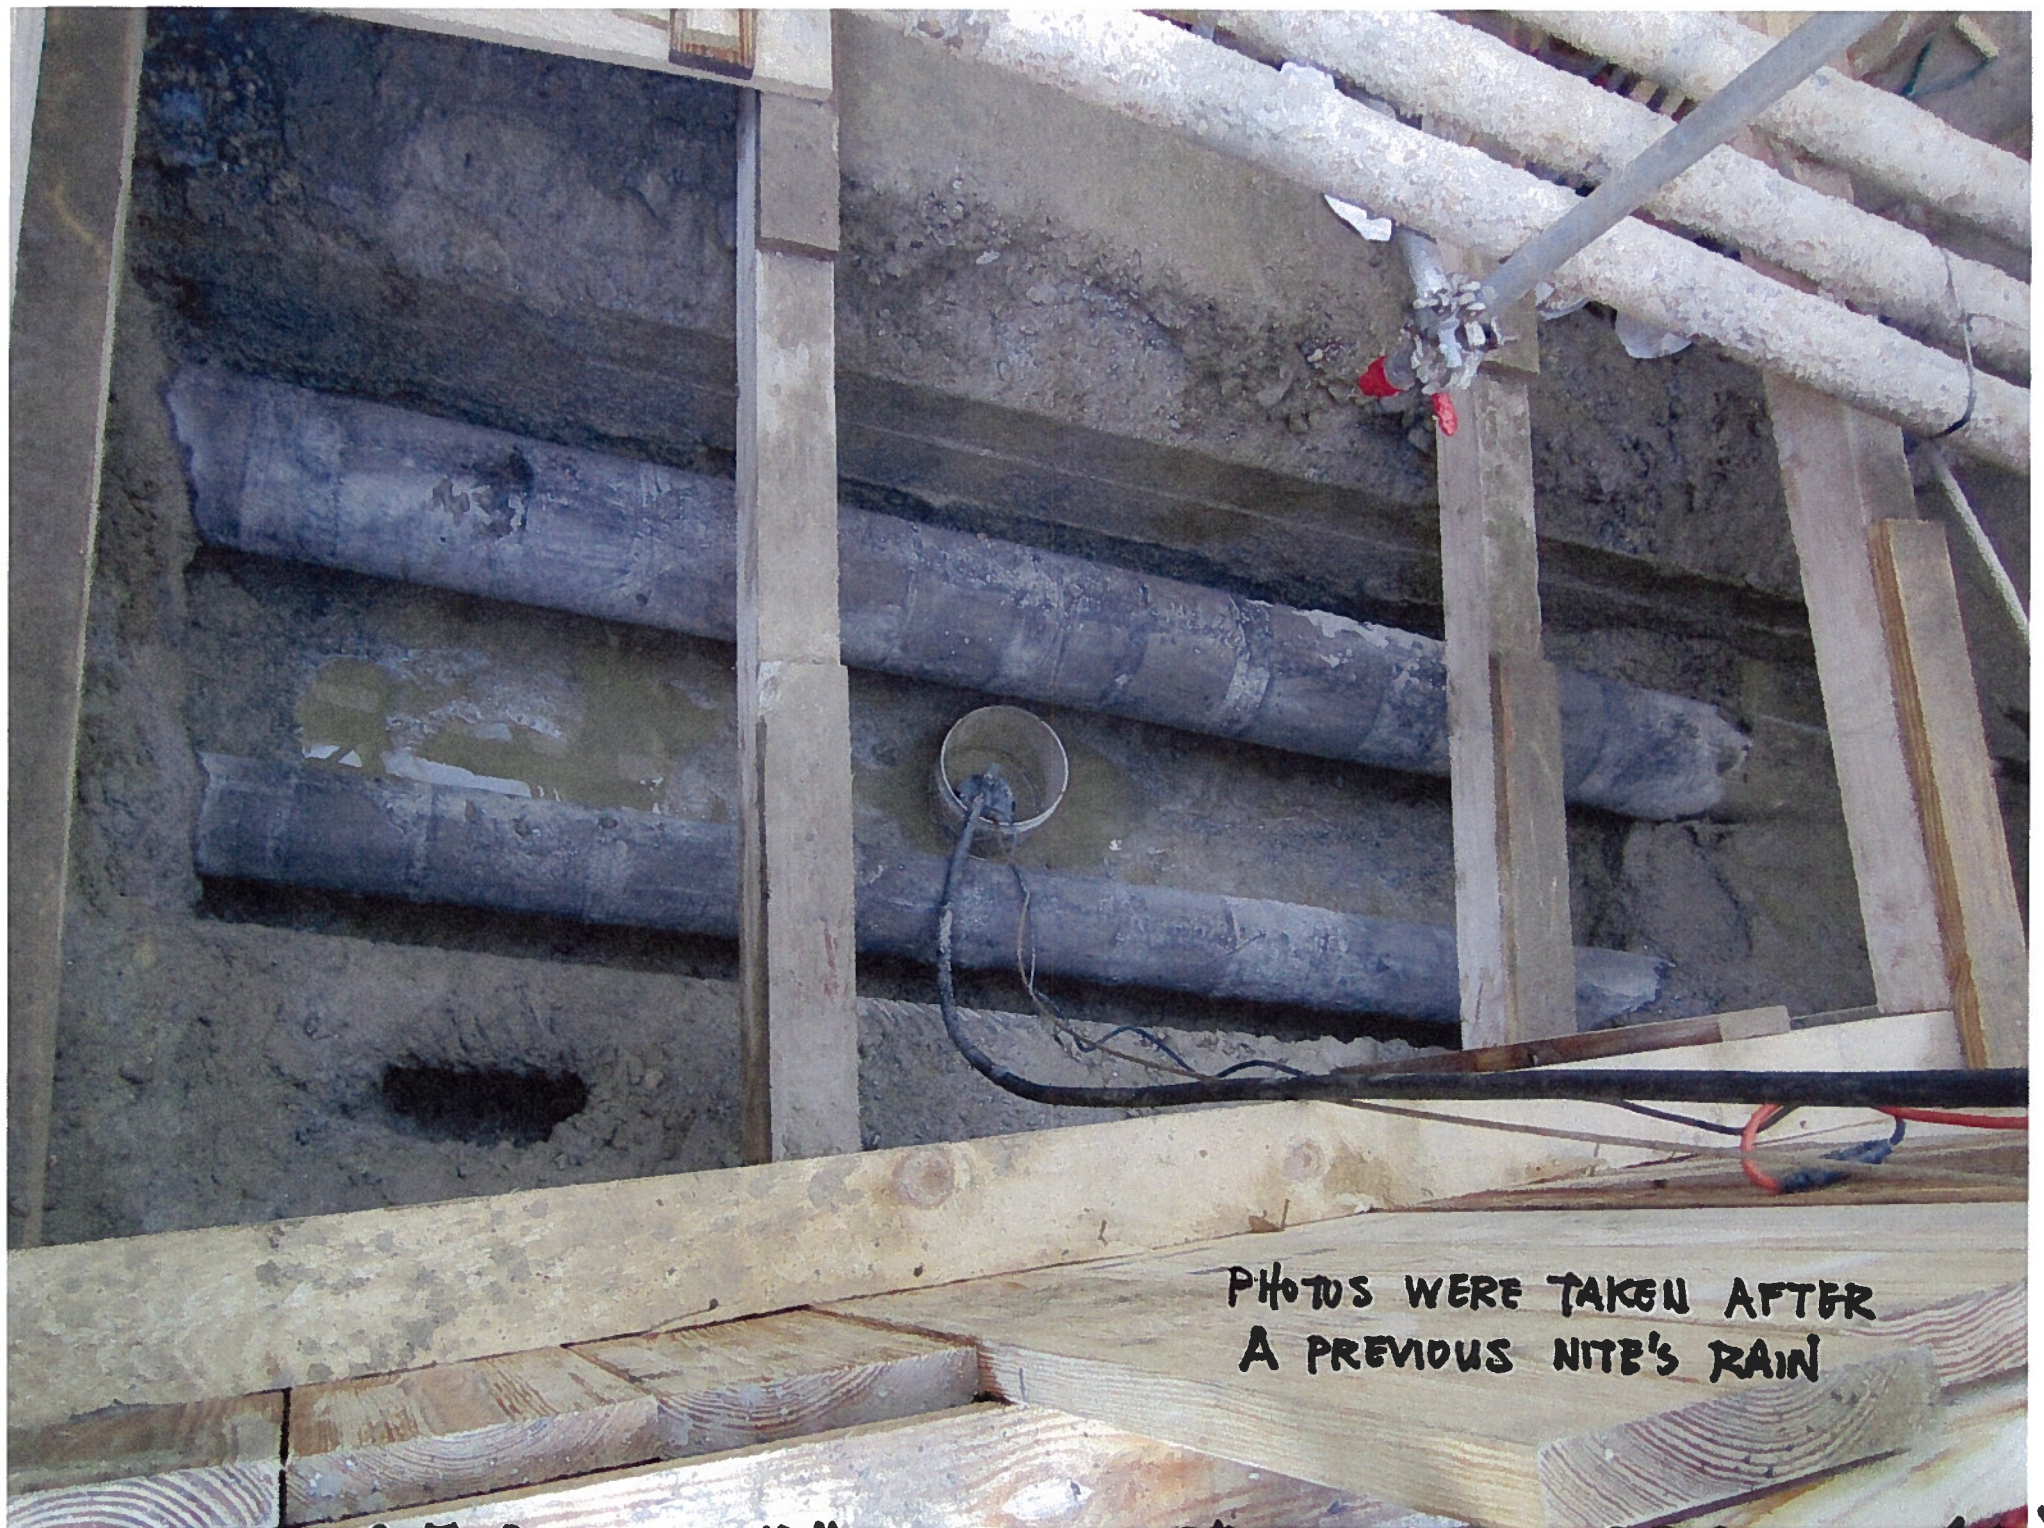
GENERAL APPEARANCE (Inspector): An approx. 14 ft length of 12-inch dia. Line 1070 was excavated, of which approx. 12 ft was exposed for its full circumference. The coating appearance was uniform in color, with no indications of degradation (blistering, peeling, flaking, cracking or separation of coating from the metal surface). The coating outerwrap appeared to be evenly applied, with the edges of overlapping layers of the wrap sealed with the coal tar enamel. Further, there was no discoloration or evidence of corrosion product under or at the edges of the wrap, and the coating surface was solid to the touch. Photos are attached.

PHOTOS WERE TAKEN AFTER  
A PREVIOUS NITE'S RAIN

TOP TO BOTTOM: 12" LINE 1A70 0" LINE 1A70 8" LINE 1A70 (ALE)

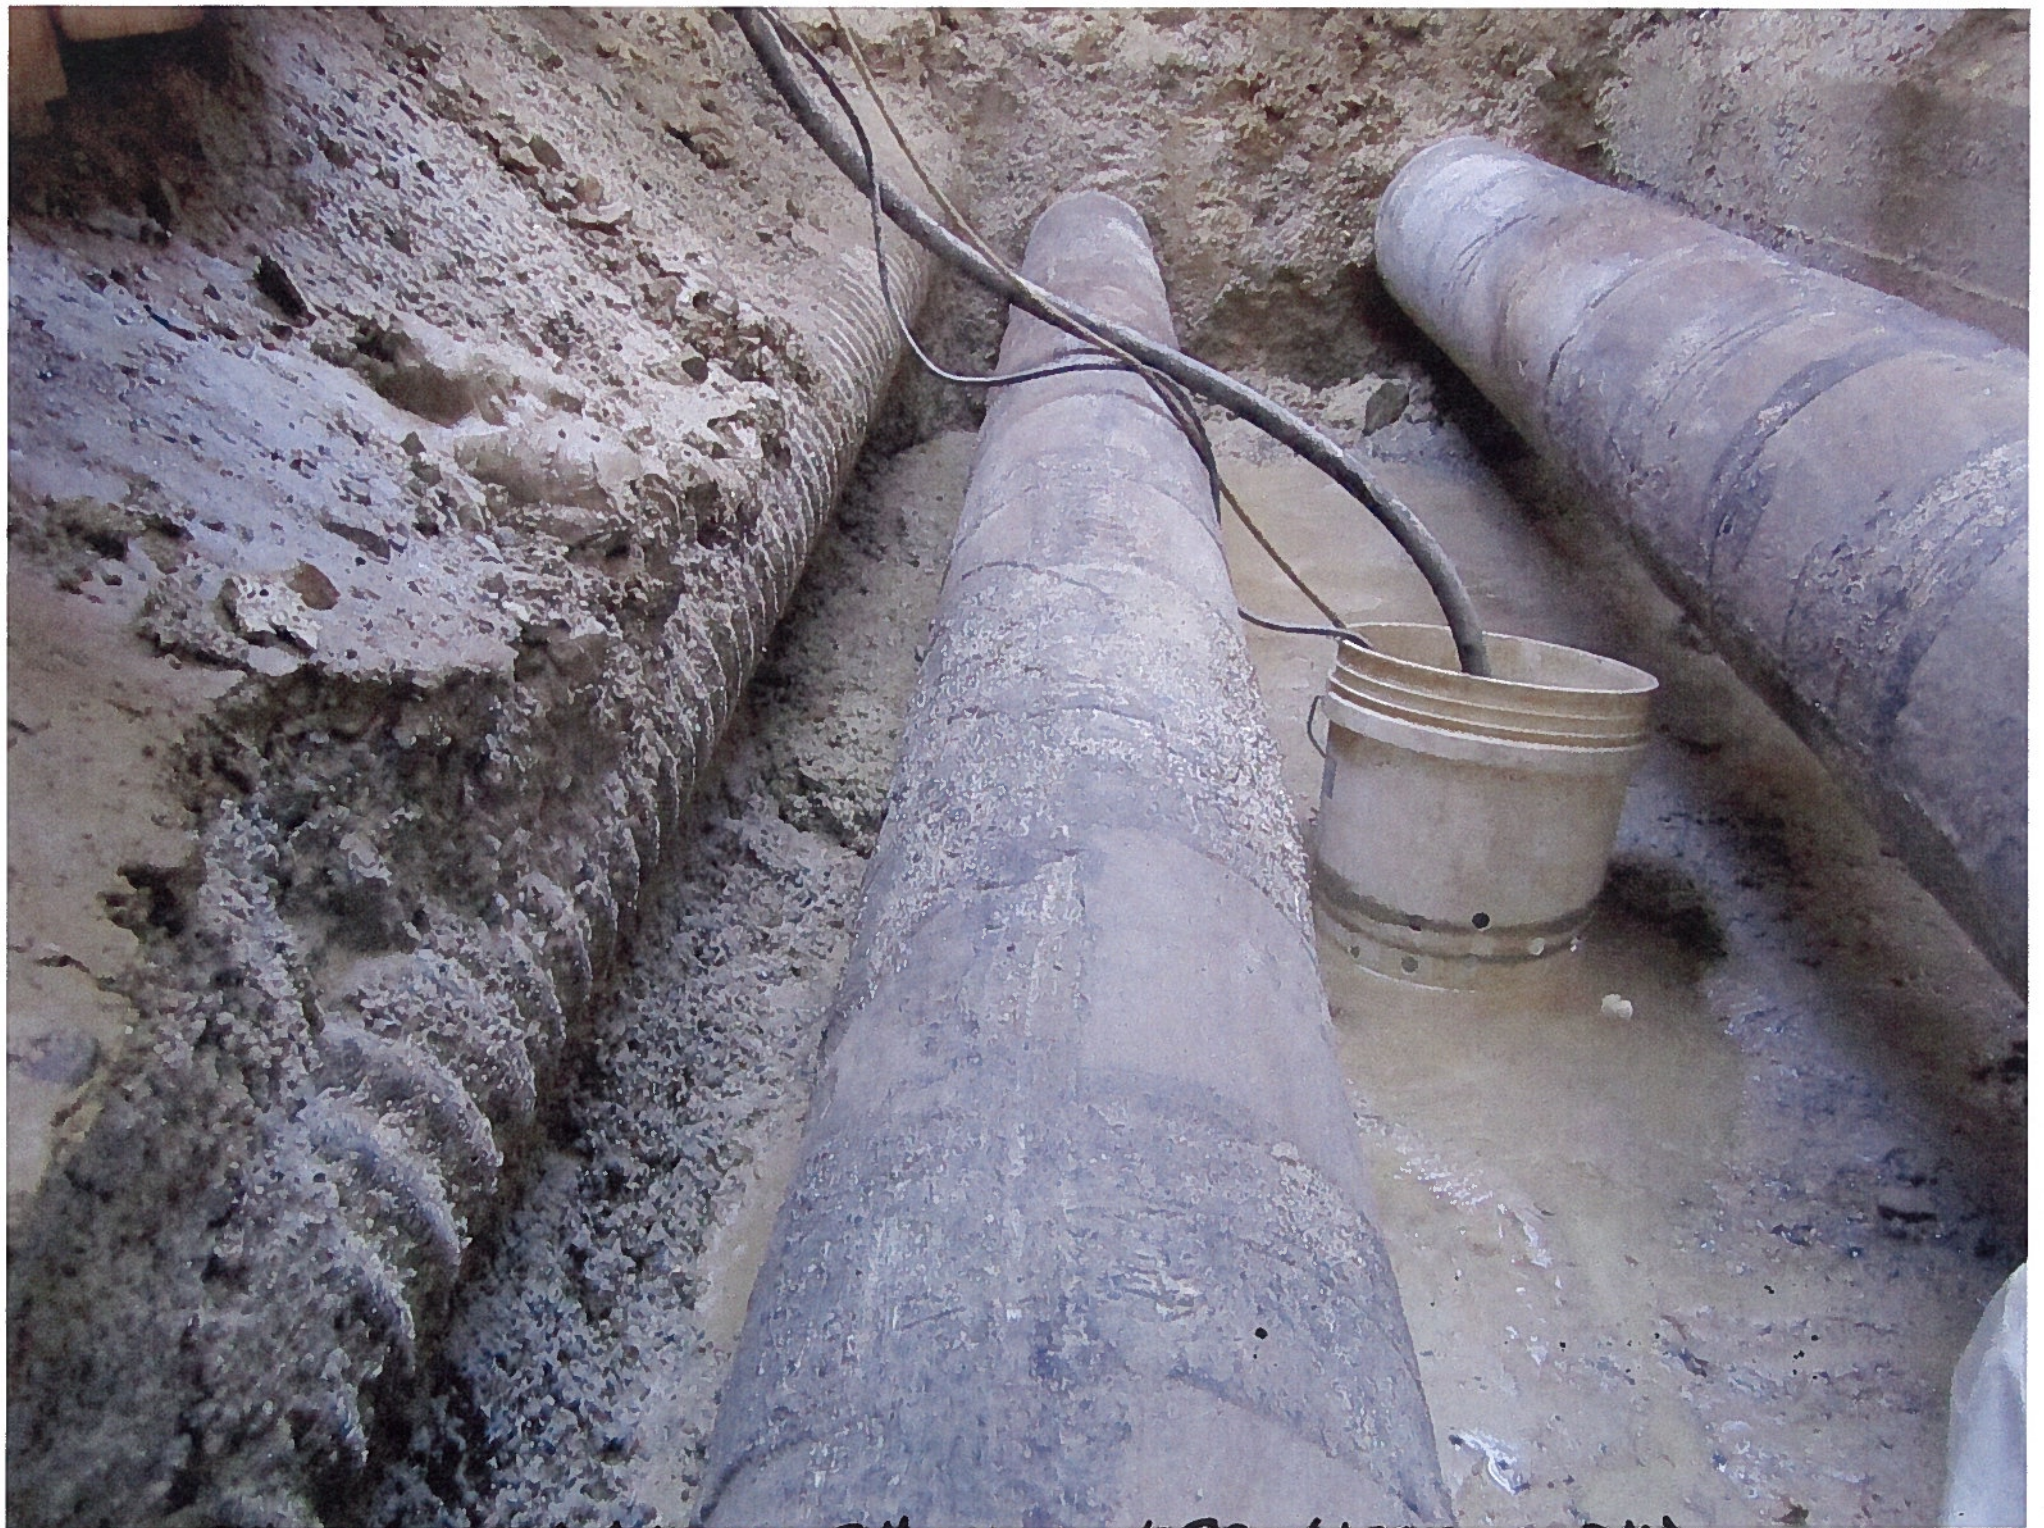
8" LINE 1080 (1/2")

8" LINE 1080 (LOOKING DIR)
