ENTERGY	ENGINEERING STANDARD	EN-EP-S-002-MULTI	REV. 0
	Buried Piping and Tanks General Visual Inspection	PAGE 12 OF 12

INSPECTION CHECKLIST

Piping / Tank IP2 Service Water 24-inch Line INSPECTION DATE: 11/23/11  
409 (WO # 279576-02)

IP2 Service Water Lines 408 & 409 Inspections (Nov. 2011)

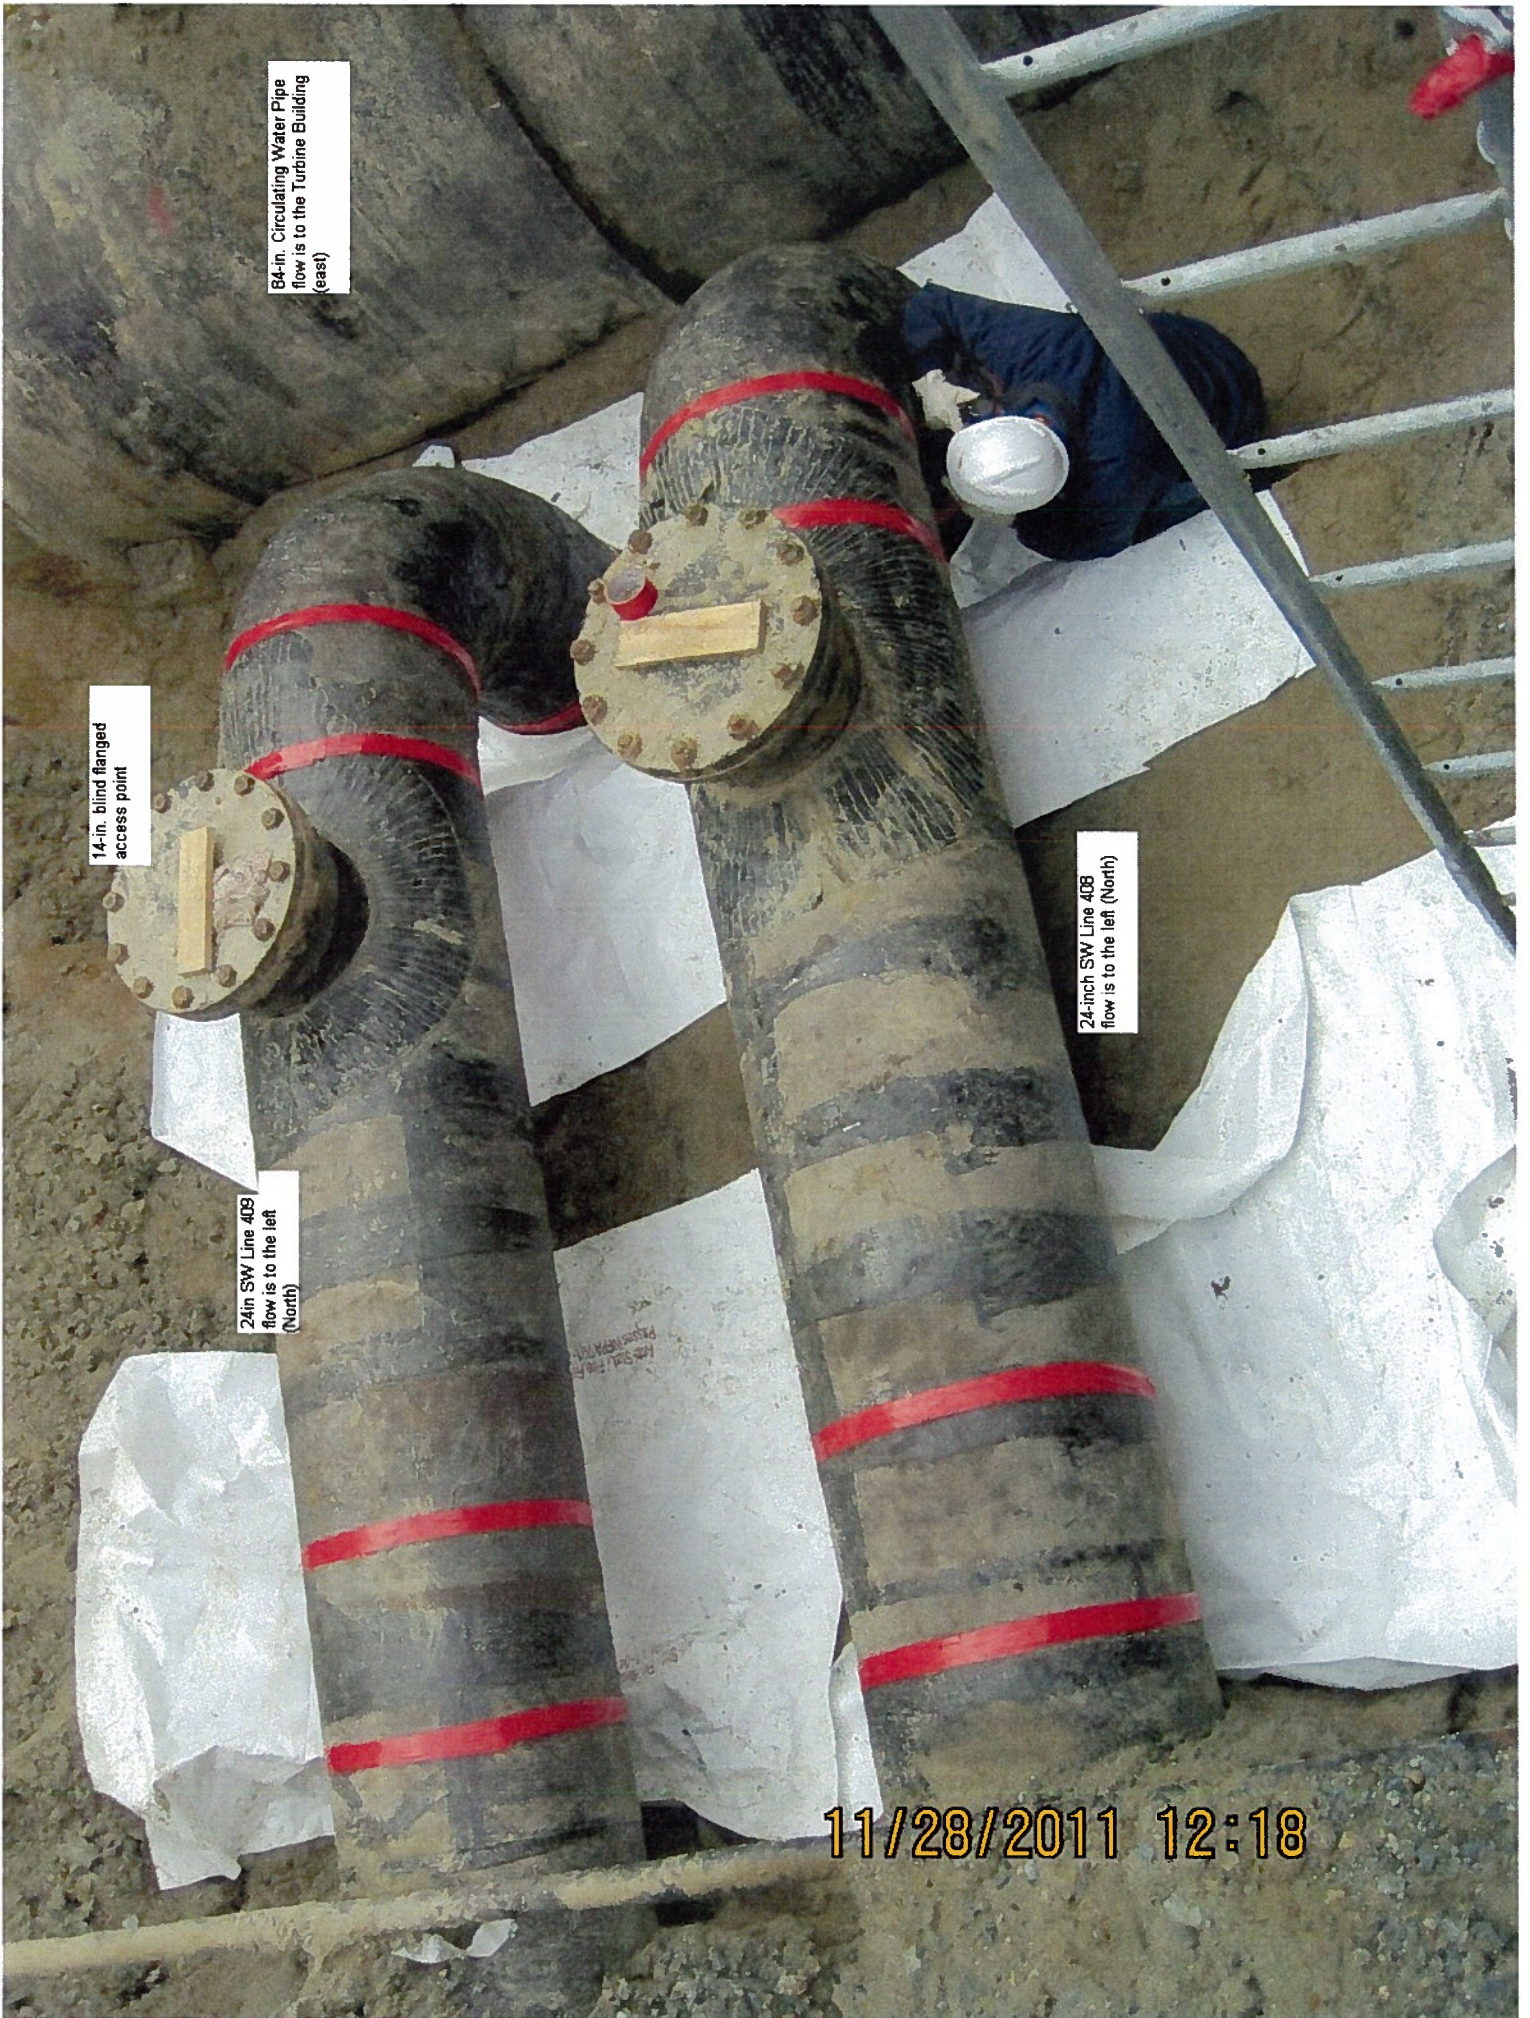
64-in. Circulating Water Pipe  
flow is to the Turbine Building  
(east)

14-in. blind flanged  
access point

24in SW Line 409  
flow is to the left  
(North)

24-inch SW Line 408  
flow is to the left (North)

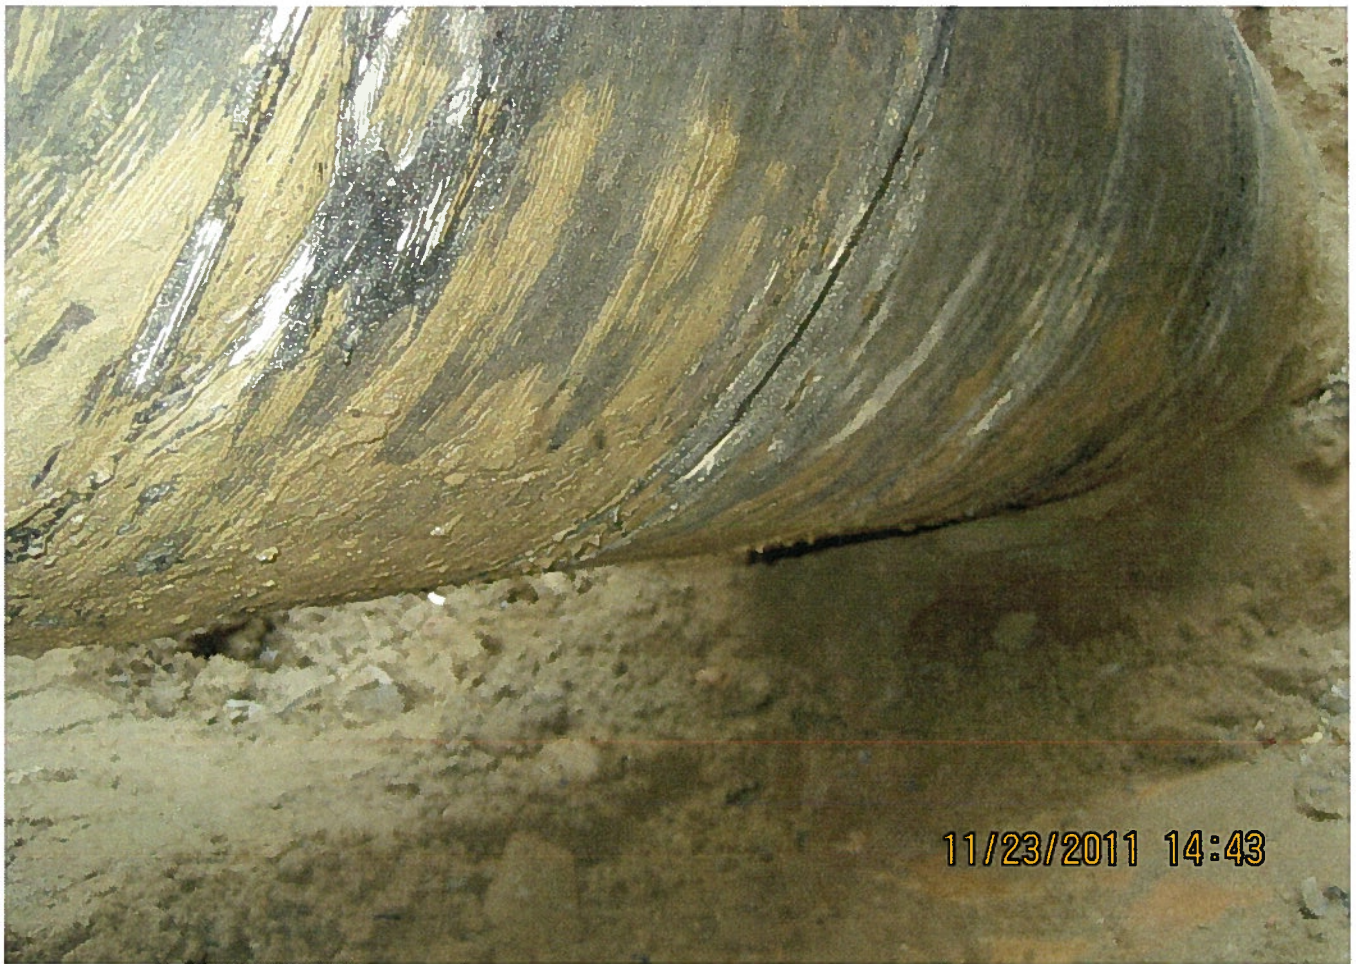
24" SW LINE 409

2" STATION AIR LINE CROSSING @ 90°

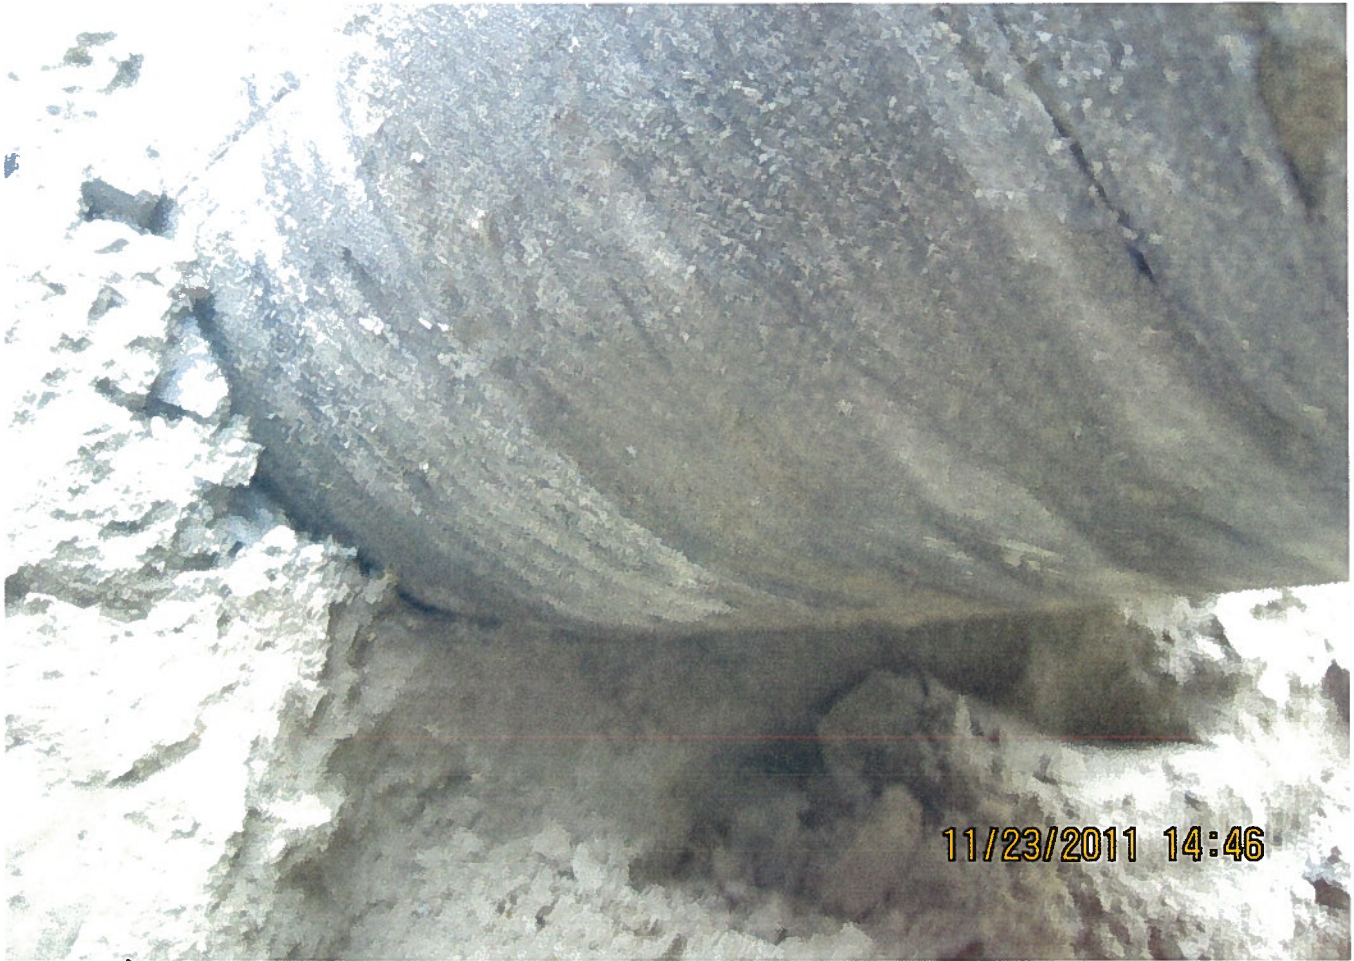
Access POINT ↓

NORTH END ↑

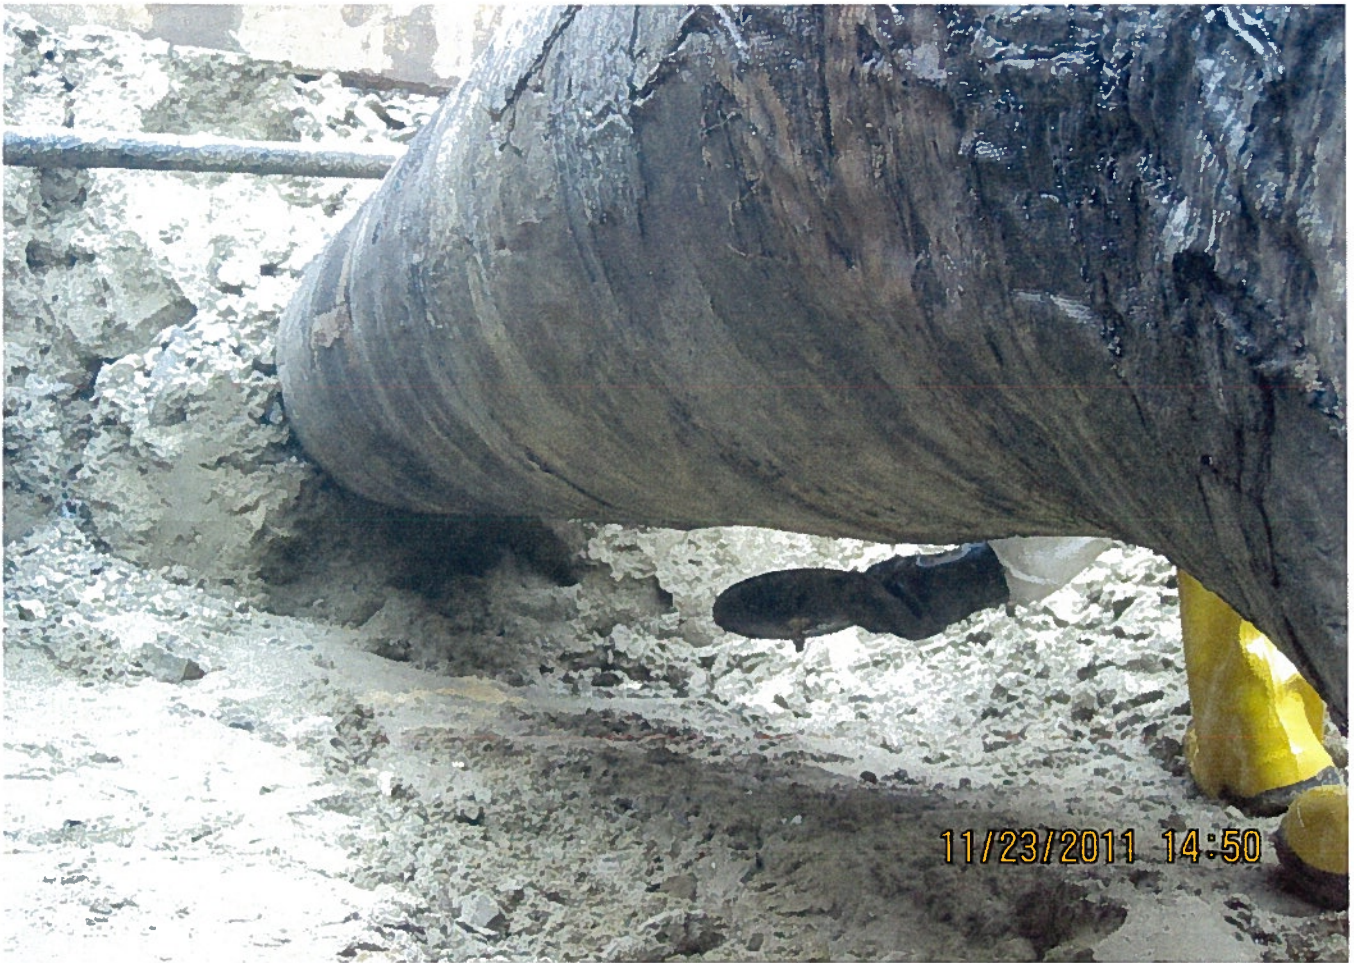
LINE 408 ↓

↑ LINE 409 ↓

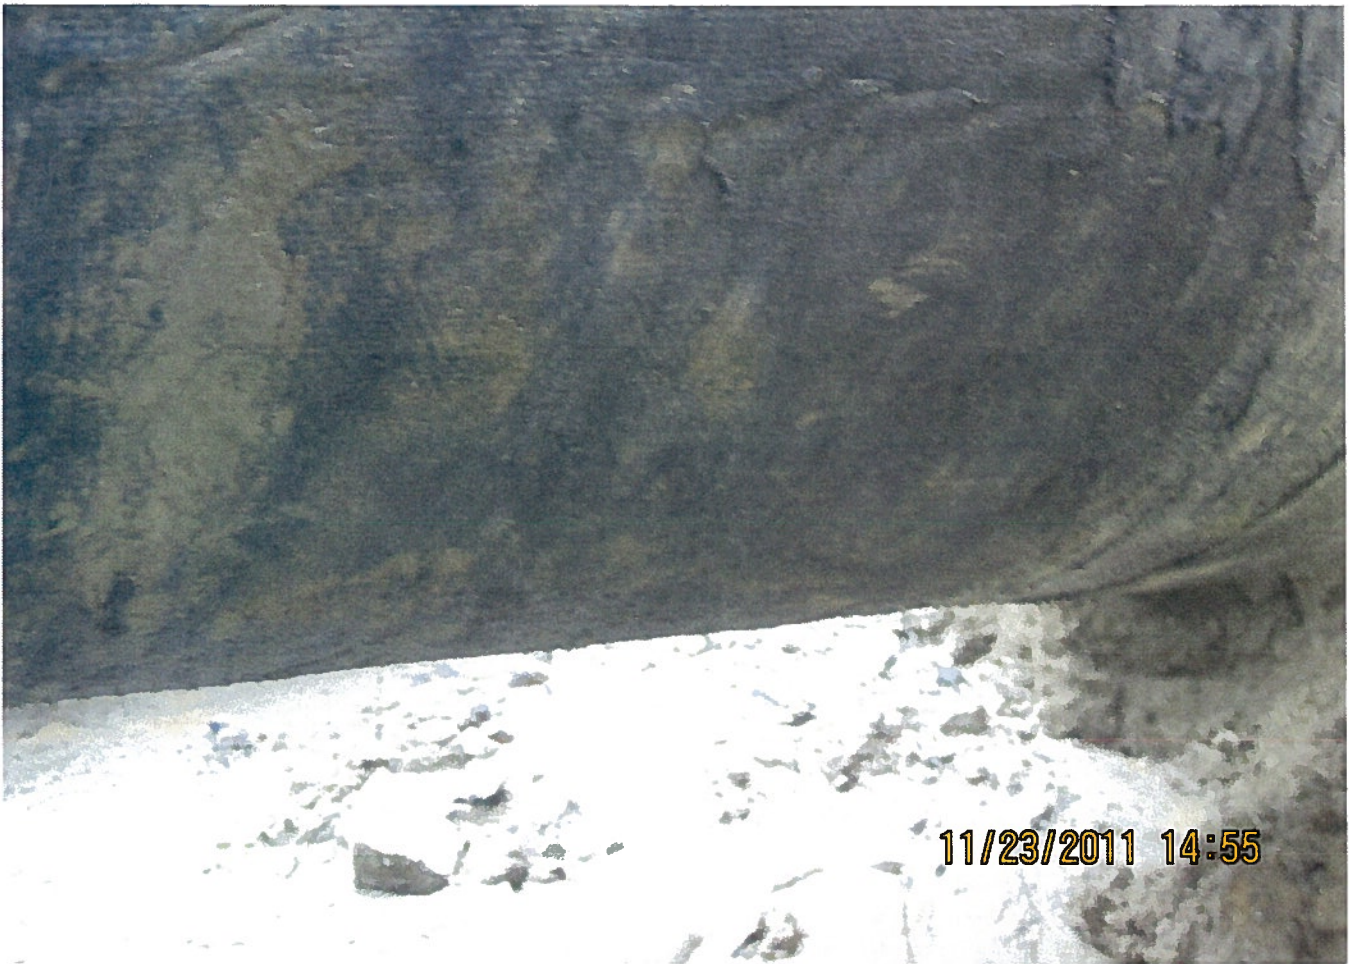
FINE CRACKS IN TOP LAYER OF WRAP ↓
