Part 21 (PAR)

Event # 47842

PART 21 REPORT - SWAGELOK U SERIES BELLOWS VALVES LOOSENING OF STEM TIPS

**Subject: Potential 10CFR21 notification**

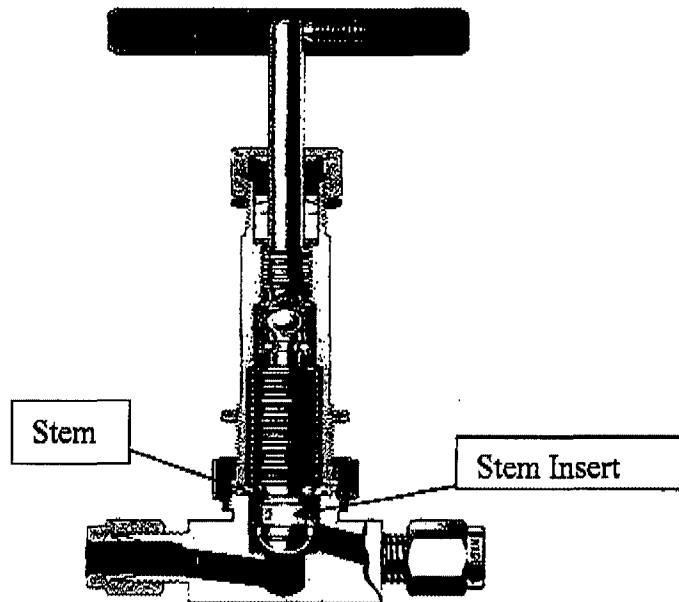
The picture above shows a cutaway version of a valve in question.

Although the stem tip may loosen when higher than normal torque is applied to close the valve, the tip will not become completely disengaged from the stem insert. The document below shows the stack up of tolerances on the 8U valve, with a loose stem tip. Even with the tip loosened until it contacts the valve body, at least one thread of engagement still remains between the tip and stem insert. This means the stem tip will remain captured within the valve body and will not enter the process stream. Similar conditions apply to the 4U and 6U Series valves.

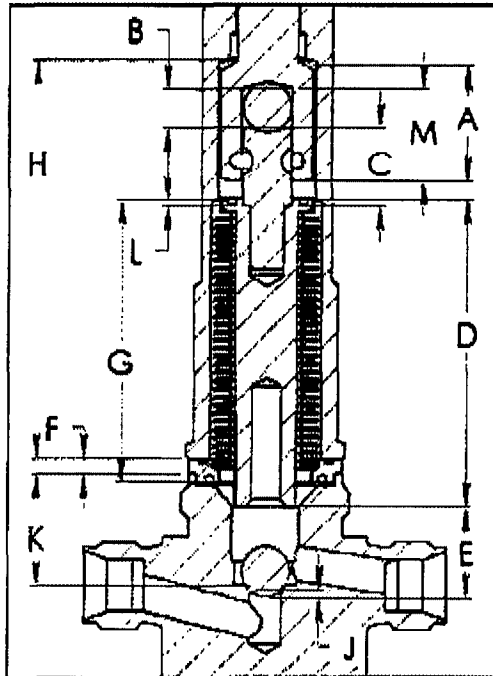
**Tolerance stack-ups between the stem and stem tip for the 8U Series valve**

<b>MAX STROKE</b>	<b>0.1755</b>
<b>NOM STROKE</b>	<b>0.1207</b>
<b>MIN STROKE</b>	<b>0.0959</b>

distance of stem adapter flat to top	0.270
distance of stem adapter flat to top- Max Stroke	0.0945
lead in to threads on stem adapter	0.026
threads per inch on adapter	24.0000
number of threads engaged at max stroke with loose stem (28E-29E*30E)	1.64

The continued engagement of the stem threads also means that the valve can be shut off, even if the threads had loosened. We have tested several conditions of the loose stem tips and confirmed that closure to catalog specification of  $4.0 \times 10^{-9}$  atm. cc/sec of helium can be achieved.
