# **Comparison of an Ultrasonic Phased Array Evaluation with Destructive Analysis of a Documented Leak Path in a Nozzle Removed from Service**

AD Cinson, SL Crawford, PJ MacFarlan, BD Hanson, and RA Mathews  
Pacific Northwest National Laboratory<sup>1</sup>, Richland, WA, USA

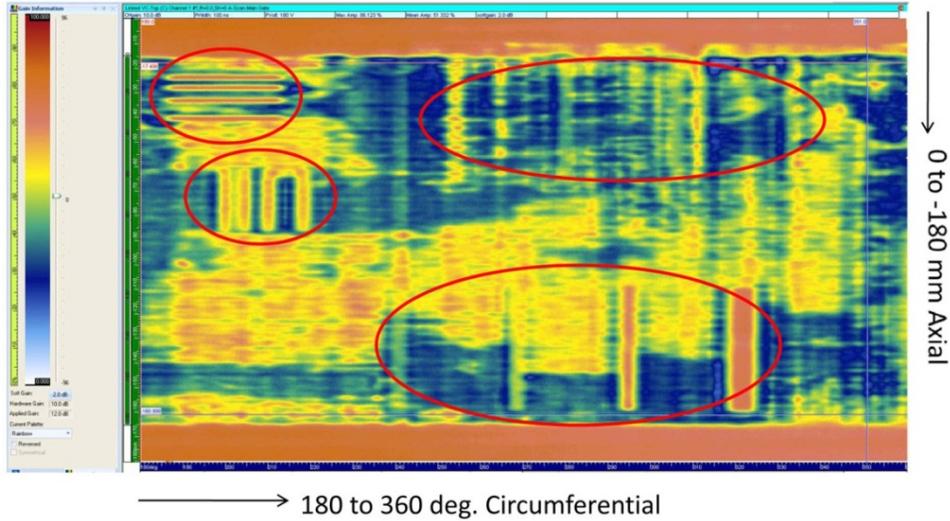
Figure 3 – Top view, plan view or C-scan ultrasonic image of the interference fit region containing calibration notches in the carbon steel head. Notch regions circled in red.

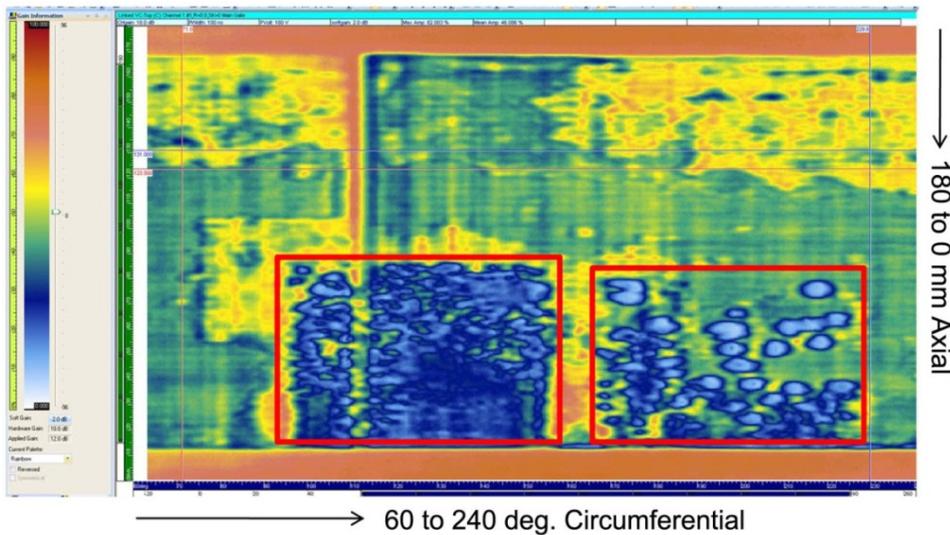
Figure 4. The boric acid regions are outlined in red. The full detailed analysis of the calibration specimen can be found in the proceedings of the 2011 ASME Pressure Vessel and Piping Conference [5]. In summary, the presence of an air gap in the interference fit resulted in a strong ultrasonic reflection. This can be seen in Figures 3 and 4 by the red and orange colors. The presence of a tight fit was shown in the regions containing boric acid and resulted in a weak ultrasonic reflection. These two areas are noted by the blue and white colors. The nominal interference fit region contained a mixture of mid-range reflections, noted by the green and yellow colors. Thus the mockup interference fit specimens provided the expected range of conditions thought to be present in Nozzle 63. Furthermore, the ultrasonic evaluation validated the capabilities of the system to distinguish between the different nozzle conditions.

Figure 4 – C-scan plan view of the boric acid deposits in the interference fit region. The horizontal axis represents the circumferential range of 60–240 degrees. Boric acid regions boxed in red.

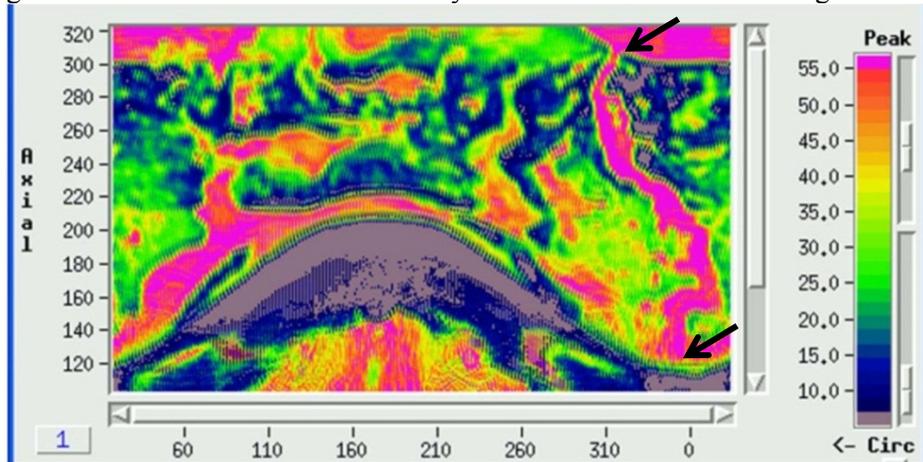
Standard ultrasonic evaluation techniques used by ISI vendors include time-of-flight diffraction (TOFD) for detecting cracks in both the circumferential and axial orientation and zero-degree PE for an interference fit examination. An examination conducted by ISI vendor, WesDyne International, discovered a probable leak path in Nozzle 63 during the 2002 outage. The data acquired with an industry-standard 5.0-MHz probe are shown in Figure 5. The data set indicates a leak path at the downhill position, traveling upward through the interference fit and is marked by the two black arrows in the figure.

Figure 5 – Ultrasonic Data from Nozzle 63 as Obtained by WesDyne International. The image was acquired with a 5-MHz probe. The horizontal axis represents the nozzle circumference in units of degrees. The vertical axis represents the nozzle axis in units of millimeters. The leak path is indicated by the black arrows.

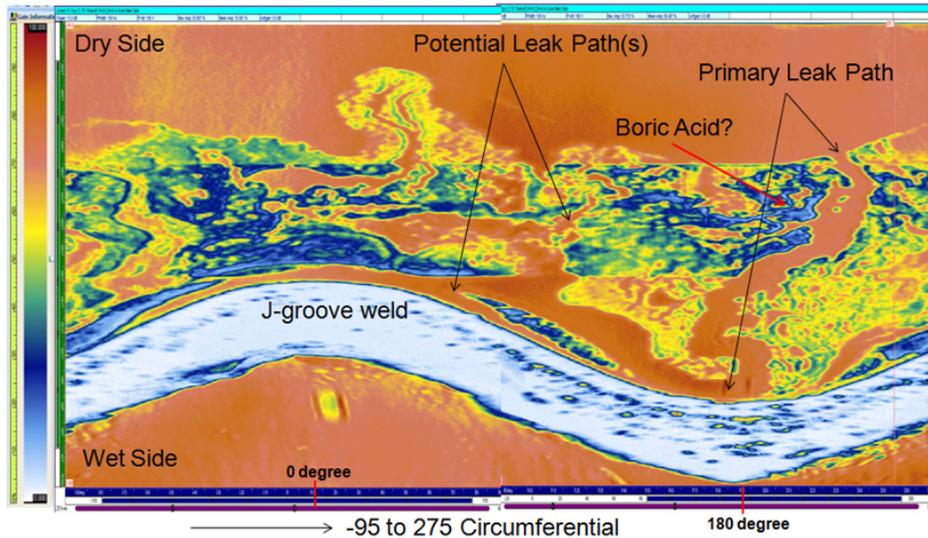
The investigation of the interference fit region on Nozzle 63 shows a large variety in the reflected ultrasonic responses. Some responses are strong in amplitude, indicating an air gap and noted as red-orange in color, while others are weak in reflected amplitude, indicating a tight interference fit and noted as white-blue. A search in the data image for a high-amplitude river pattern connecting the weld to the top of the interference fit region reveals the primary leak path. This leak path originates at approximately the 180-degree location (downhill point on the nozzle) and is marked in Figure 6. The lower amplitude

Figure 6 – A composite 360-degree ultrasonic data image from Nozzle 63. The vertical axis represents 360 mm (14.17 in.)

(blue) cluster regions near the leak path in the interference fit indicate the potential presence of boric acid as was observed in the calibration specimen. Boric acid deposits have been noted in actively leaking nozzles [1, 2].

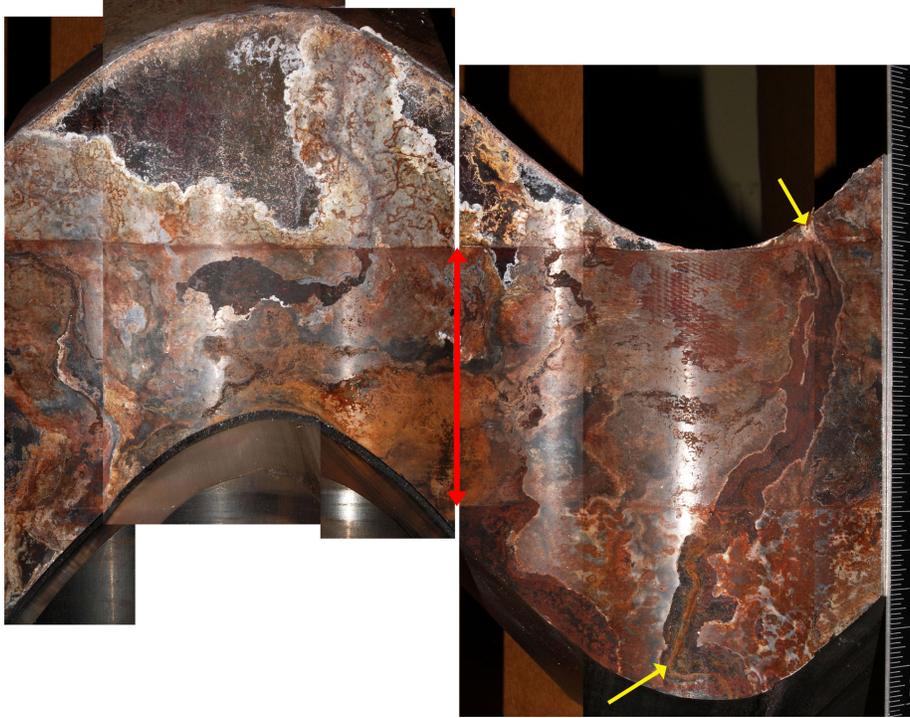
The exposed reactor pressure vessel (RPV) head was photographed and the composite image is displayed in Figure 7. The main leak path (yellow arrows) and other features observed in the ultrasonic images are clearly evident. Boric acid deposits are visible in white and corrosion products in the rust color. The interference fit band is apparent in the photograph and is marked with the red line. For comparison to the ultrasonic data, refer to Figure 6. The ultrasonic features well match the features seen visually on the RPV head annulus. Clearly, the main leak path was precisely imaged and other partial leak paths are evident.

Figure 7 – RPV head surface. The red line marks the interference fit region and the two yellow arrows identify the main leak path.

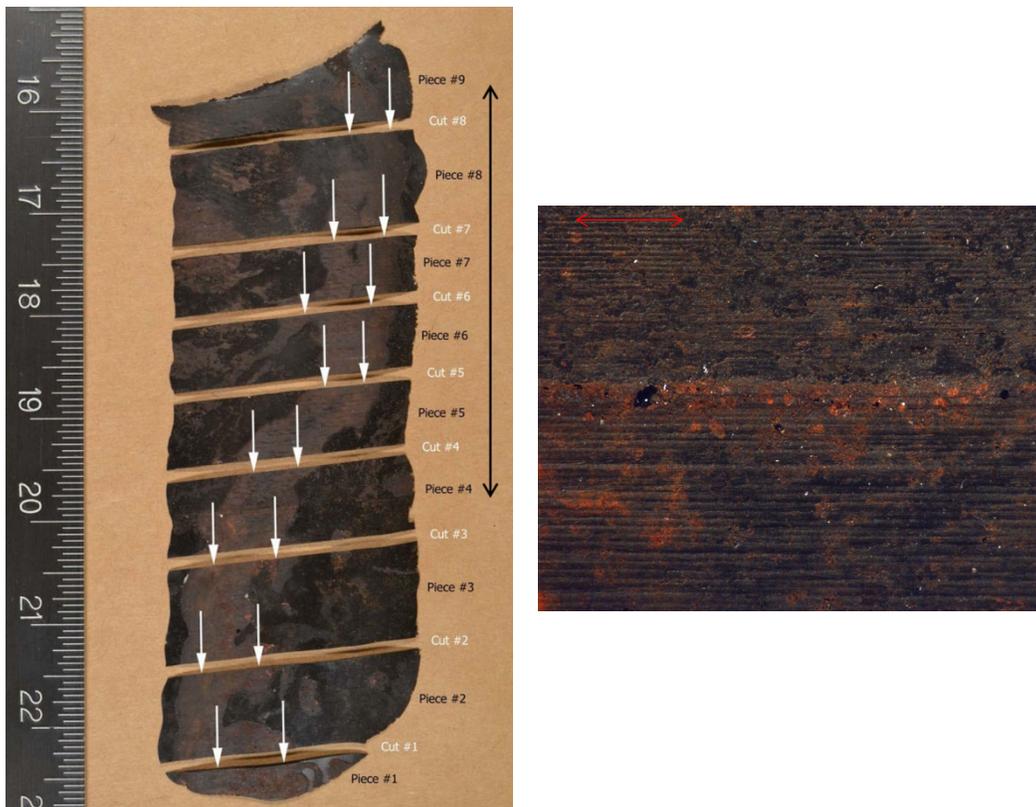
Lastly, replicated surfaces were viewed with a stereomicroscope to better document the surface conditions and to attempt to quantify the corrosion or erosion of the low-alloy steel in the annulus region. The replica of the main leak path is displayed on the left in Figure 8. Machining marks were observed on the replicated surfaces indicating minimal corrosion, erosion, or wastage throughout the leak path region. These replica observations indicated a low flow rate through the annulus during plant operation. Piece 4 obtained at the transition from below the interference fit to the interference fit shows the surface machining marks still present as seen on the right in Figure 8. It was estimated that the finish within the interference fit region was equivalent to a turned finish of 1.6 micrometers (63  $\mu\text{in.}$ ) while the finish below the interference fit was equivalent to a milled 1.6 micro-meter- (63  $\mu\text{in.}$ -) finish. A noted corroded area was visible at the exit point of the main leak path at the top of the head. It covered an area approximately 12.7 by 1.6 mm (0.5 by 0.06 in.) and had a depth of 0.25 mm (0.01 in.).

Figure 8 – Replicated leak path on the left and piece 4 on the right with machining marks evident. The red line on the right represents 2.0 mm (0.80 in.) in length.
