Davis-Besse Nuclear Power Station, Unit 1  
Docket Number 50-346, License Number NPF-3  
Submittal of Contractor Root Cause Assessment Report

Root Cause Assessment

Davis-Besse Shield Building

Laminar Cracking

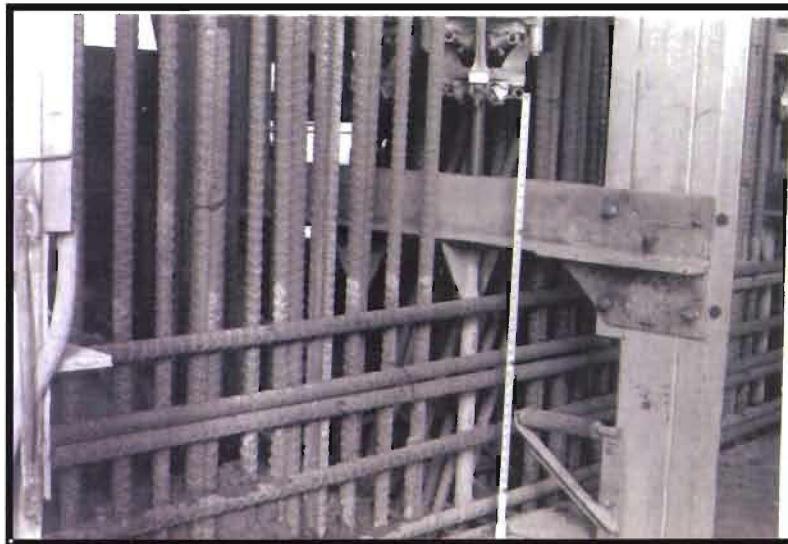
There are locations, such as the top 20 feet of the walls where the nominal spacing of the horizontal rebar is 6". With lap splices and normal construction tolerances, this can lead to regions where there is less than 2" of clear concrete spacing between the horizontal rebar. It was also observed that in some locations the vertical rebar was adjusted on either side of the jacking bars in order to accommodate the hydraulic jacking heads used during the slip-forming operation. The following figure illustrates the high density rebar that exists in the outer rebar mat at some locations of the Shield Building.

**Figure 3: High Density of Reinforcement at Outer Rebar Mat (Photo during Construction)**

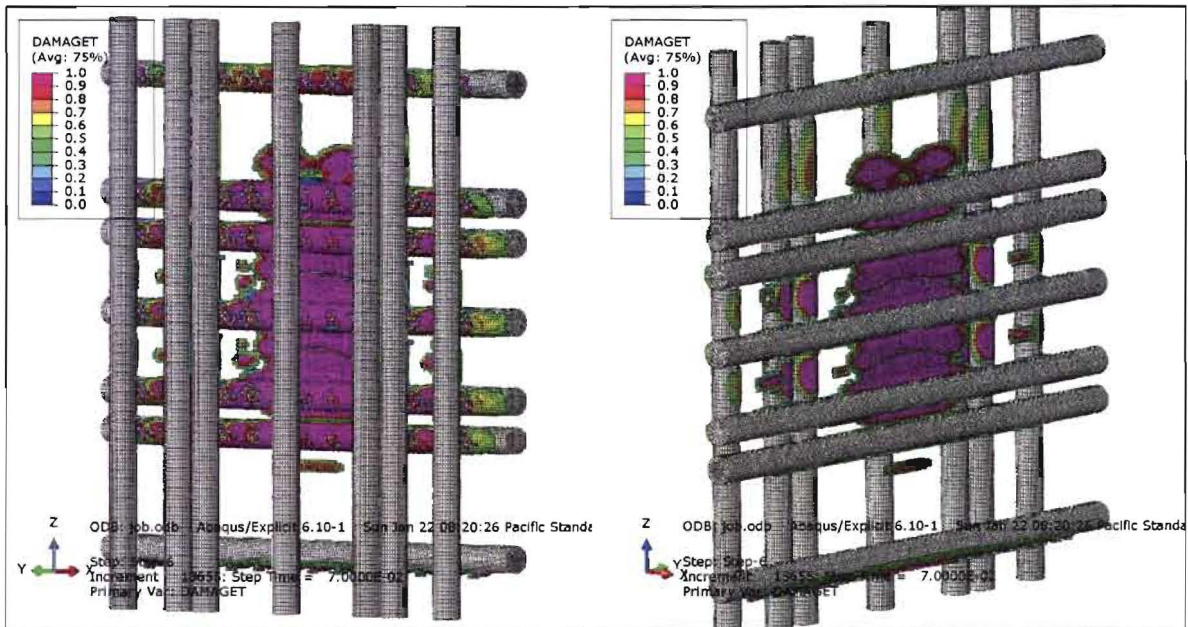
Figure 8 & Figure 9 respectively show laminar cracking due to water freezing near dense rebar and laminar cracking that is absent due to water freezing near sparse rebar.

Figure 8: Laminar Cracking (Nominal 6" Spacing, 0.6% VF)

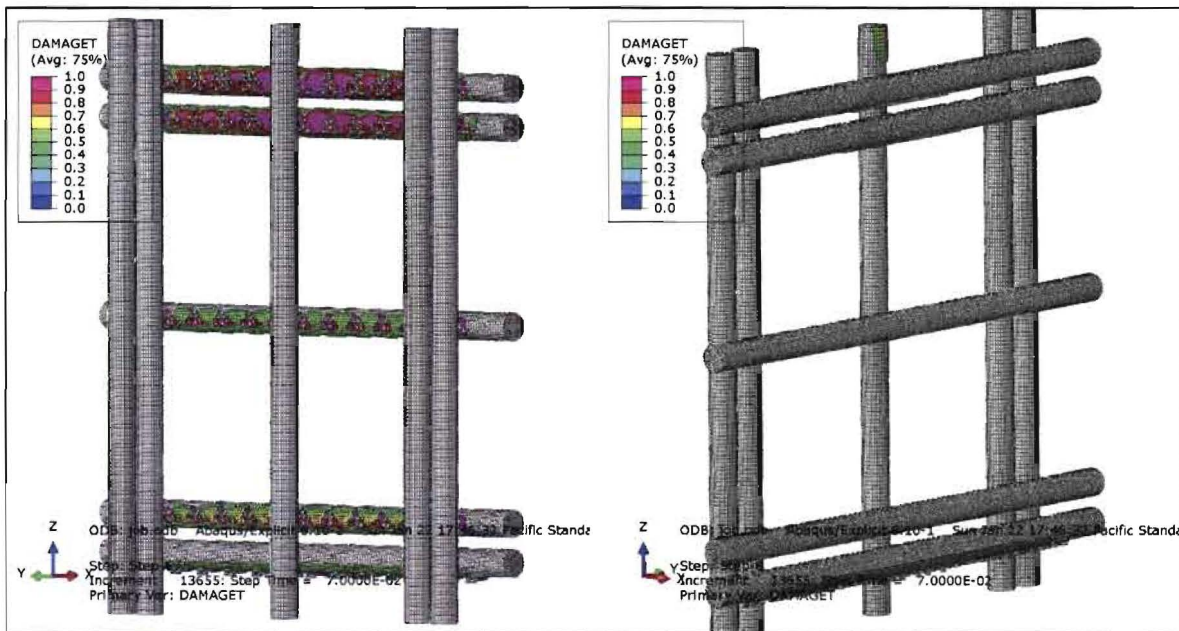
Figure 9: Debonding but No Laminar Cracking (Nominal 12" Rebar, 0.6% VF)

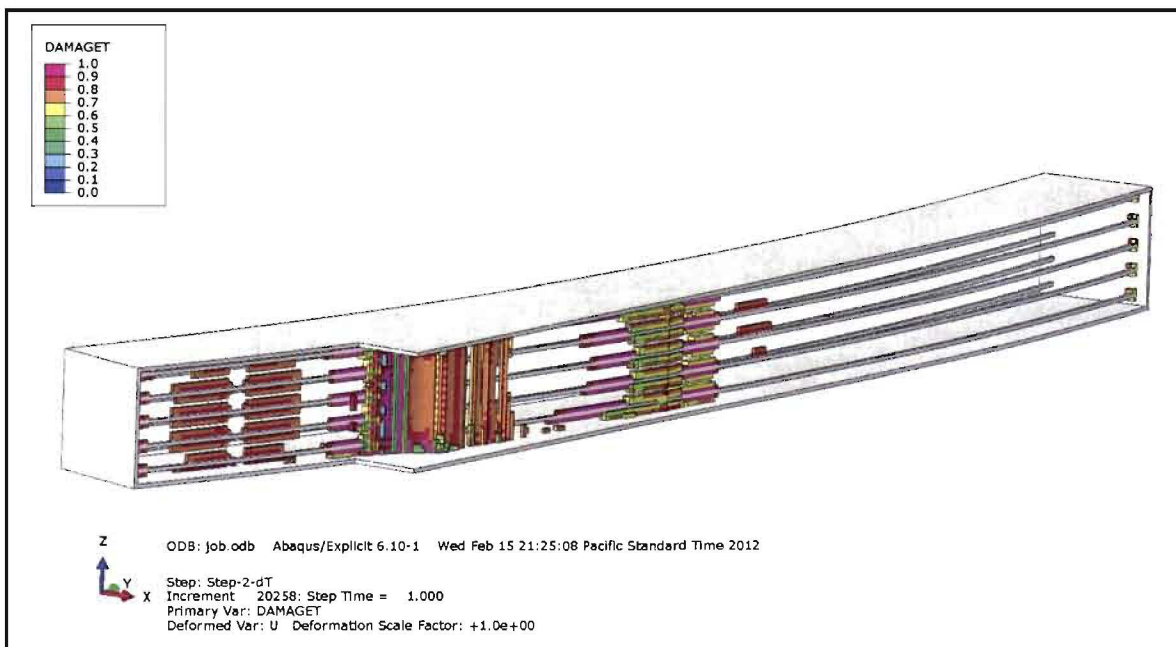
Figure 34: Cracking Result during the 1978 Blizzard showing regions with DAMAGE > 0.7

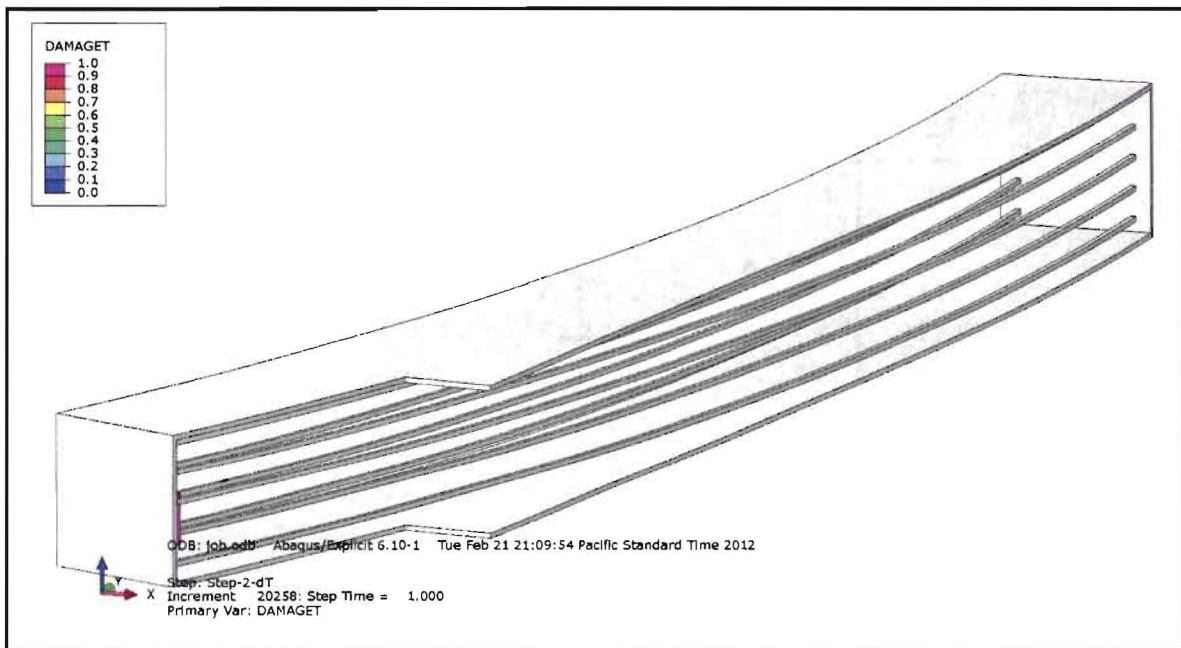
Figure 37: Cracking Result during the 1977 Blizzard showing regions with DAMAGE > 0.7

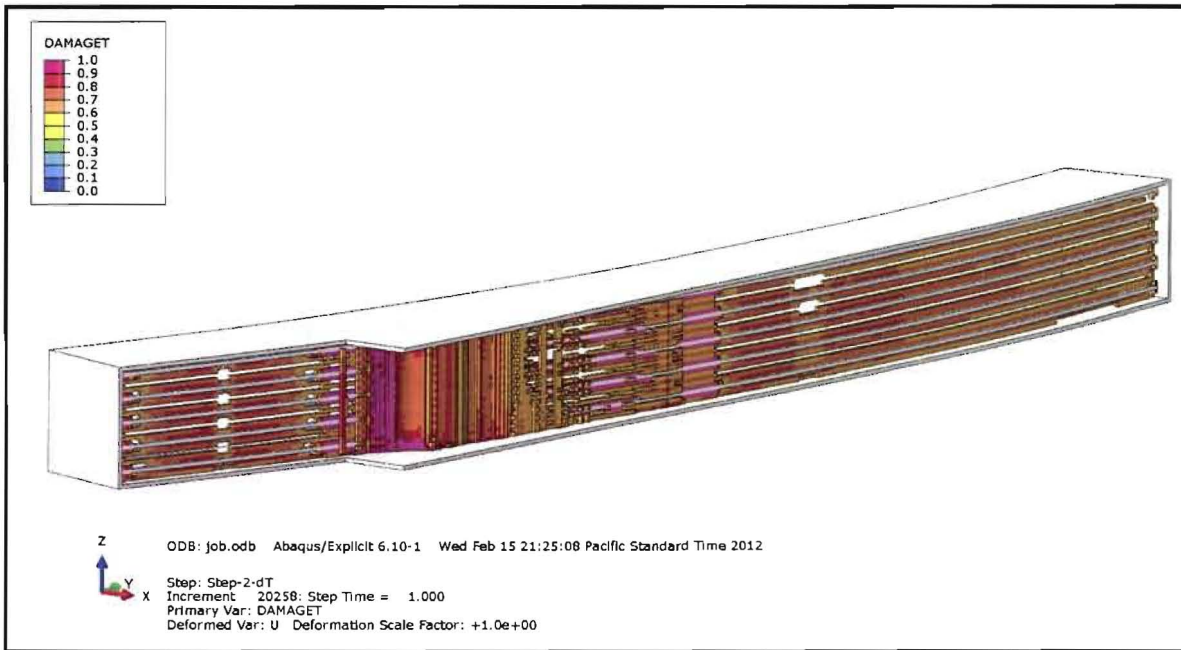
The results at the top 20' location, perturbed by the 1978 blizzard are shown in Figure 39 and Figure 40. The 20°F offset temperature contours can be seen in Figure 39 and the cracking results are shown in Figure 40.

Figure 40: Cracking Result in Top 20' of the Wall showing regions with DAMAGE > 0.6

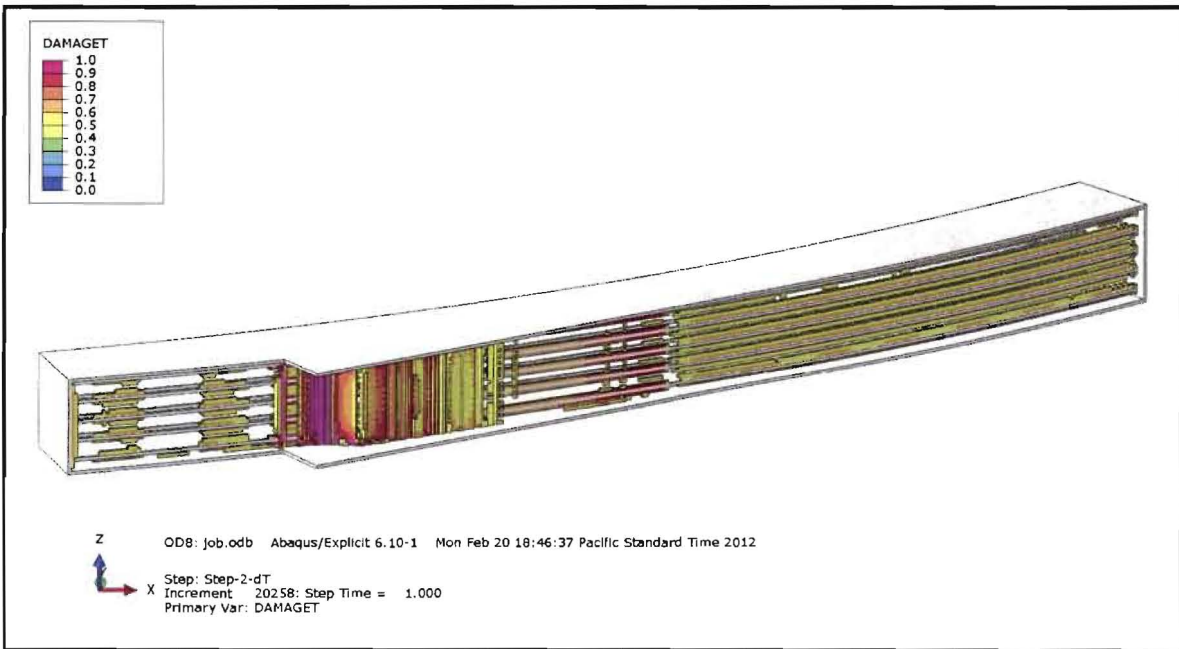
The results at the steam line location, perturbed by the 1978 blizzard are shown in Figure 41 and Figure 42. The 20°F offset temperature contours are in Figure 41 and the cracking results are shown in Figure 42.

Figure 42: Steam Line Area Cracking Result showing regions with DAMAGE > 0.6

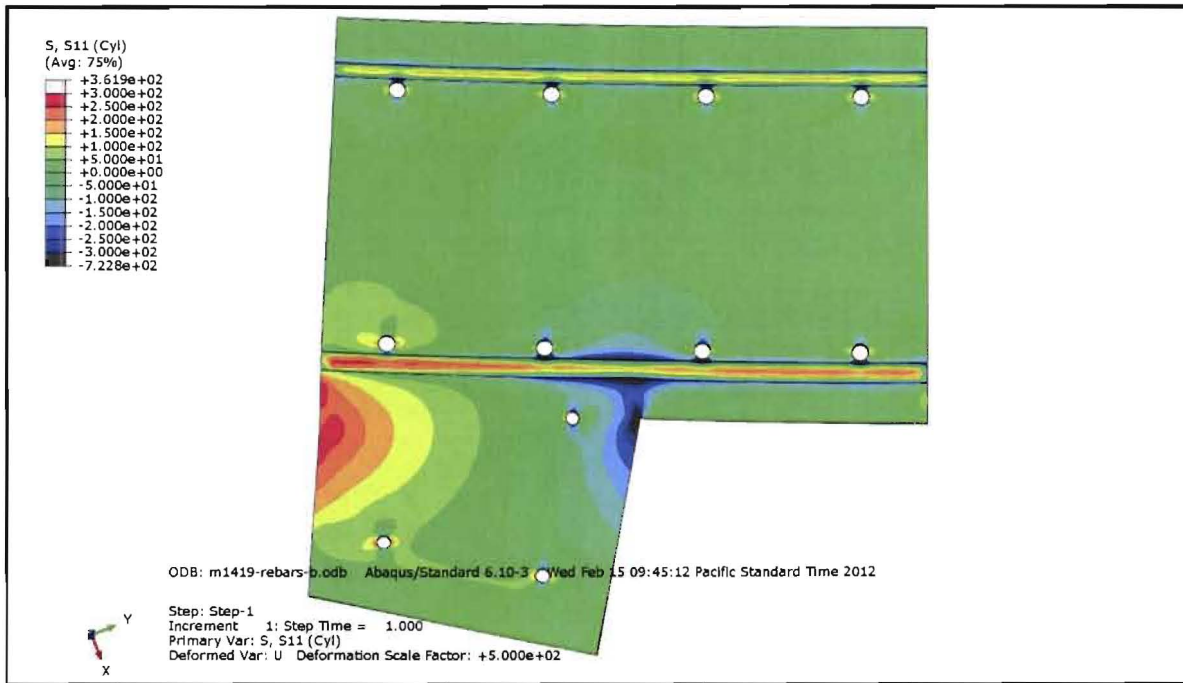
Comparing the stress in the three radial, hoop, and vertical directions (Figure 47 through Figure 49 respectively) indicates that the radial component has the highest tensile stress. As shown in Figure 47, the radial tensile stress is below 300 psi which is less than the tensile strength of the concrete. It is concluded that the hot summer temperature condition is not capable of delaminating the structure in the flute/shoulder location.

Figure 47: Radial Stress (psi) in the [redacted] laced in the Shoulder 10 Location

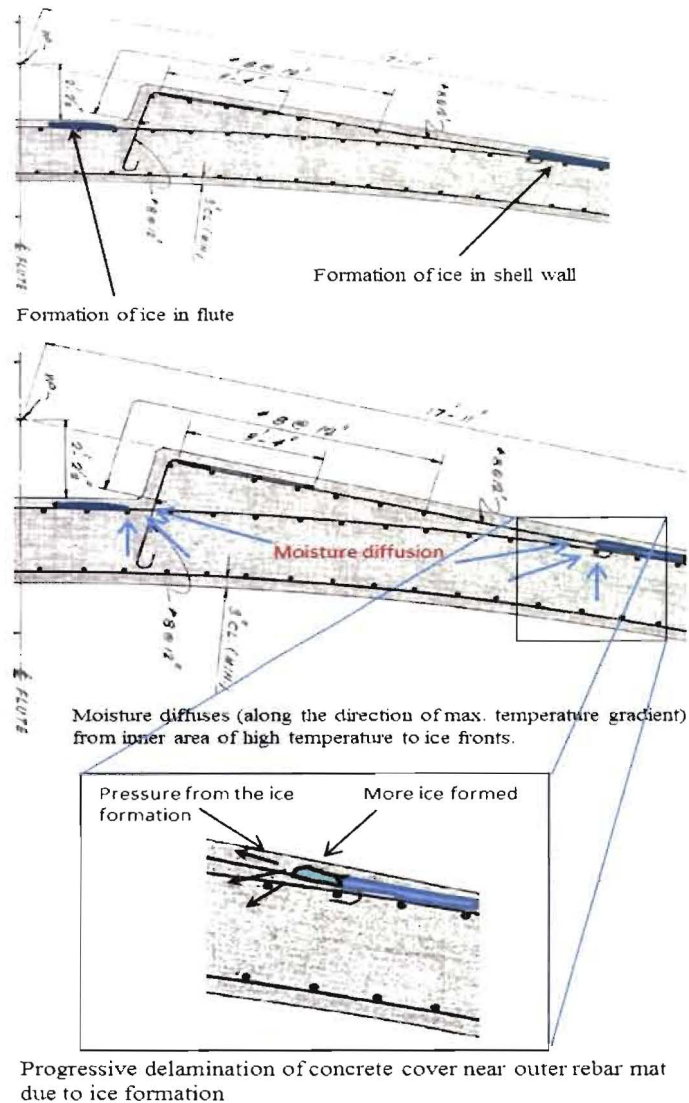
Fig. 1 Freezing damage near outer rebar mat in the shoulder

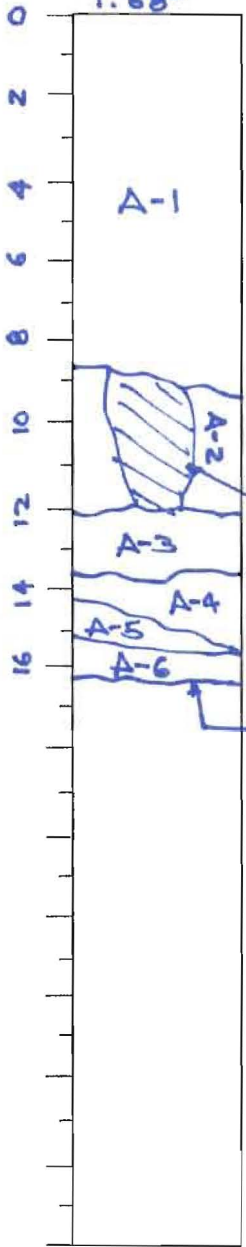
This cracking through the aggregate does not provide any reliable information about the rate of crack propagation.

(TYP.)  
EXTRACTION  
FRACTURE THRU  
AGGREGATE
