FUKUSHIMA DAI-ICHI INITIATING EVENT SIGNIFICANCE

FUKUSHIMA DAI-ICHI FLOODING DAMAGE

FUKUSHIMA DAI-ICHI HYDROGEN GENERATION

FUKUSHIMA DAI-ICHI RADIOLOGICAL RELEASE

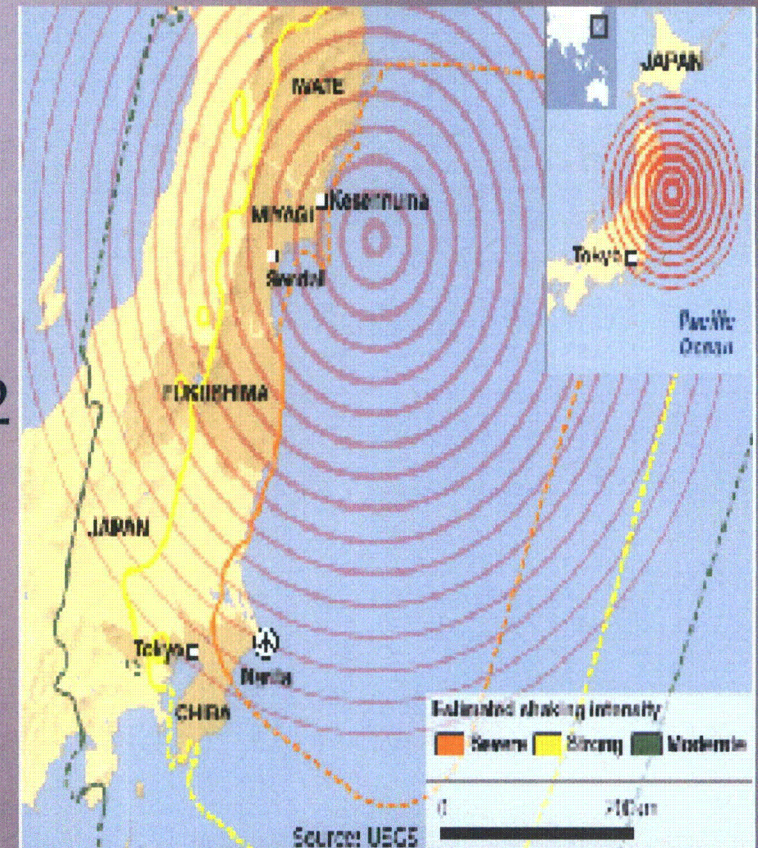
EARTHQUAKE

Plants were designed for:

- 440 cm/sec-squared horizontal (.45 g)
- 412 cm/sec-squared vertical (.42 g)

Seismic Acceleration measured at Unit 2

- 550 cm/sec-squared horizontal (.56 g)
(25% > design basis)
- 302 cm/sec-squared vertical (.31 g)

Plant elevation in relation to sea level
dropped 1-3 meters (3-9 feet)

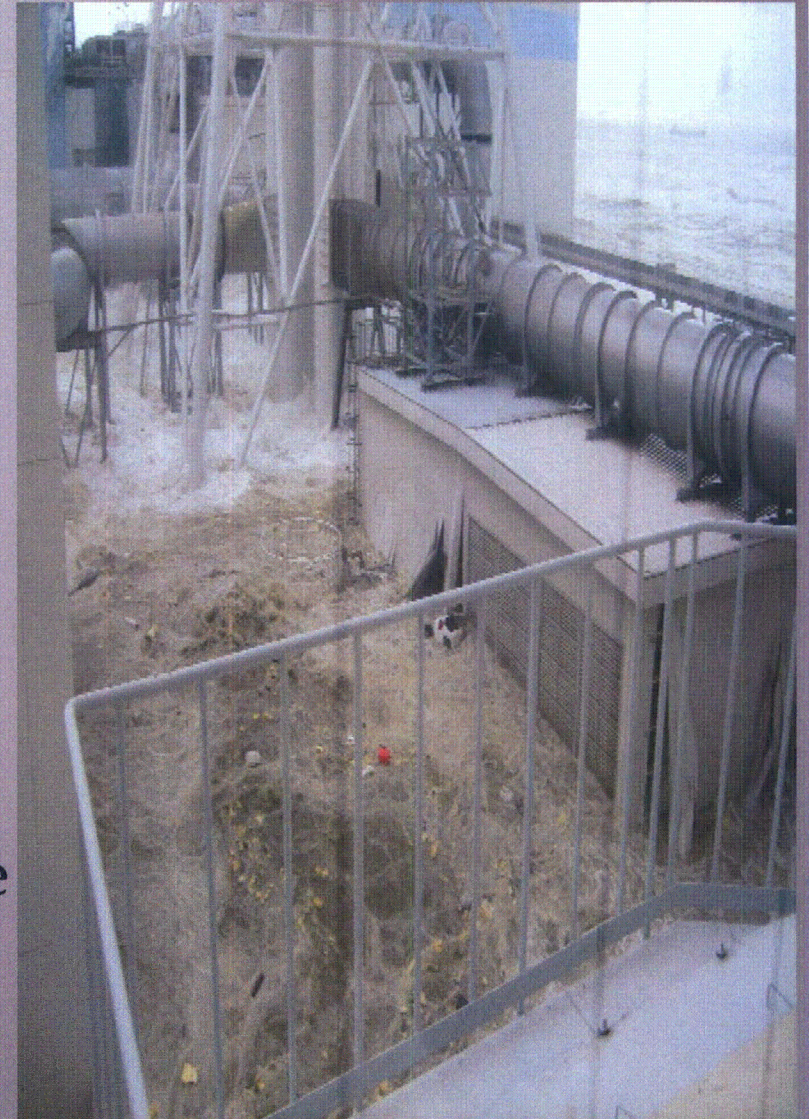
TSUNAMI

- Estimated water volume displaced by earthquake at epicenter = 125 cubic kilometers (4.4E12 cubic feet or 30 cubic miles (3.1³ miles))
- Plants were designed for 6 meters (20 feet) at the shoreline
- Latest estimates of height at site are 14 meters (46 feet) (250% of design basis)

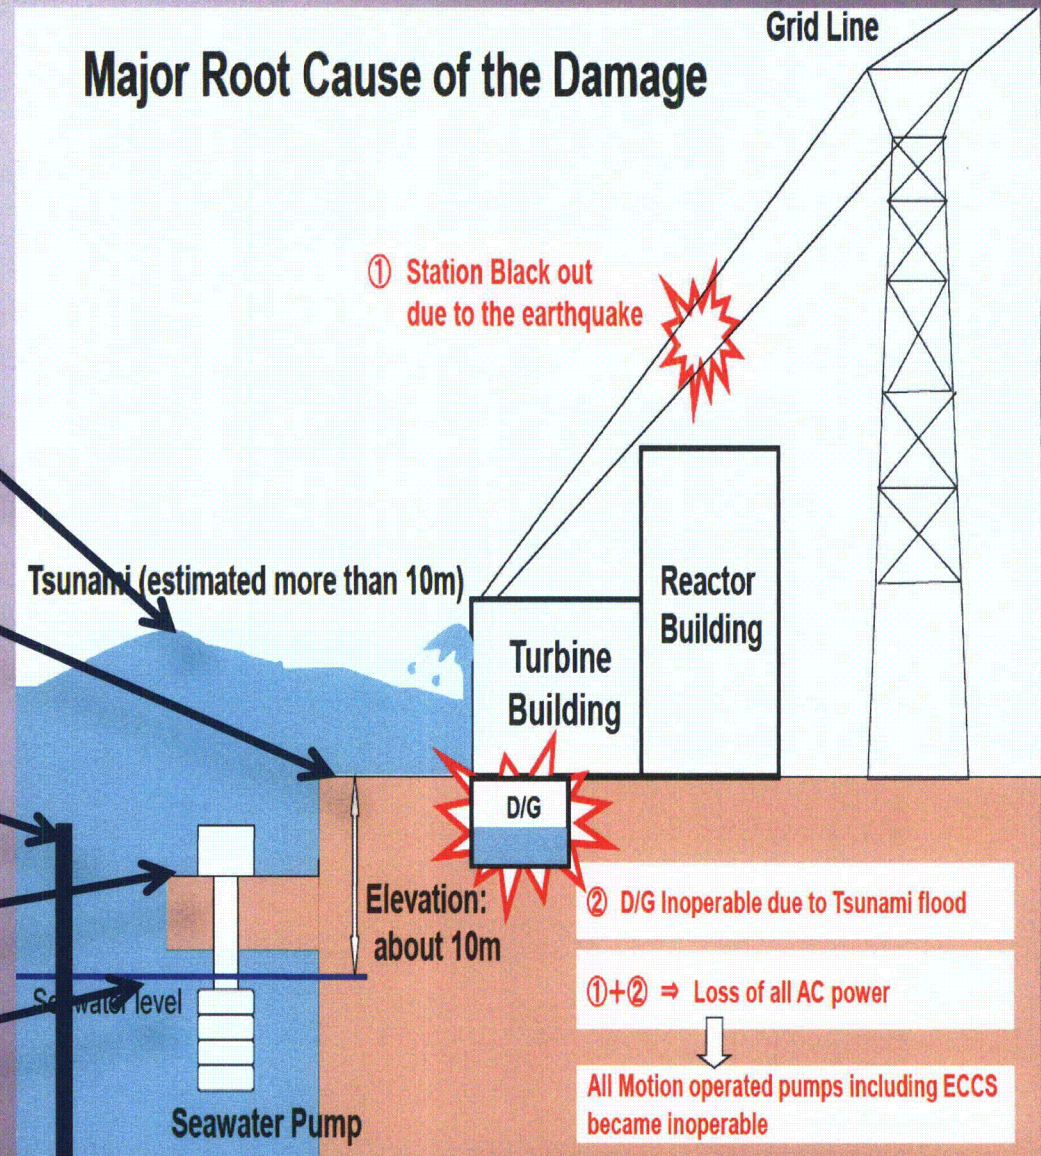
Reference Levels

- 46 feet. Tsunami Peak Elevation
- 42.5 feet Ground elevation of Units 5-6 TB/RB
- 33 feet Ground elevation of Units 1-4 TB/RB
- 17 feet Assumed highest tsunami and elevation of break wall
- 13 feet Ground elevation of intake structure
- 0 Feet Sea level

Major Root Cause of the Damage

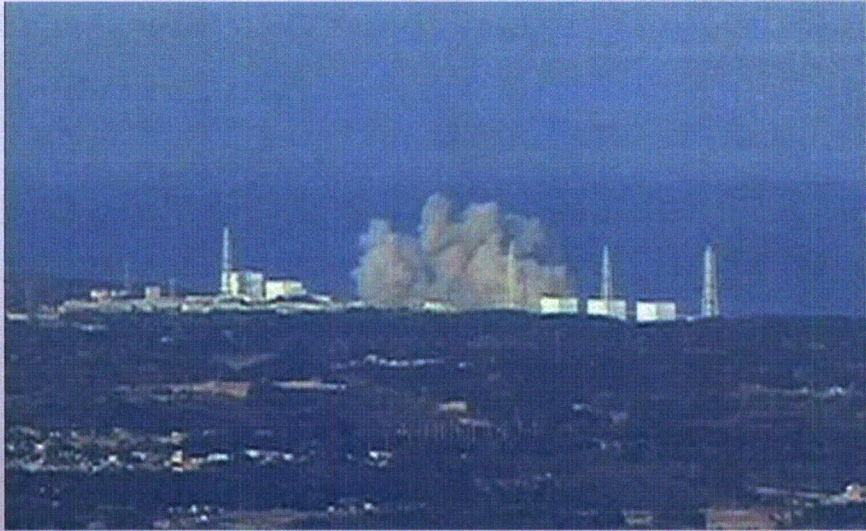
UNIT 1

FUKUSHIMA DAI-ICHI HYDROGEN EXPLOSIONS

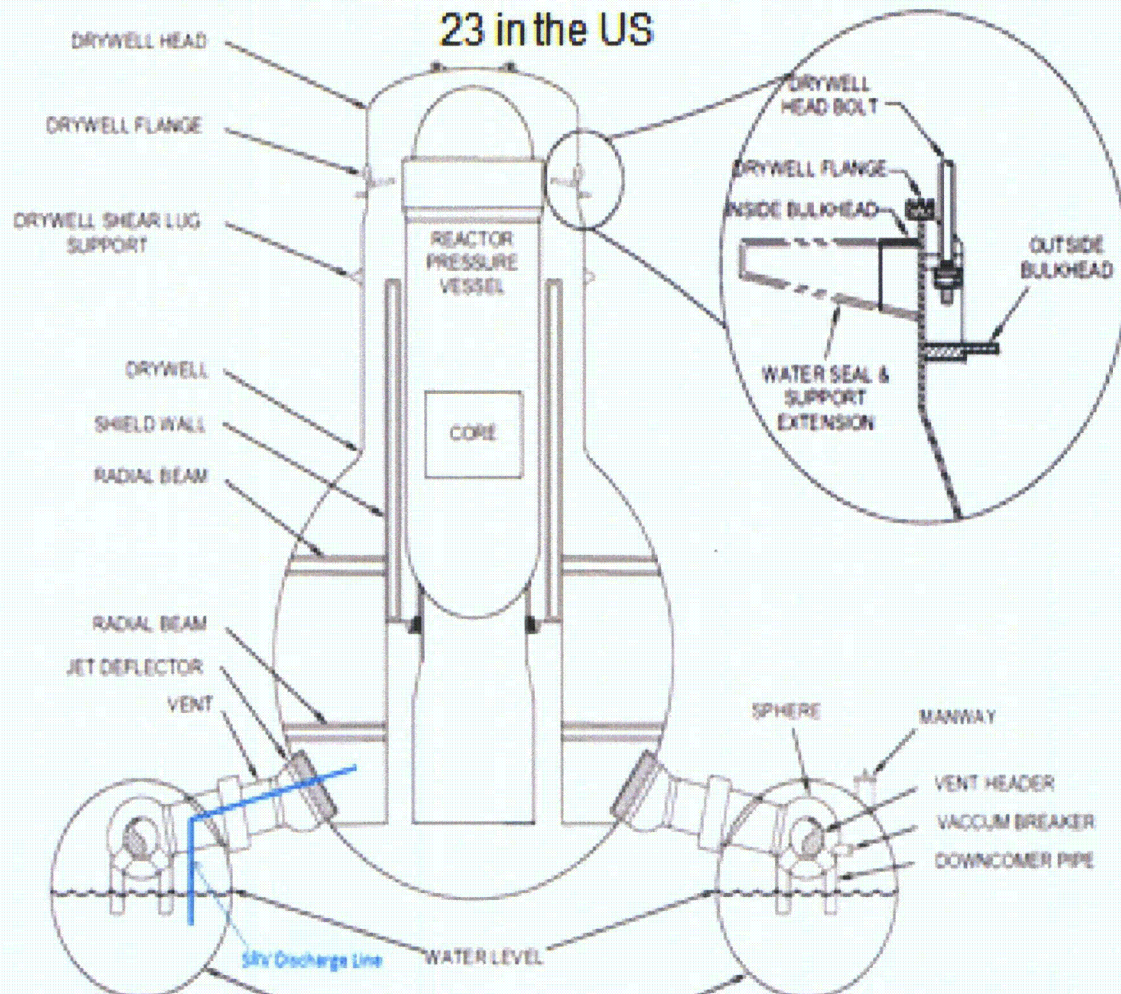
**TYPICAL
BWR MARK 1 CONTAINMENT
23 in the US**

- SRV operation vents RPV internals to Suppression Pool
- Hydrogen accumulates in Suppression Chamber
- Hydrogen vents to Drywell atmosphere
- Containment failure or intentional venting passes hydrogen to the Reactor Building atmosphere
- 4-78% hydrogen in air is flammable/explosive

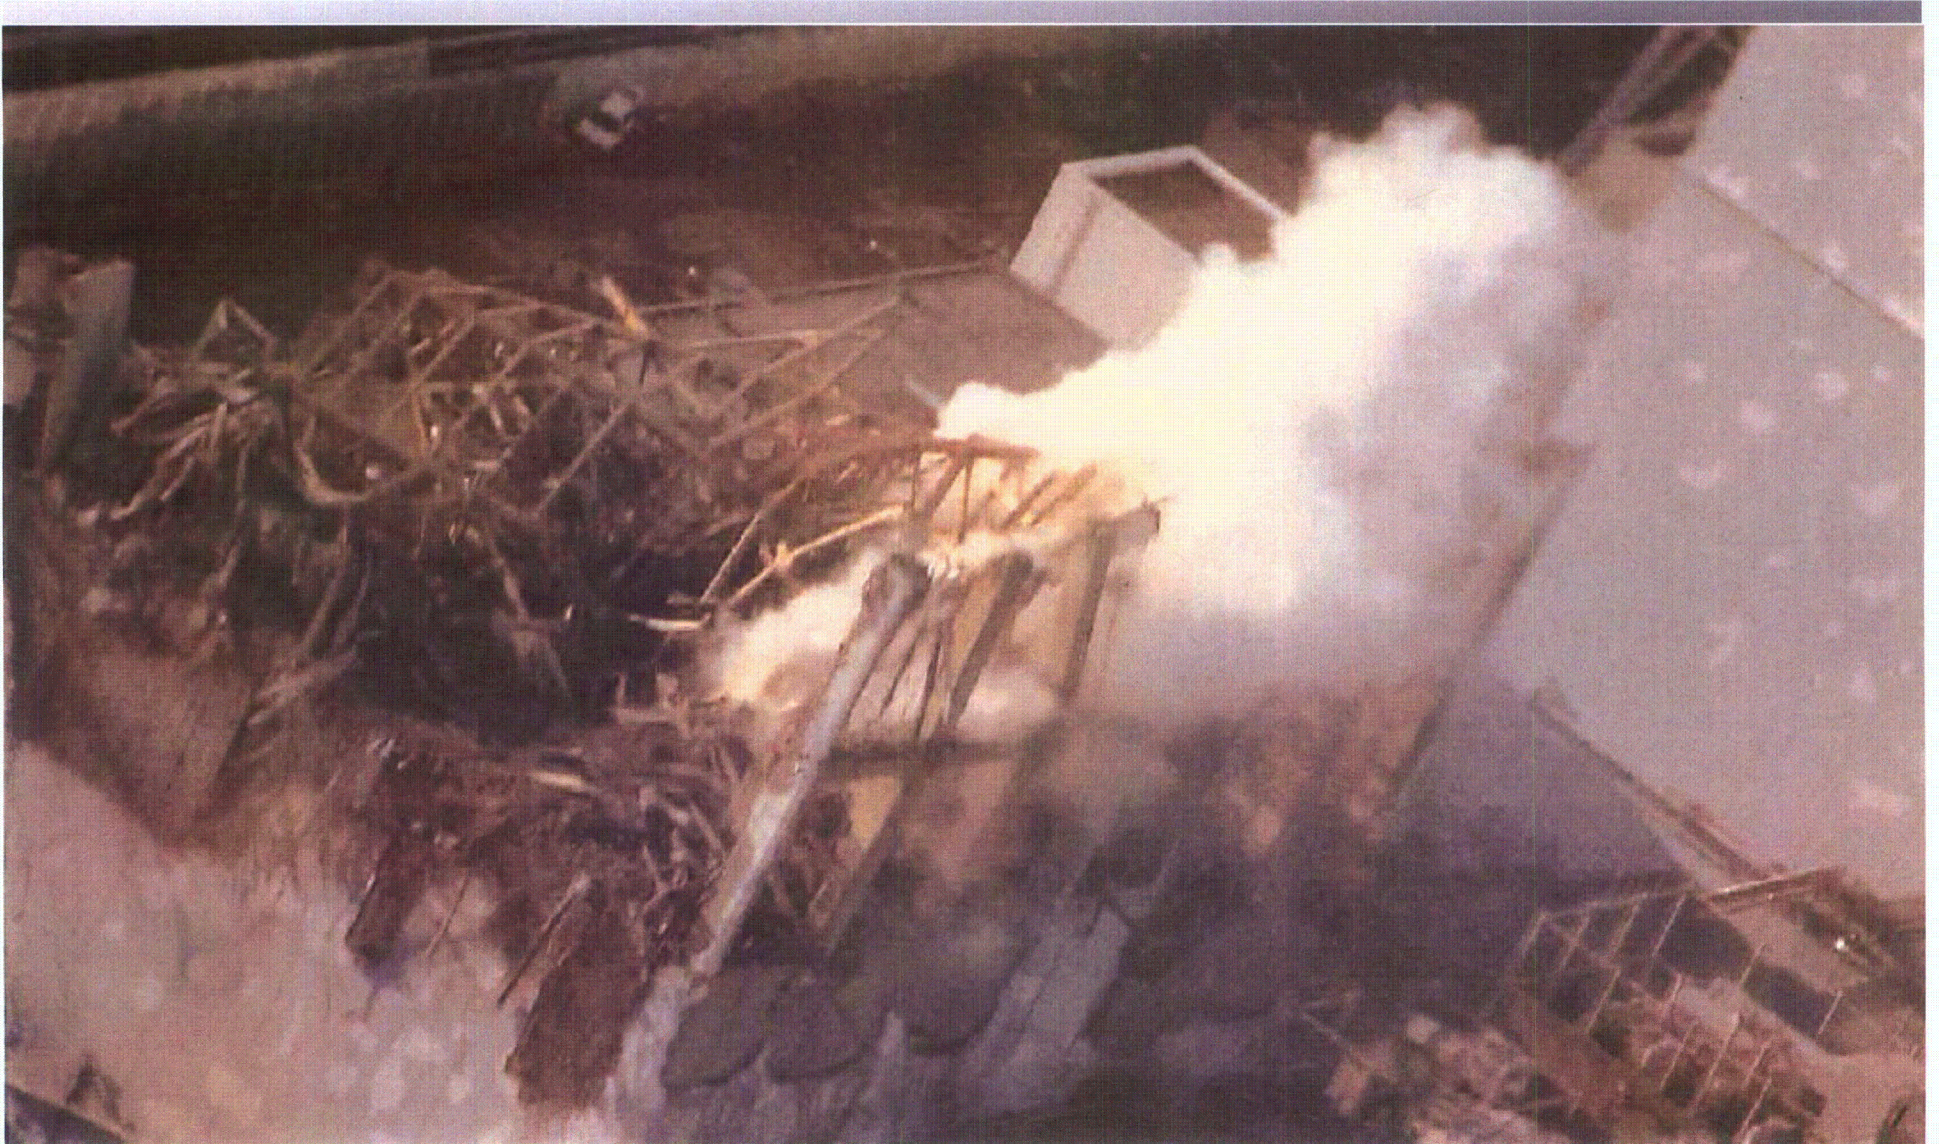
Fukushima Dai-ichi Unit 3 (airborne imagery: TEPCO)
