Assessment of NDE Methods on Inspection of HDPE Butt Fusion Piping Joints for Lack of Fusion

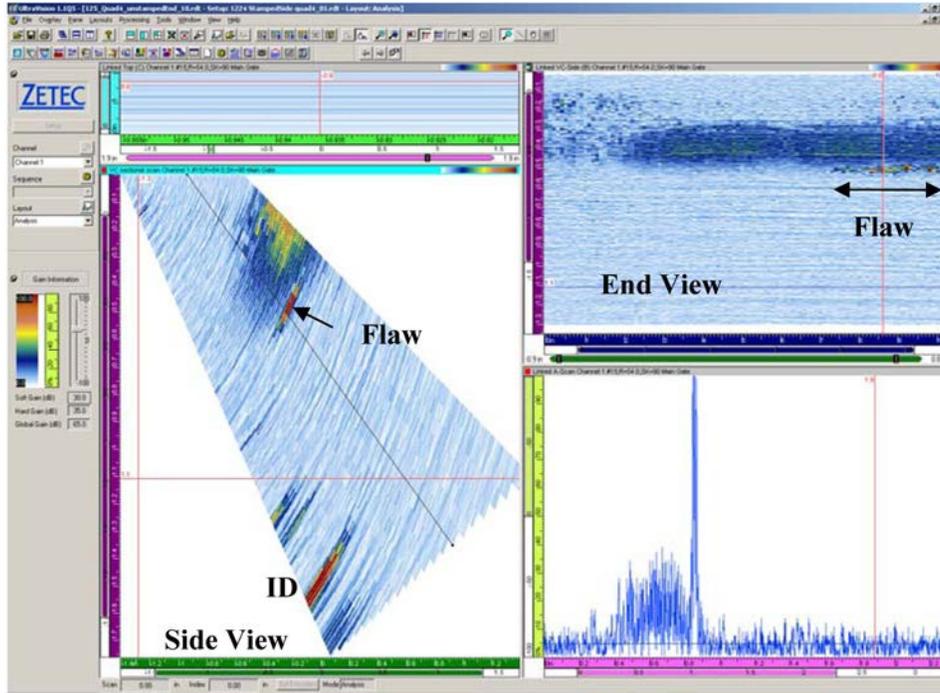
Figure 3.19 Phased Array Results on HDPE Pipe 125, Quadrant 4 Showing a Possible Lack of Fusion in the Noted Flaw Area

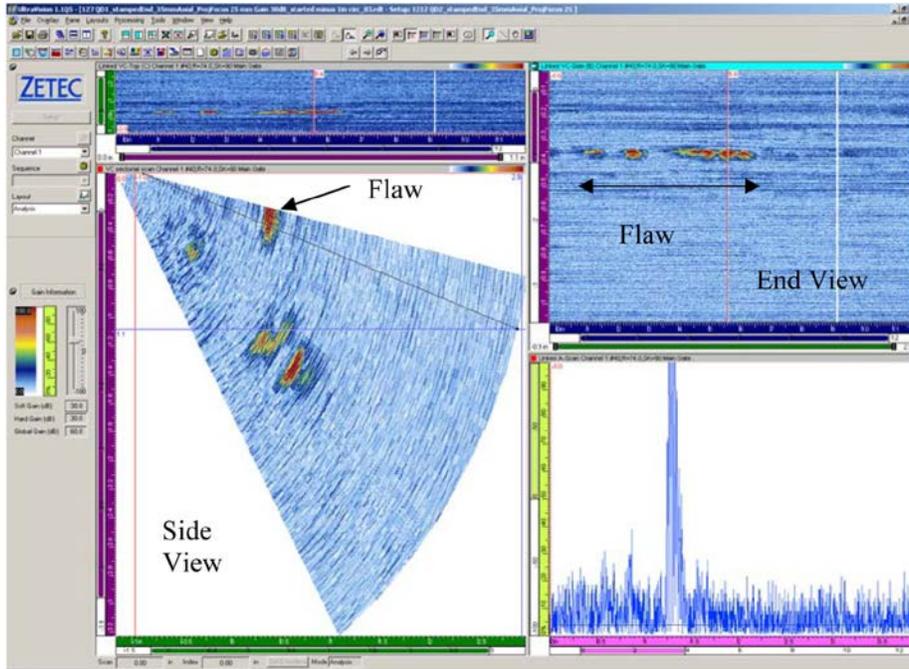
Figure 3.22 Pipe Joint 127 Quadrant 1 from the Stamped Side Showing Flaw Indications. This is the worst joint condition of the six possible.

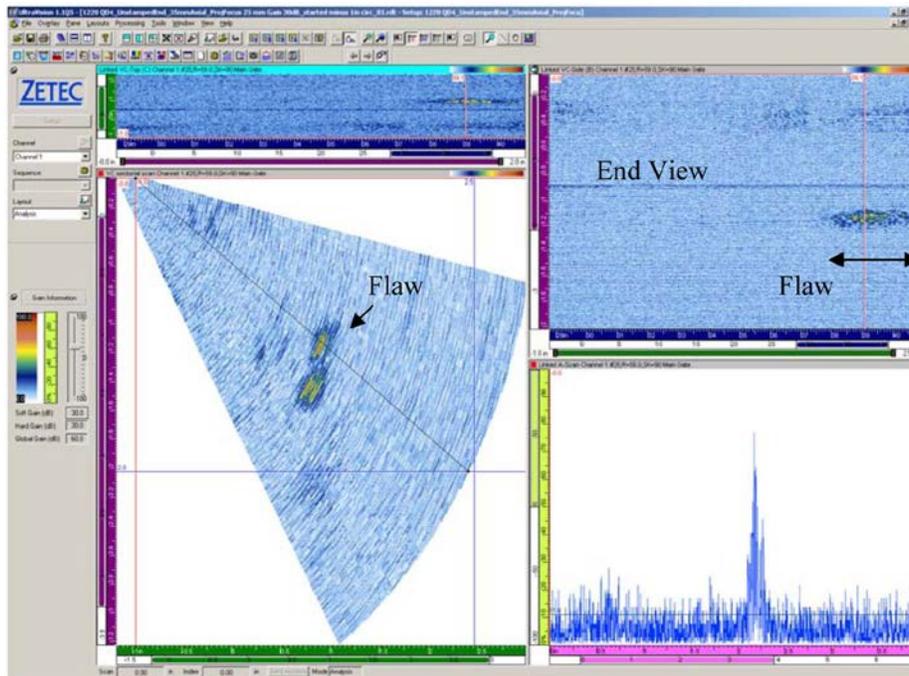
Figure 3.23 Pipe Joint 120 Quadrant 4 from the Unstamped Side Showing a Flaw Indication with Diffraction Pattern

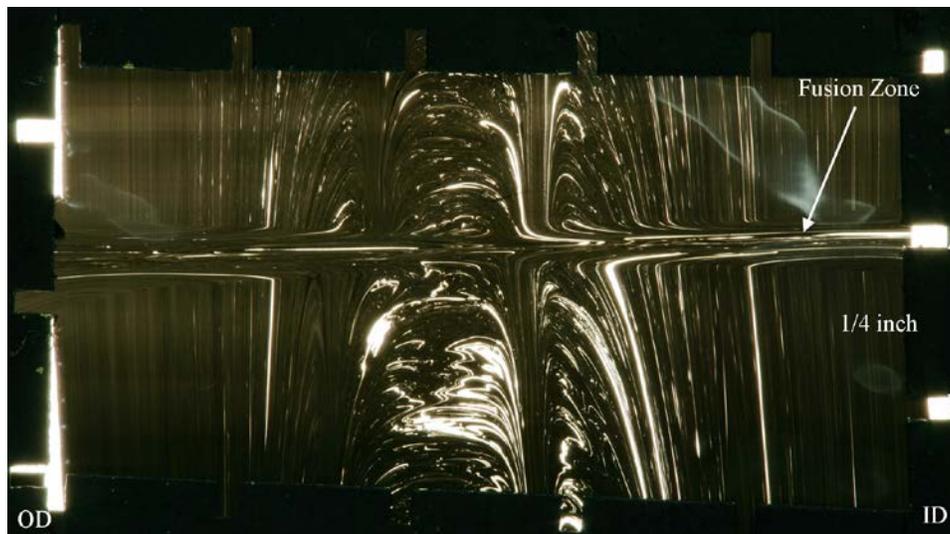
Figure 4.4 A Slice from HDPE Pipe 125, Quadrant 4 at Approximately 8.6 Inches (21.8 cm). Lack of fusion in the fusion zone is not evident due to light colored material streaks and swirls from uneven base material mixing.

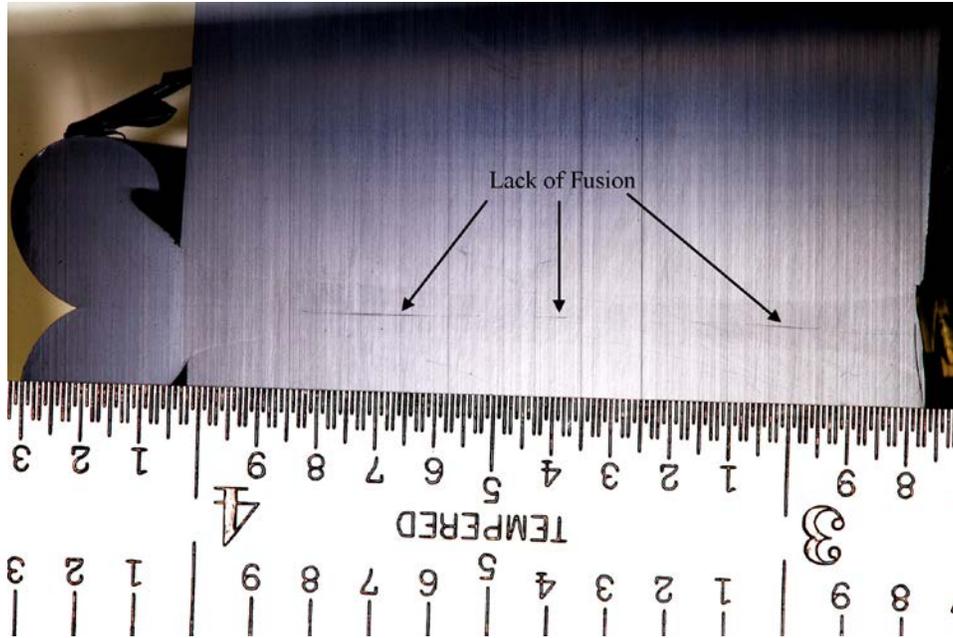
Figure 4.5 Surface of HDPE Pipe 125, Quadrant 4 at Approximately 8.6 Inches (21.8 cm). Areas of lack of fusion are noted. Units displayed in scale are inches.

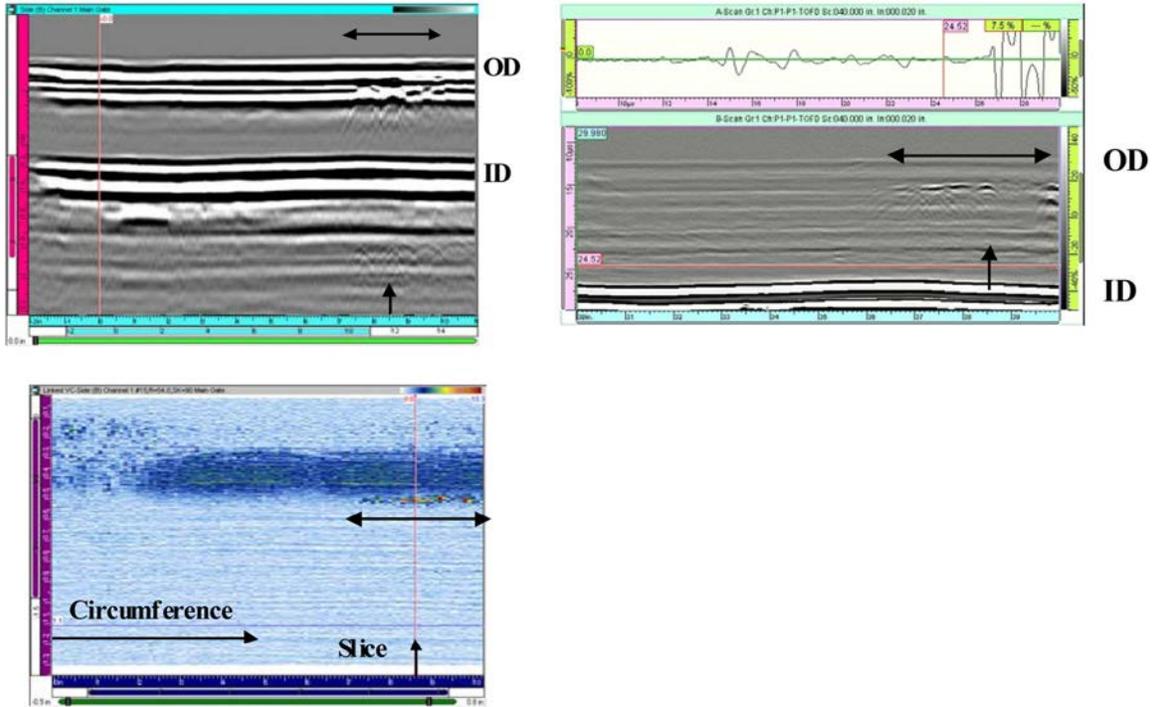
A fusion area from pipe 125 containing a flaw indication at an approximate 7–9 in. (17.8–22.9 cm) circumferential position was cut out of the pipe. Slices were made in the axial direction, perpendicular to the weld. These slices were in the 25–35-micron-thick range, making them thin enough to transmit visible light yet thick enough to maintain their integrity. A tomographic slice at approximately 8.6 in. (21.8 cm) in the pipe circumference is shown in Figure 4.4. Because of uneven mixing of carbon black in the 3408 base material of the pipe, light and dark swirls are observed. When joining two pipe sections, this swirl pattern changes direction due to melting and fusing in the joint, causing a pattern that runs along the fusion line. These light and dark lines in the fusion zone camouflage LOF in this region. Evidence of LOF is, however, seen on the cut (or sectioned) pipe surface as shown in Figure 4.5. The microtome cut was made from the bottom of the piece to the top, leaving cut marks that run perpendicular to the fusion line. Sufficient and diffuse lighting, and/or tilting of the pipe section, highlights these LOF lines in the joint. A liquid penetrant test (PT) of this surface was also performed in attempts to enhance the LOF indication. A red dye was applied to the cut surface and allowed to soak for at least one hour. Normally during this dwell time the liquid penetrant is absorbed into surface discontinuities by capillary action. After the dwell time, the surface was wiped clean of the dye and a white developer applied. The developer typically draws dye out of discontinuities and maps out the flaw shape/opening on the surface of the specimen. No flaw was seen on this specimen face with the PT. It is assumed that these LOF areas are so tight that the dye could not seep into the discontinuity.

Figure 4.6 PNNL TOFD (upper left), Fluor/NDT Innovations, Inc. TOFD (upper right), and PNNL PA Data from the Fourth Quadrant of Pipe 125. All images show a flaw indication in the approximately 7–9 inch (17.8–22.9 cm) circumferential position.

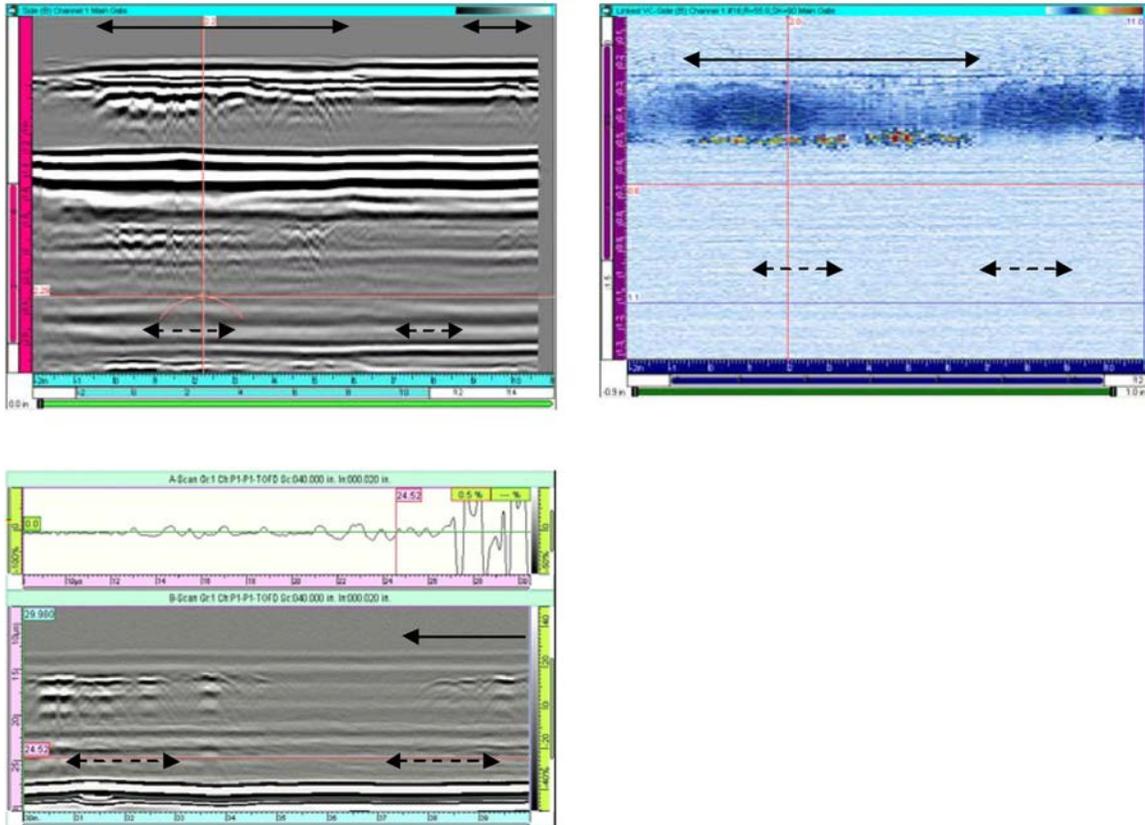
Figure 4.11 Areas Marked for Tensile Testing as Shown by the Lower Arrows in the NDE Images for Pipe 126, Quadrant 4. Upper arrows in the NDE images show regions called defective. Results are for PNNL TOFD, upper left, PNNL PA, upper right, and for Fluor TOFD, lower left.

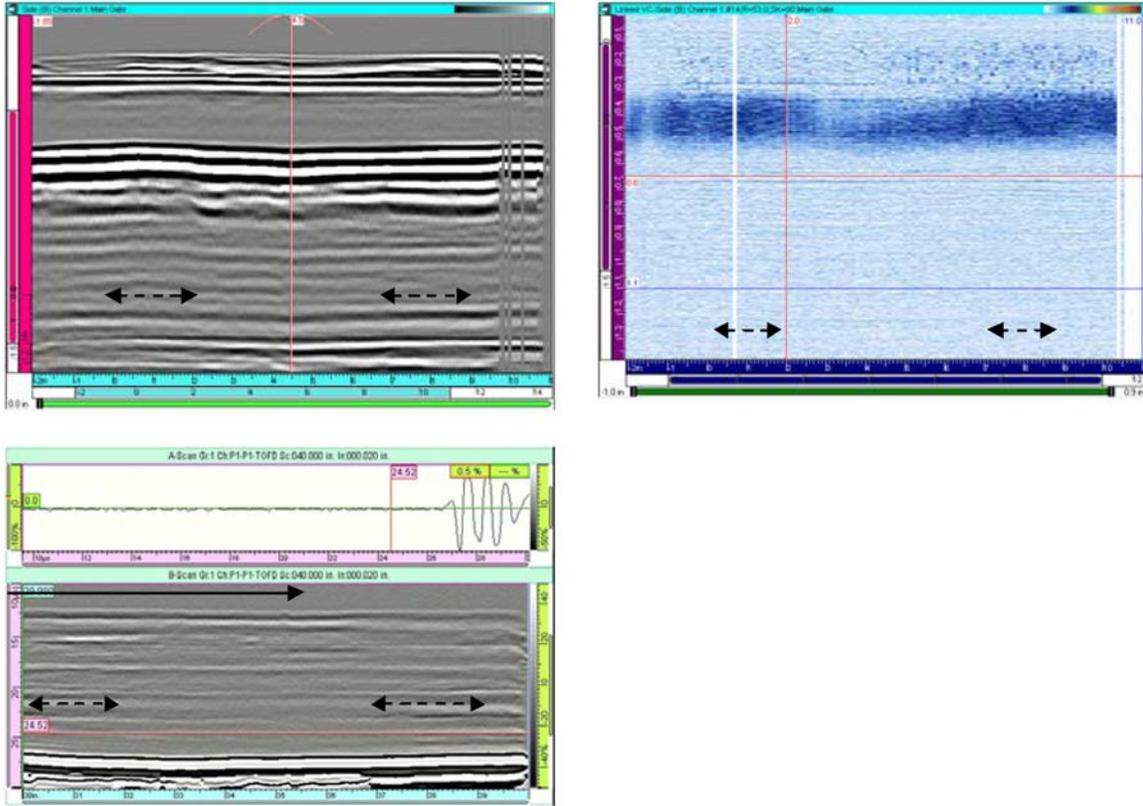
Two areas from pipe 1215, fused under a less severe condition, were selected for tensile testing, shown in Figure 4.12. The left area produced a TOFD indication noted by Fluor/NDT Innovations, Inc. but not by PNNL TOFD or PA. The other area produced no detected ultrasonic indications.

Figure 4.12 Areas Marked for Tensile Testing as Shown by the Lower Arrows in the NDE Images for Pipe 1215, Quadrant 4. Upper arrow in the NDE images show regions called defective. Results are for PNNL TOFD, upper left, PNNL PA, upper right, and for Fluor TOFD, lower left.

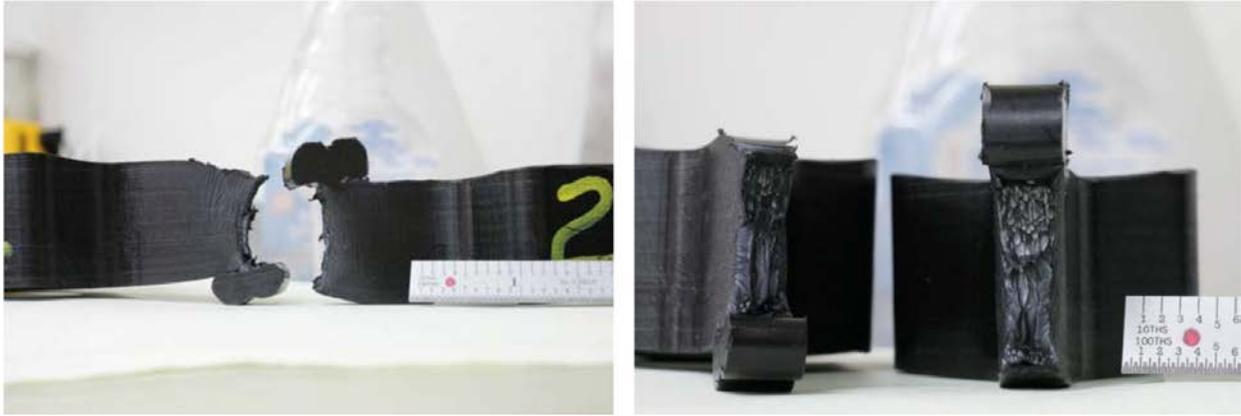
Figure 4.15 Coupon 2 from Pipe 1215 Quadrant 4 with a Long Open/Close Time of 20 sec Showing a Ductile Failure at or Near the Joint. PNNL called this area good and Fluor called it bad.

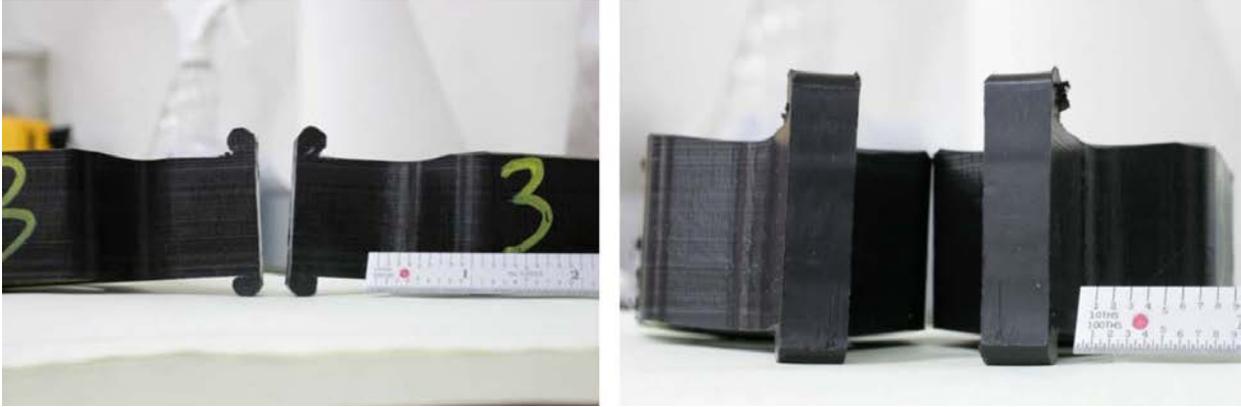
Figure 4.16 Coupon 3 from Pipe 126 Quadrant 4, Fused with Fusion Pressure During the Heat Cycle and a 20-sec Open/Close Time. The failure mode is brittle. Both PNNL and Fluor called this area bad.

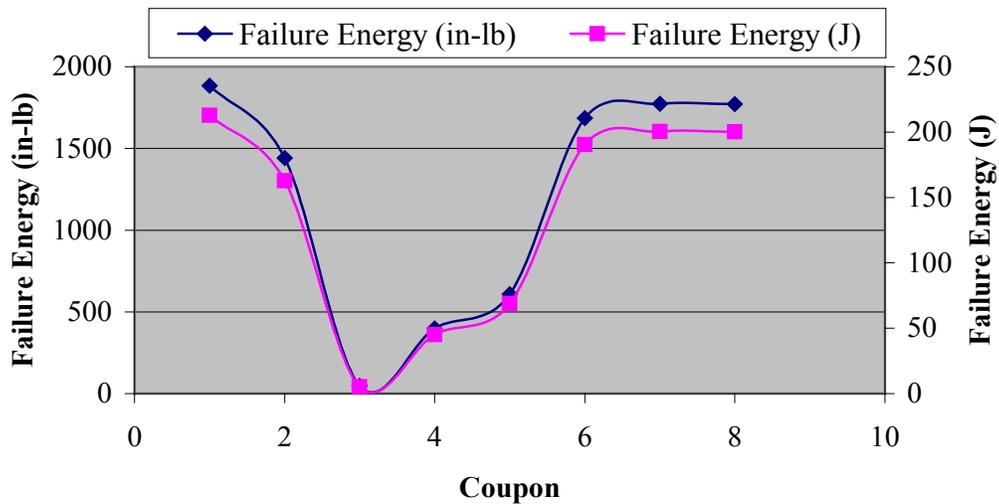
Figure 4.20 Failure Energy Show a Quantitative Measure of Failure Among the Six Coupons. Coupon 3–5 failed in the brittle mode but with differences. Coupons 1, 2, 6–8 failed in the ductile mode but with differences.

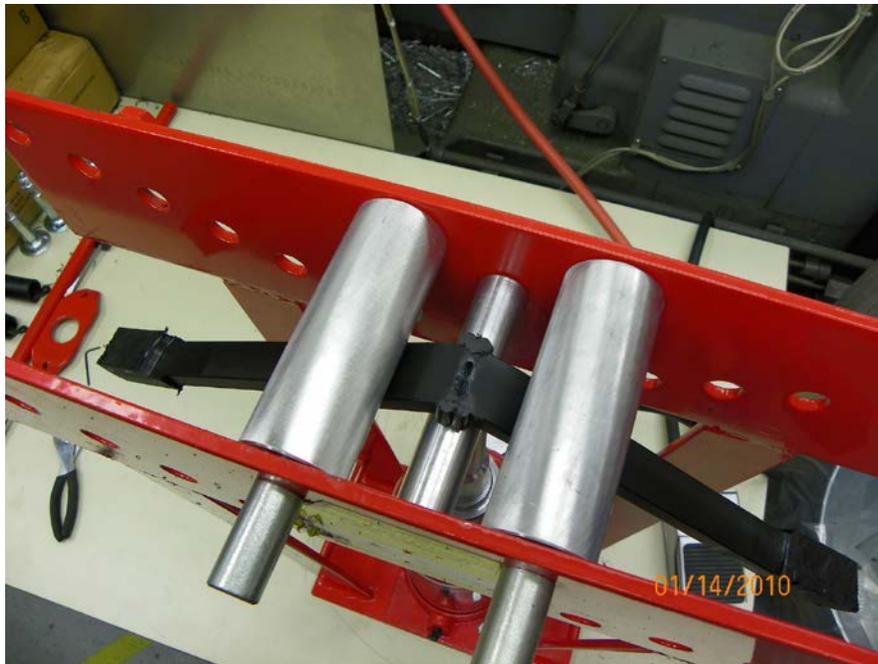
Figure 4.23 Specimen from Pipe 126 Part Way Through the Side-Bend Test Showing the Early Stages of Failure

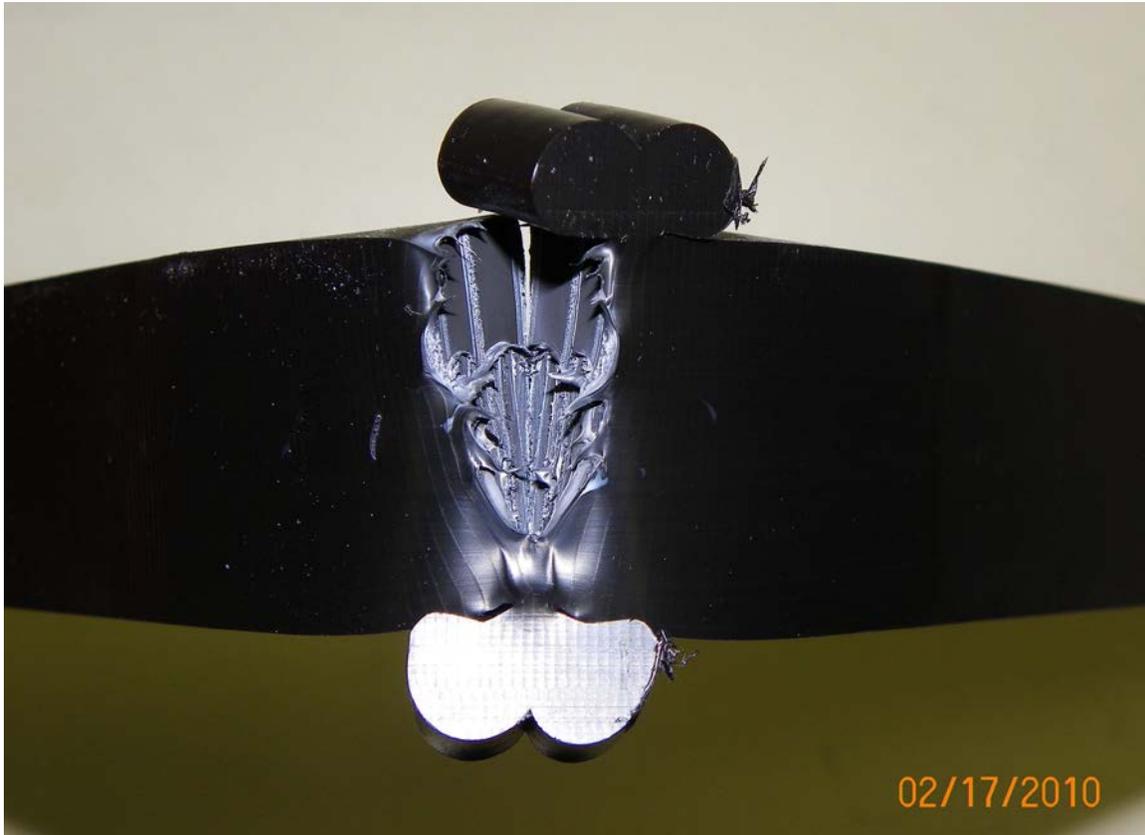
was a flaw in which there was still a remaining ligament on either the ID or the OD. This condition was color-coded **yellow** and an example is shown in Figure 4.26.

Figure 4.26 Example Where Only One Ligament Remained at Location +12 on Pipe 1224 – Example of a Yellow SBT Result

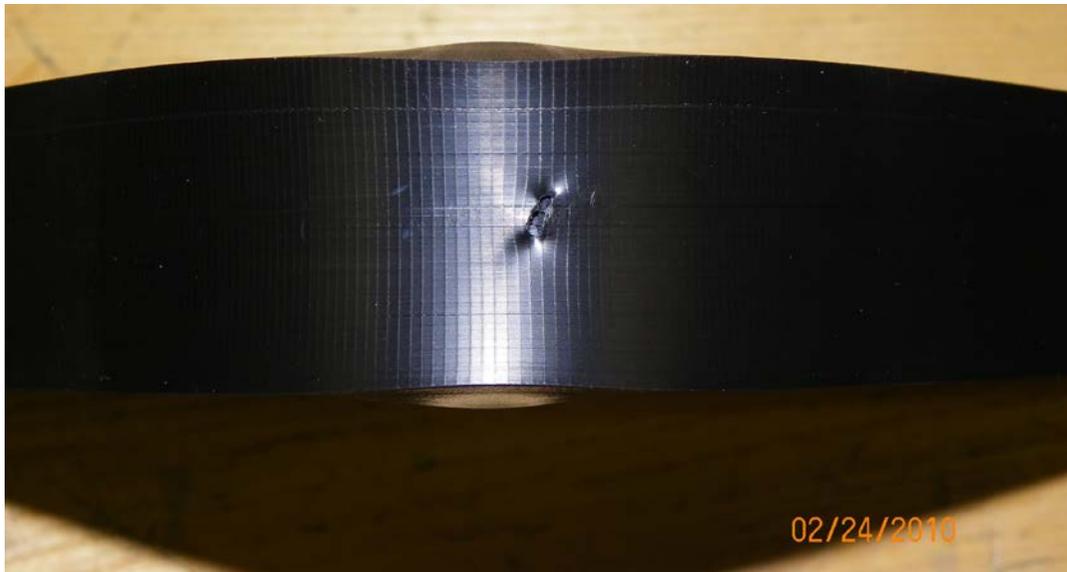
Figure 4.28 Largest Base Material Flaw Found in the 22 Base Material Samples Tested for Pipe 1224

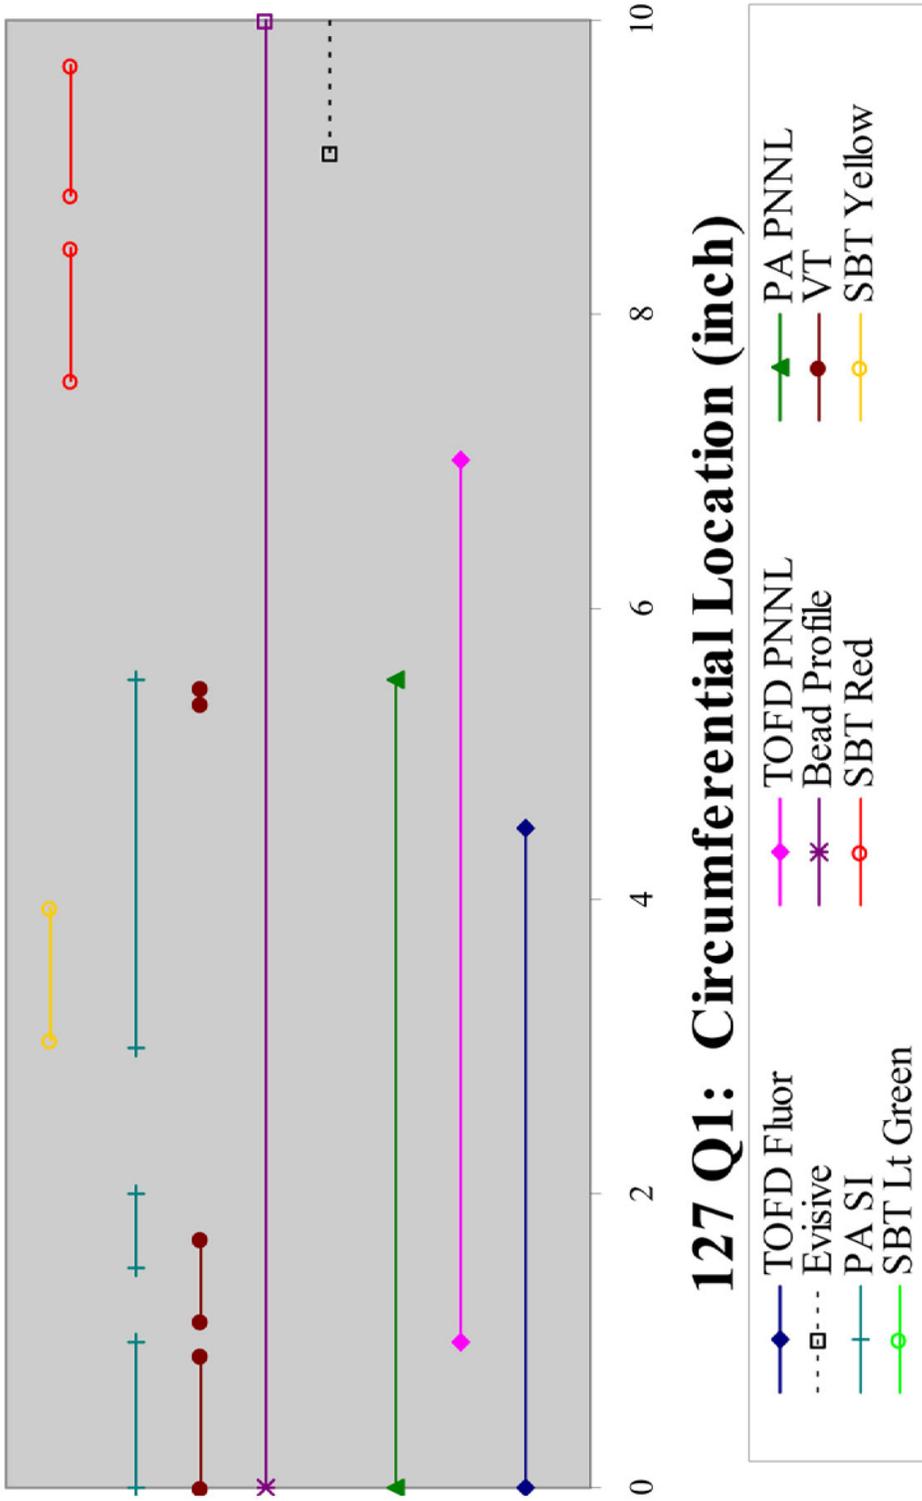
Figure 5.3 SBT Yellow Region was Detected with the NDE PA-SI, PA-PNNL, TOFD-PNNL, and TOFD-Fluor. The SBT Red region was not detected by any of the NDE techniques. Note that only a select few regions from pipe 127 were subjected to the SBT and they all failed in the Yellow or Red mode. It was assumed that the entire pipe joint was bad so these plotted summary results should be used only for a correlation of the plotted SBT results and the NDE results and not as an indicator of false calls.

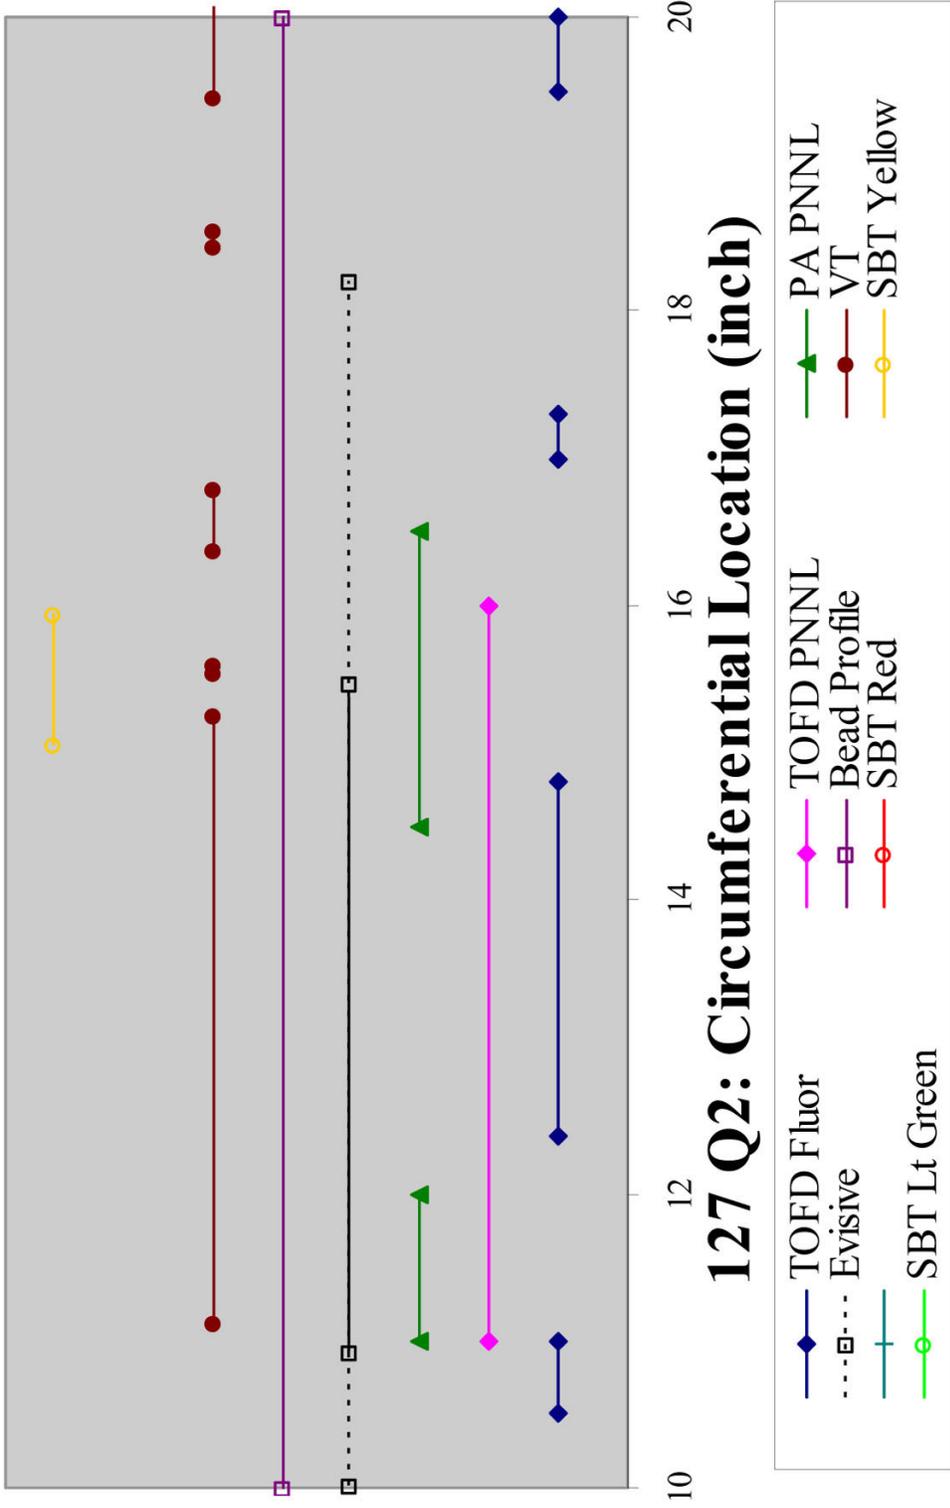
Figure 5.4 SBT Yellow Region was Detected by NDE Evisive in Part, PA-PNNL, and TOFD-PNNL. Note that only a select few regions from pipe 127 were subjected to the SBT and they all failed in the Yellow or Red mode. It was assumed that the entire pipe joint was bad so these plotted summary results should be used only for a correlation of the plotted SBT results and the NDE results and not as an indicator of false calls.

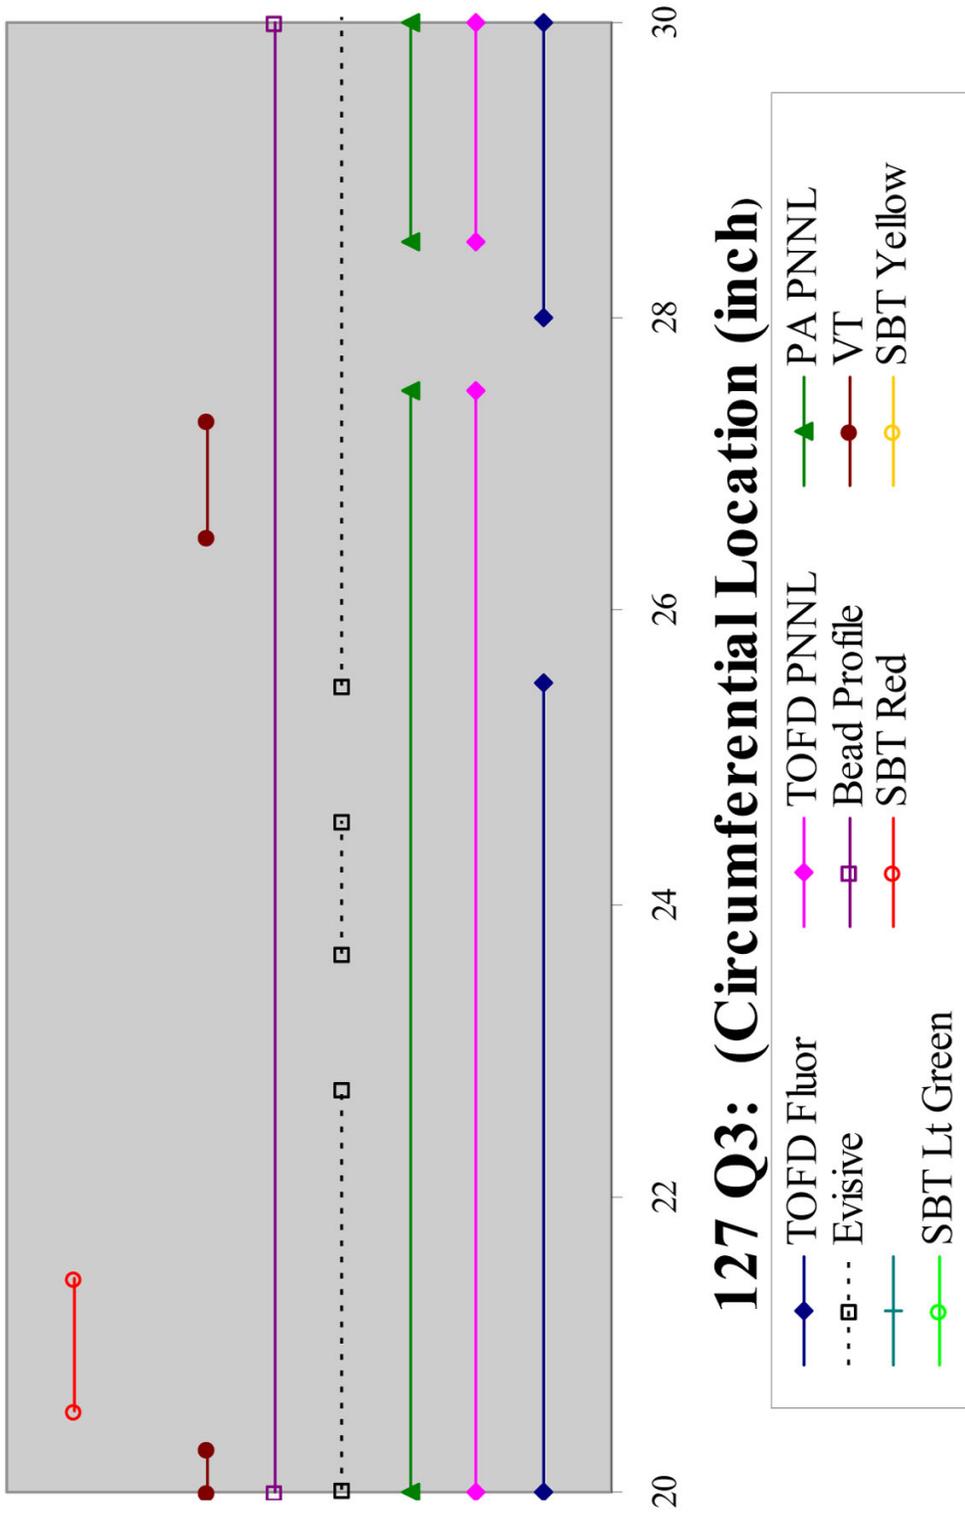
Figure 5.5 SBT Red Region was Detected with PA PNNL, TOFD PNNL, and TOFD Fluor. Note that only a select few regions from pipe 127 were subjected to the SBT and they all failed in the Yellow or Red mode. It was assumed that the entire pipe joint was bad so these plotted summary results should be used only for a correlation of the plotted SBT results and the NDE results and not as an indicator of false calls.

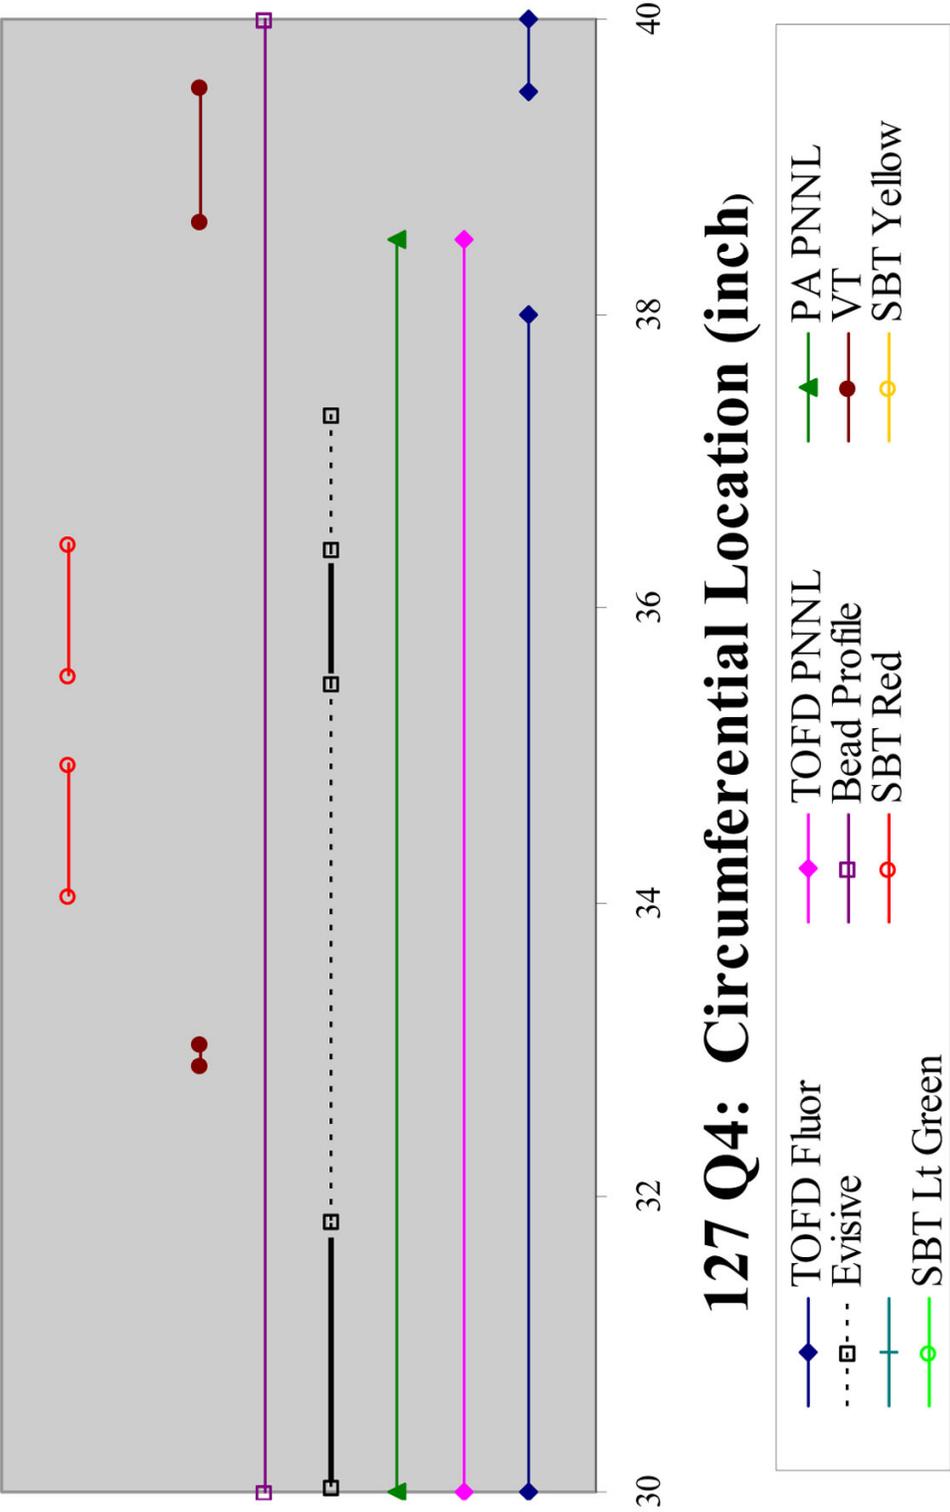
Figure 5.6 SBT Red Region was Detected in Part by Evisive and by PA PNNL, TOFD PNNL, and TOFD Fluor. Note that only a select few regions from pipe 127 were subjected to the SBT and they all failed in the Yellow or Red mode. It was assumed that the entire pipe joint was bad so these plotted summary results should be used only for a correlation of the plotted SBT results and the NDE results and not as an indicator of false calls.

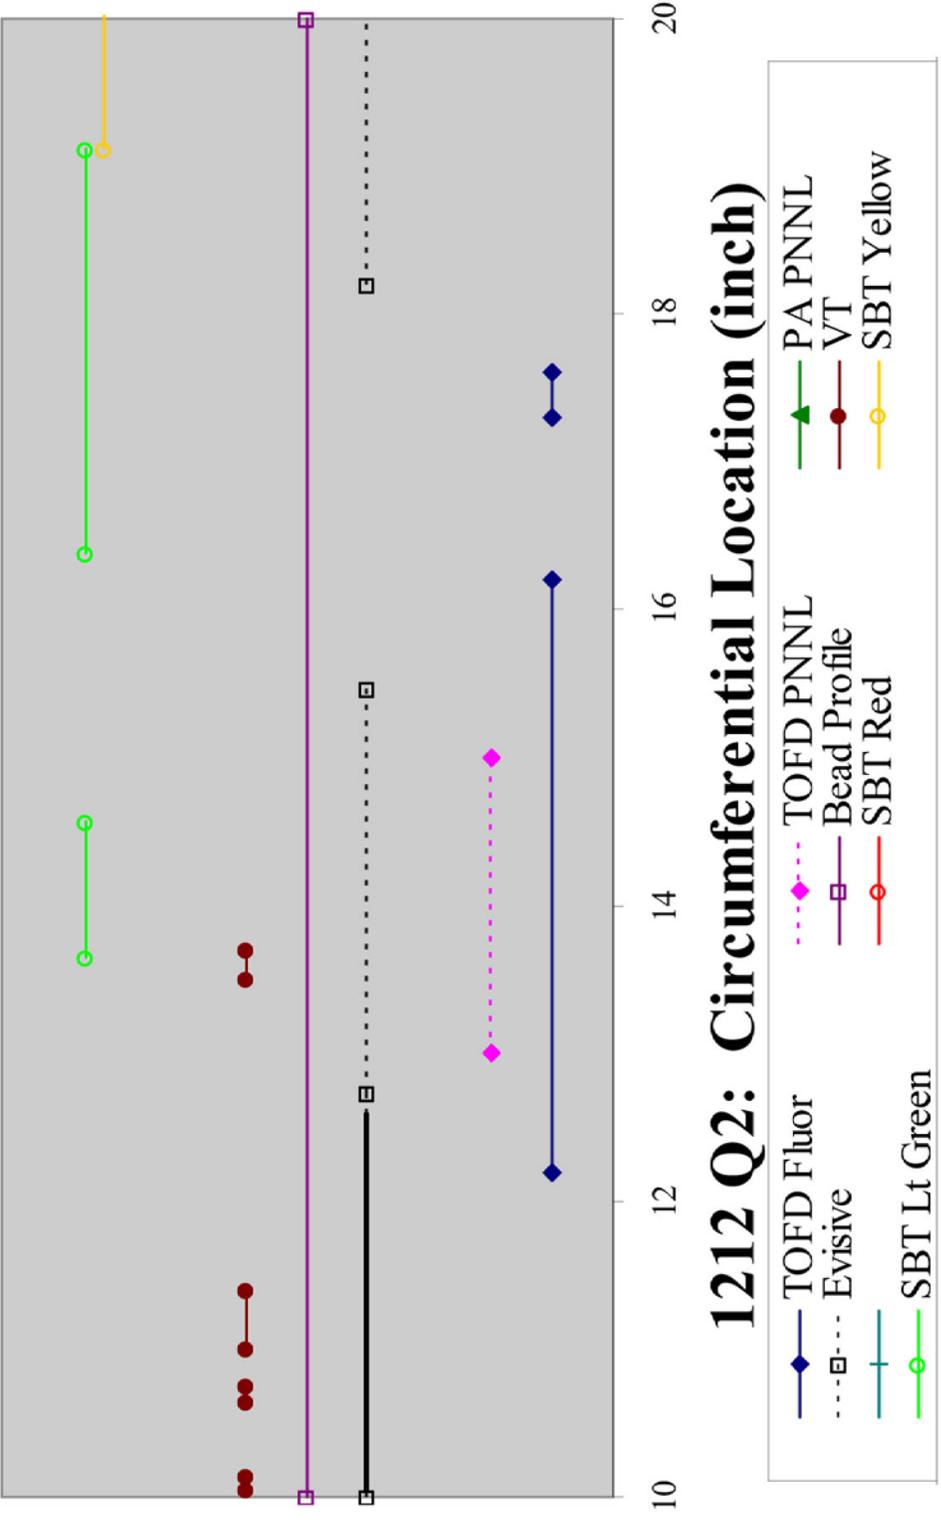
Figure 5.8 SBT Failure Regions were Only Detected with NDE TOFD-Fluor; However, There were False Call Regions as Well

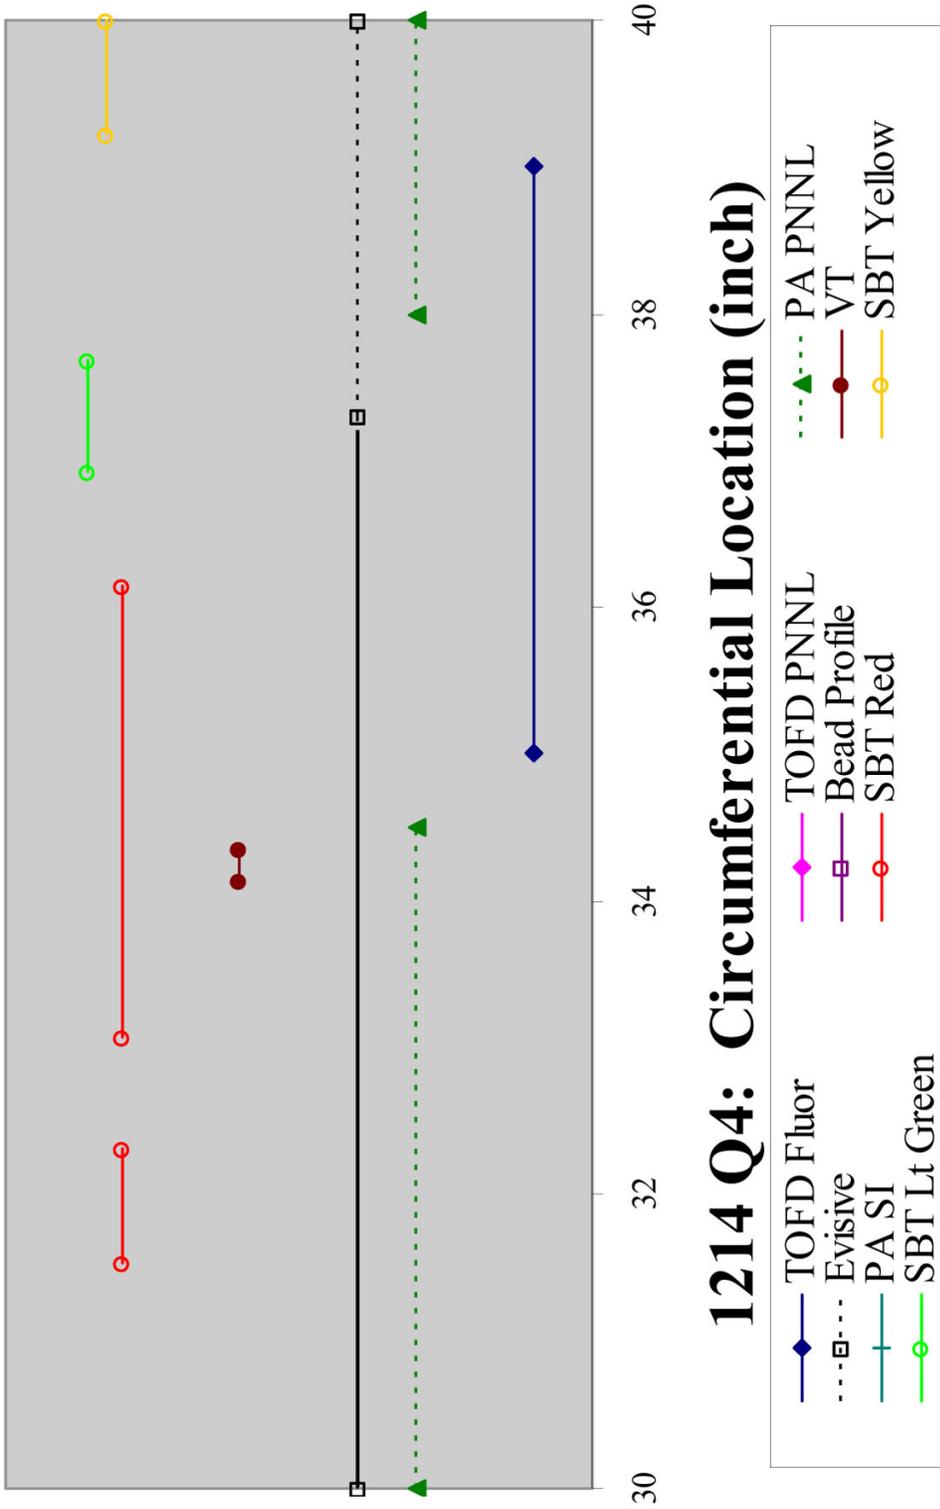
Figure 5.10 SBT Failure Regions Covered Most of This Quadrant and were Partially Detected with Evisive and TOFD Fluor NDE

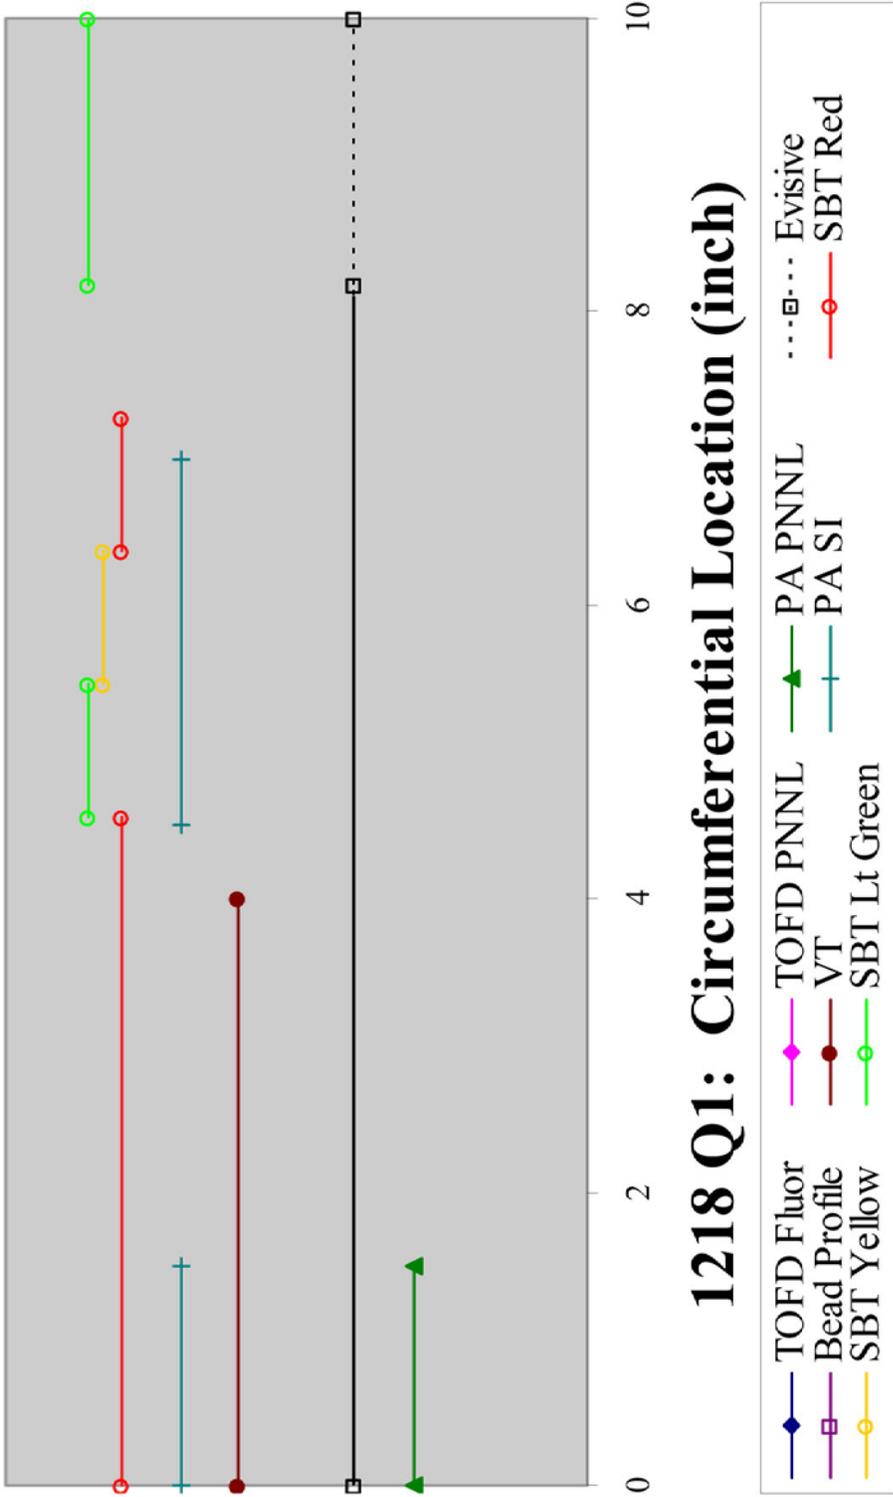
Figure 5.11 SBT Failure Regions Covered Most of This Quadrant and were Well Detected with Evisive NDE. PA SI and PA PNNL detected some of the failure regions.

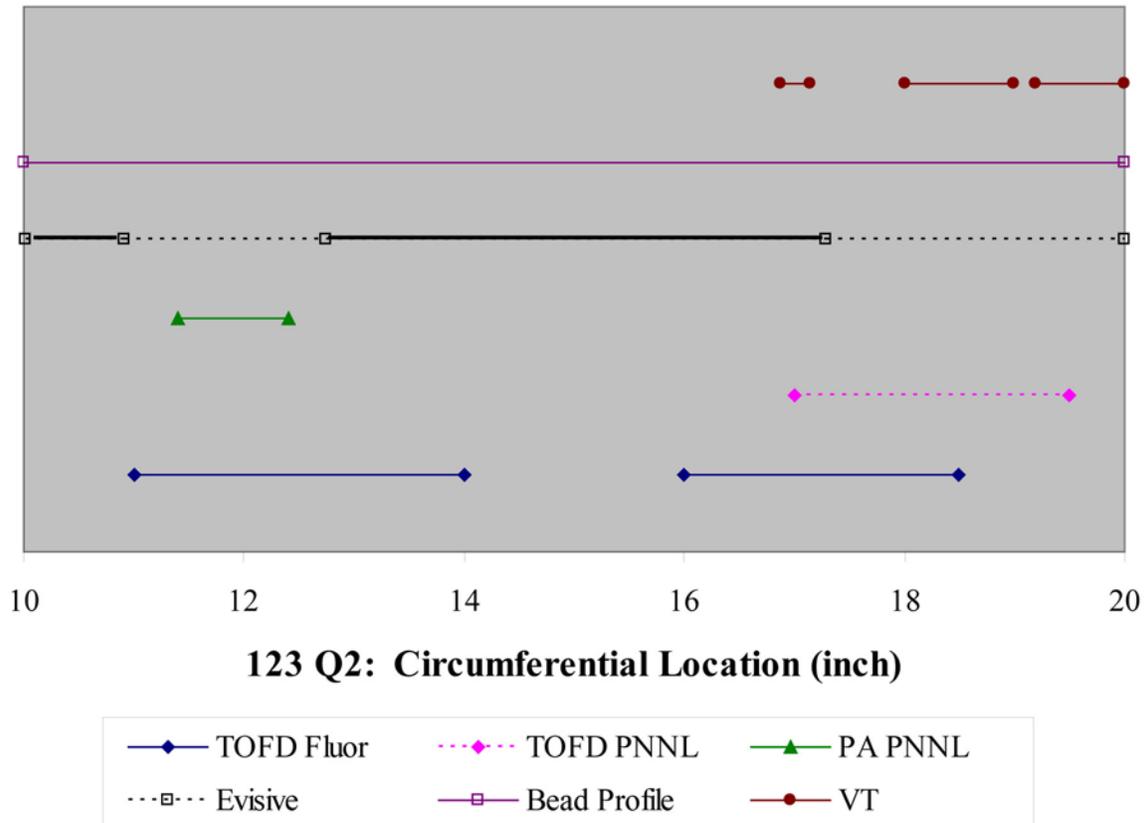
Figure E.1 Evisive, PA PNNL, and TOFD Fluor had areas called defective but the correlation between the three techniques is not very good.

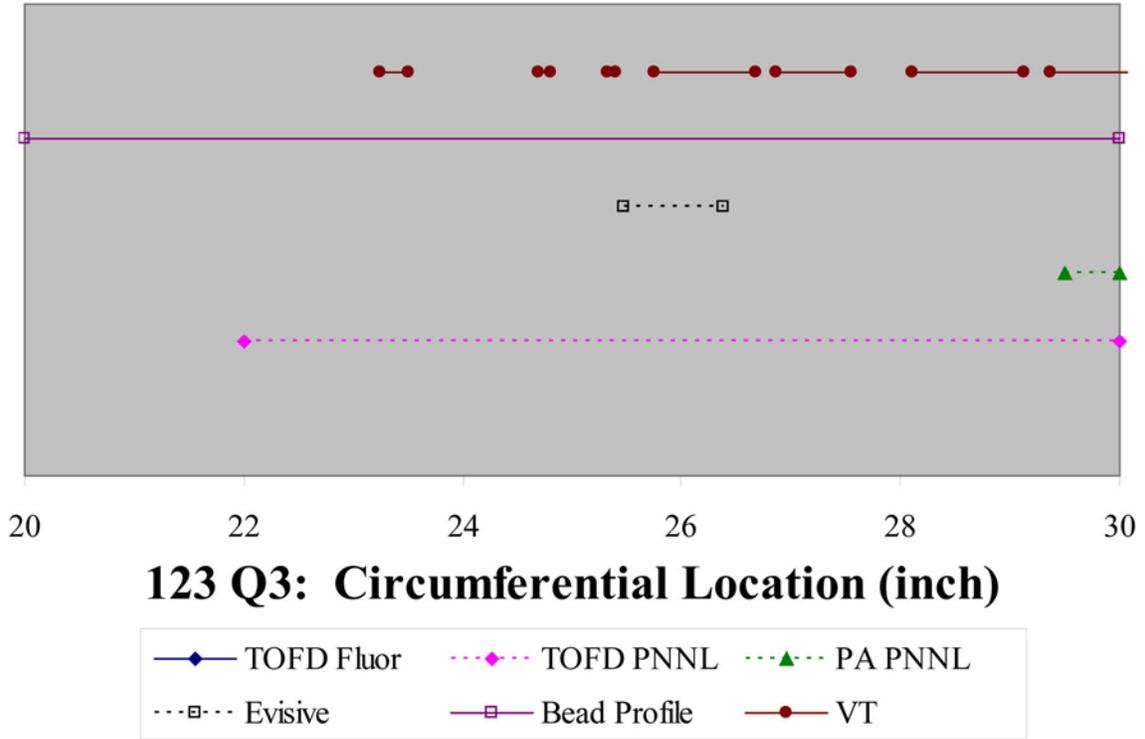
Figure E.2 There were no definitive NDE flaw calls in this quadrant.
