Assessment of NDE Methods on Inspection of HDPE Butt Fusion Piping Joints for Lack of Fusion

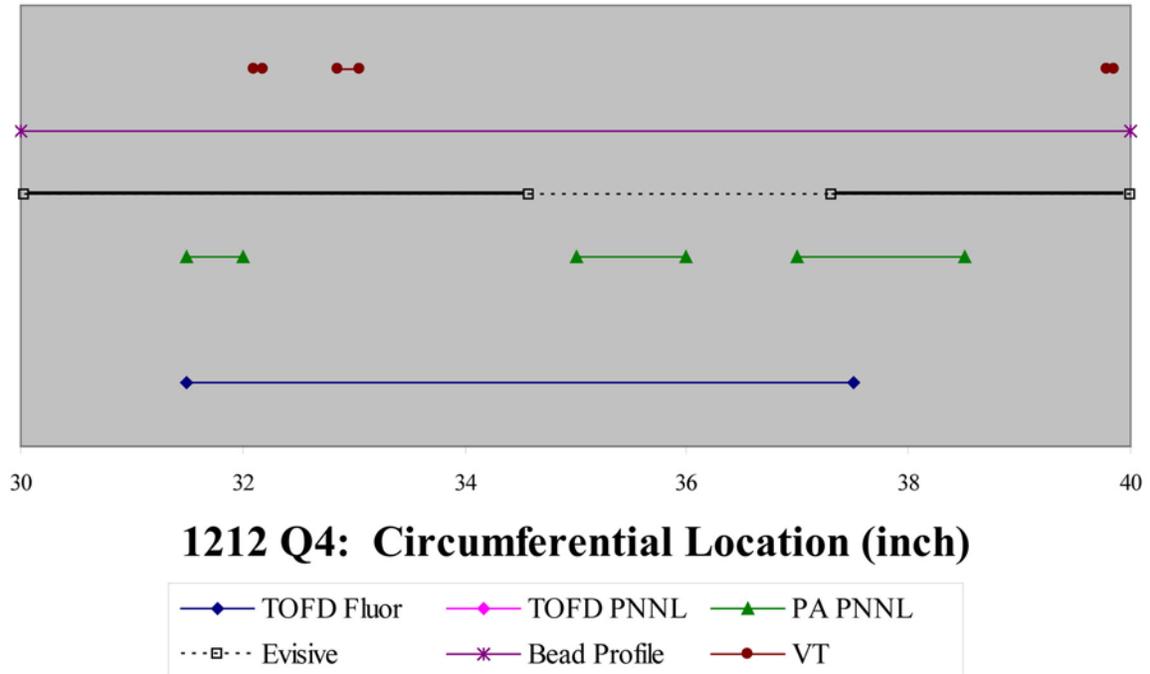
Figure E.4 Evisive, PA PNNL and TOFD Fluor called defective areas in this quadrant. There was better agreement in the TOFD and PA results than the Evisive results.

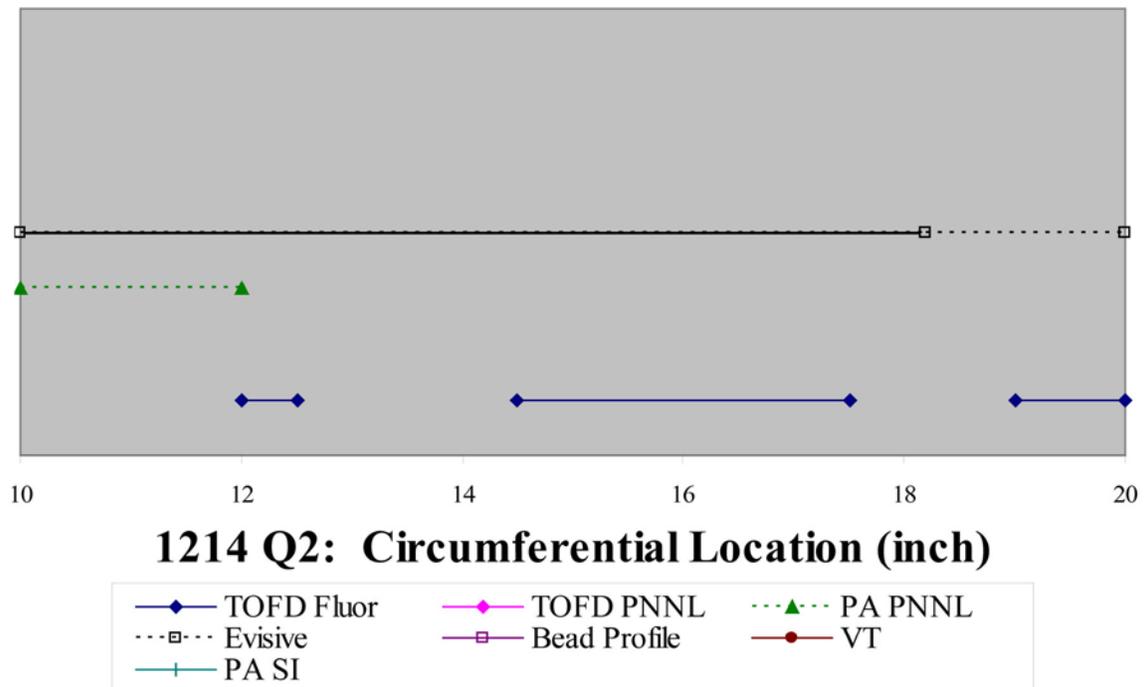
Figure E.5 Evisive called most of the quadrant defective. TOFD Fluor called three regions defective and two of these regions fell in the Evisive defective area.

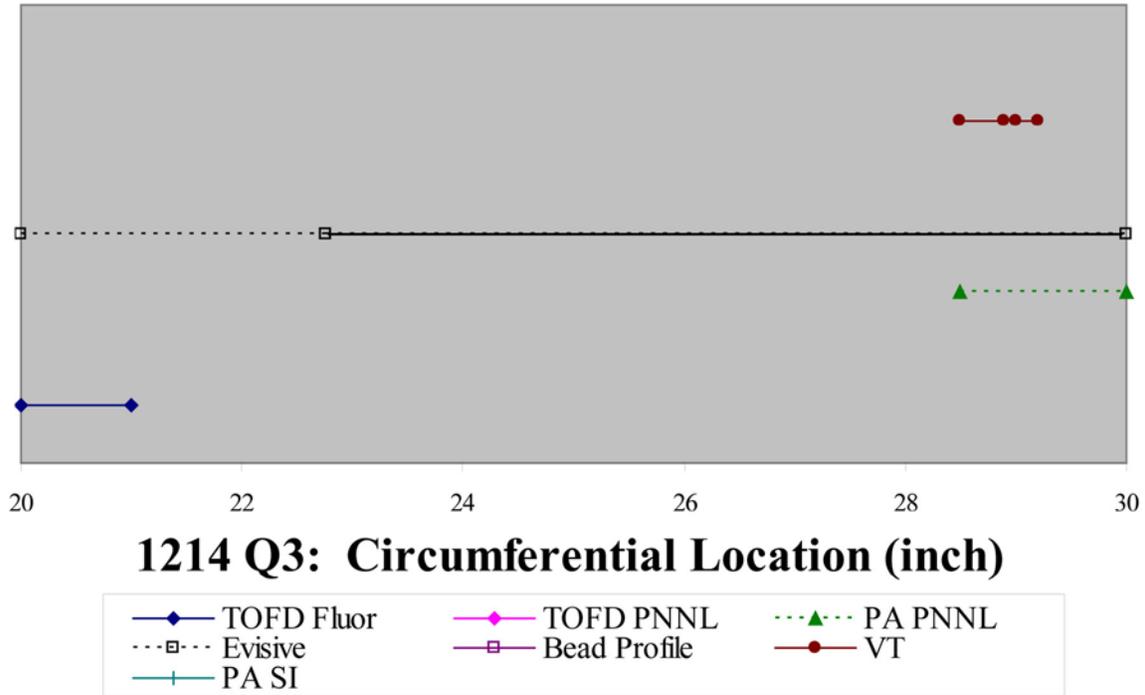
Figure E.6 Evisive called most of the quadrant defective. TOFD Fluor called one small area defective and this did not fall in the Evisive defective area.

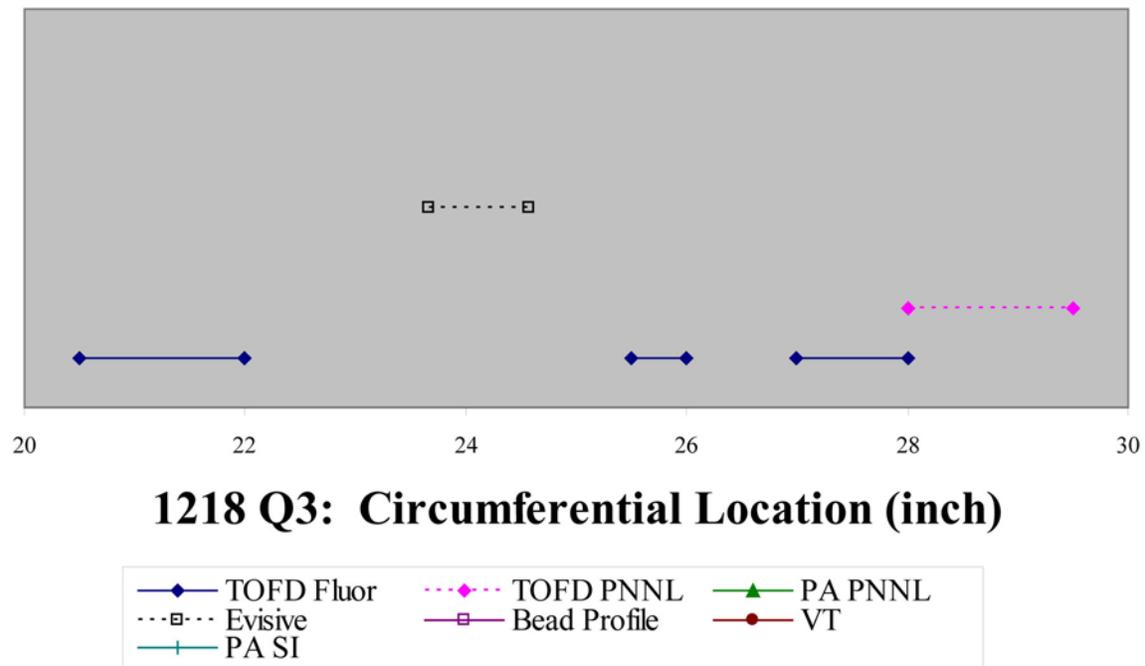
Figure E.7 TOFD Fluor was the only NDE technique to call defective regions.

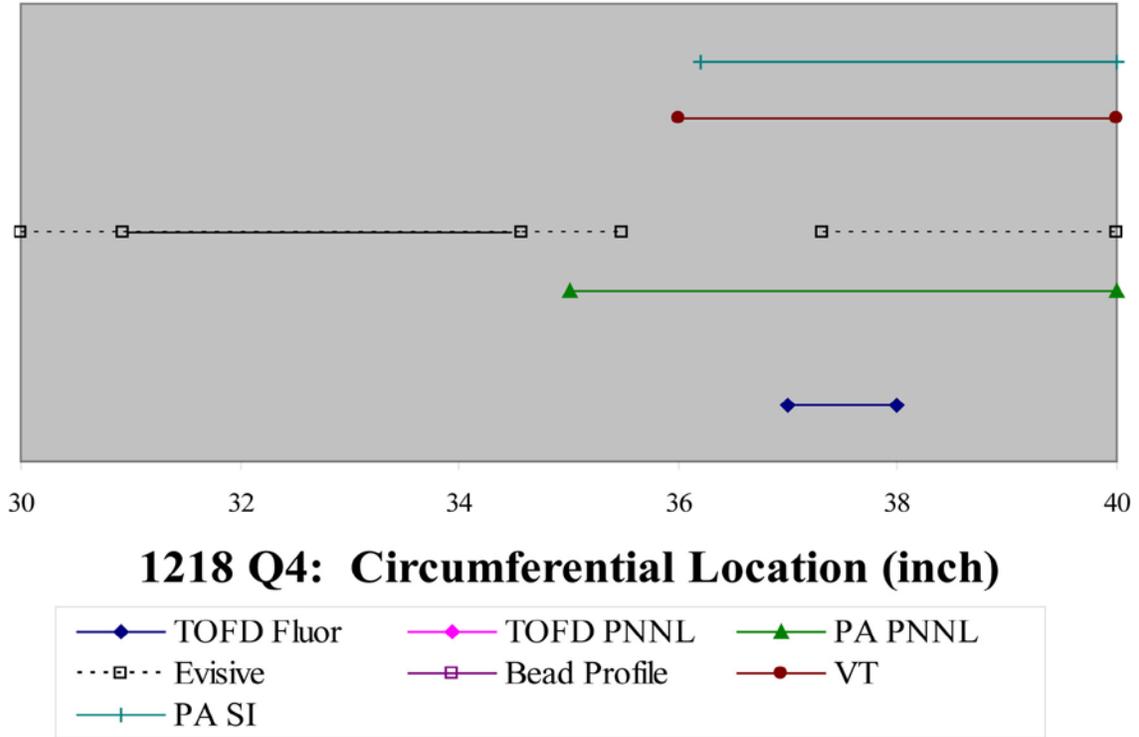
Figure E.8 Evisive and PA PNNL called defective regions but they did not intersect. TOFD Fluor called a small defective region that fell within the PA PNNL called flaw region.

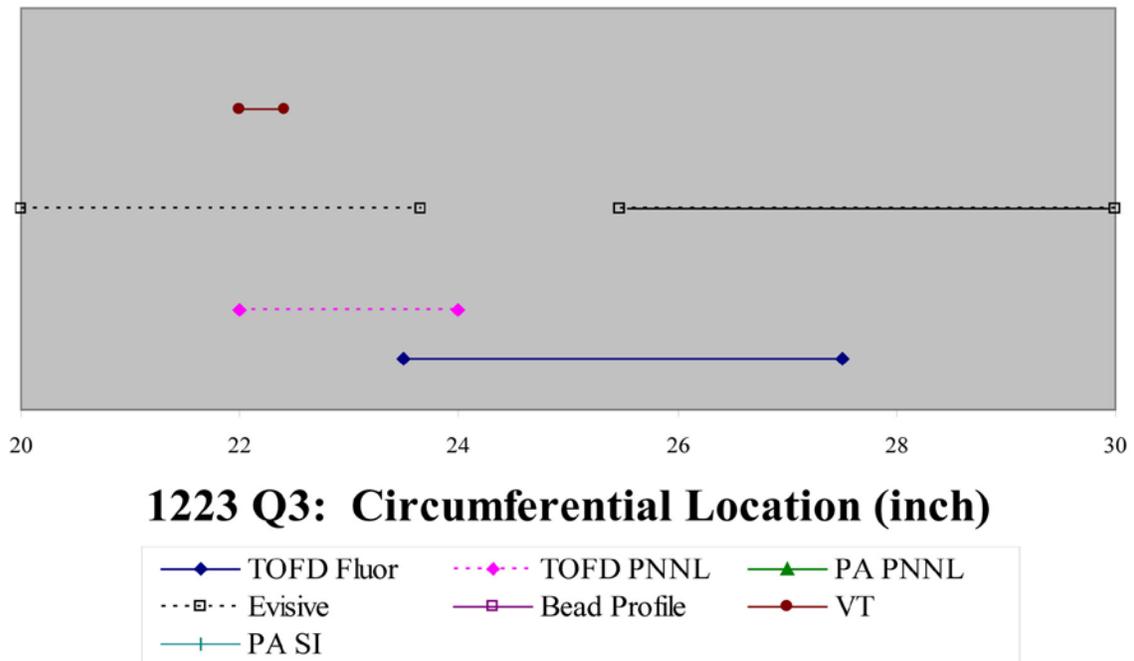
Figure E.9 Evisive and TOFD Fluor called defective regions with an approximate 50% intersection of the called flawed regions.

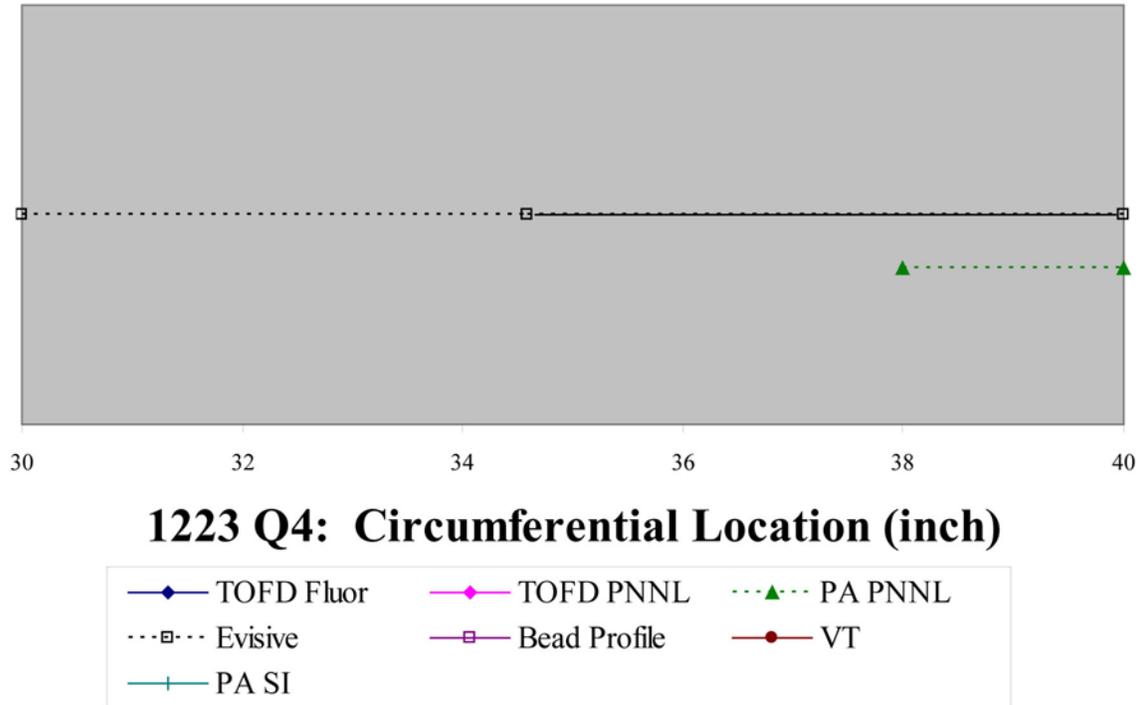
Figure E.10 Evisive called approximately half of the quadrant flawed. There were no other detected flaw regions.
