ENTERGY NUCLEAR VERMONT YANKEE, LLC
and ENTERGY NUCLEAR OPERATIONS, INC.

(Vermont Yankee Nuclear Power Station)

**Assessment of Proposed Program to Manage Aging of the Vermont
Yankee Steam Dryer Due to Flow-Induced Vibrations**

**Dr. Joram Hopenfeld
1724 Yale Place
Rockville, MD 20850
(301) 801-7480**

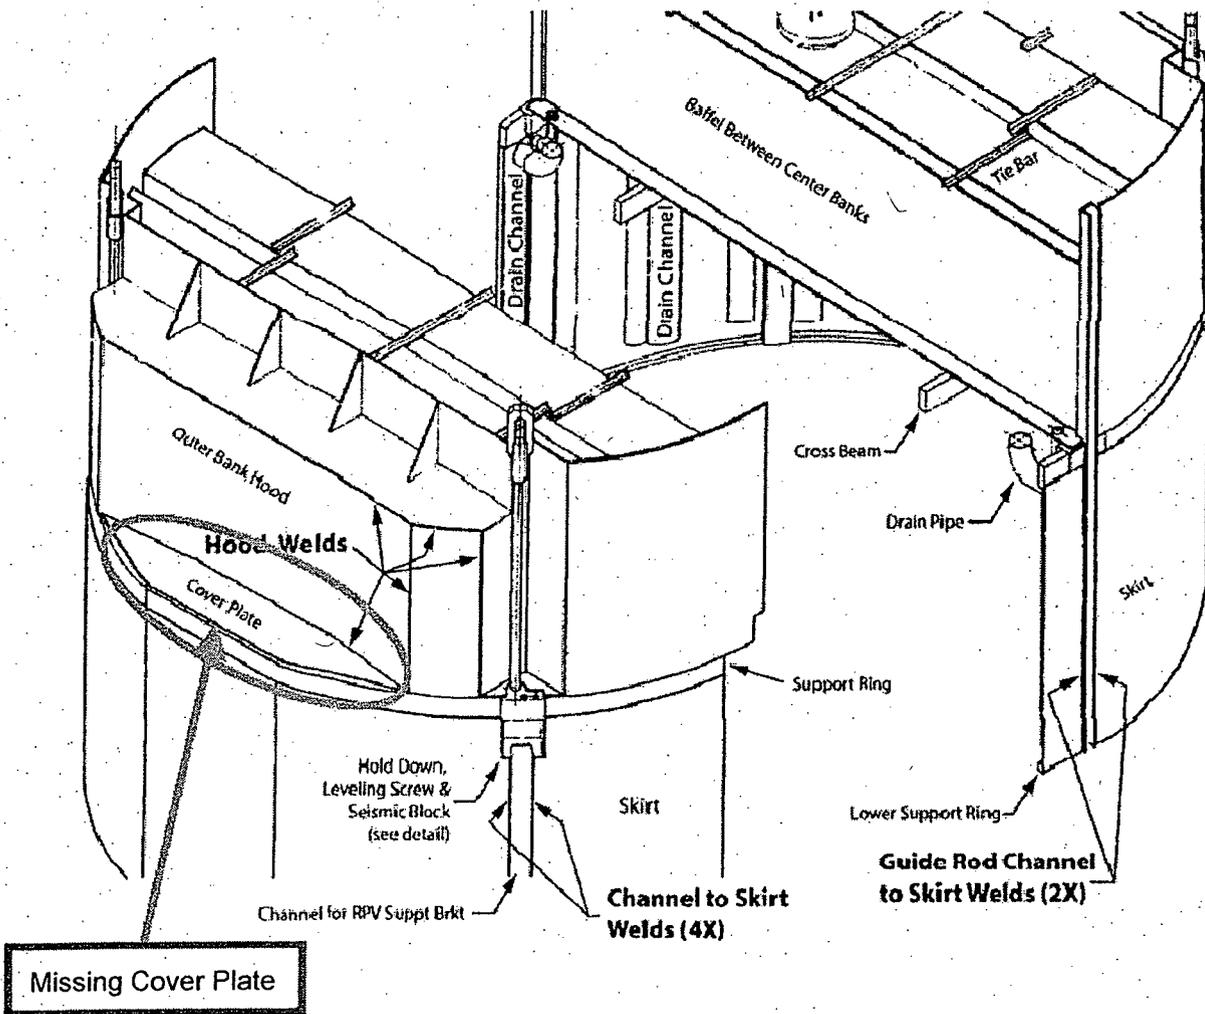
Figure A-1: Location of the 2002 Lower Cover Plate Failure

Lower horizontal cover plate failure occurred in a BWR/3 in 2002. In this failure, almost the entire lower horizontal cover plate came completely loose, with some large pieces falling down onto the steam separators and one piece being ingested into the main steamline and lodging in the flow restrictor. This failure was accompanied by a significant increase in moisture content, along with changes in other monitored reactor parameters. The cause of this failure was attributed to the higher fluctuating pressure loads at extended power uprate (EPU) operation. In particular, there may have been a potential resonance condition between a high frequency fluctuating pressure loading (in the 120-230 Hz range) and the natural frequency of the cover plate. Appendix A provides a more detailed description of this event.

The cover plates on both sides of the dryer have been replaced with ½-inch continuous plates (this eliminates two intermediate welds on the original plates). The fillet weld connecting the plate to the support ring was increased to ¾-inch and the weld to the vertical face of the dryer hood was increased to ½-inch. The plant has been returned to service with interim, enhanced monitoring of moisture content, reactor steam dome pressure, MSL flow rates and reactor water level. As an additional measure, the plant has implemented dynamic response monitoring of the MSLs to determine if higher flow induced vibration occurs as the steam flow is increased.

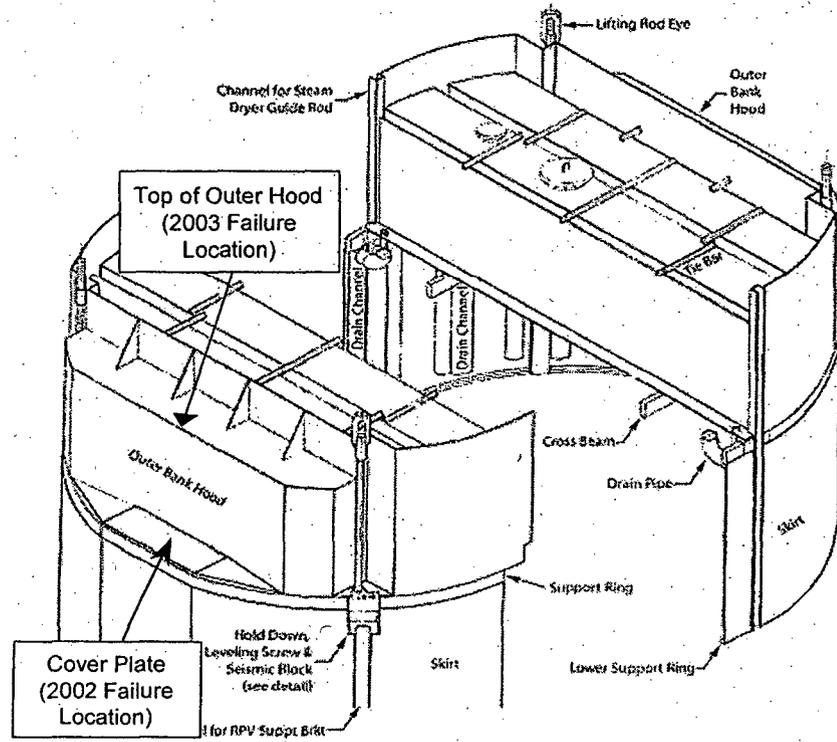
Figure B-1: Location of the 2003 Outer Hood Failure

The same BWR/3 experienced extensive through-wall cracking in the outer bank hood on

the 90° side in May 2003. On the opposite side of the steam dryer (270° side), incipient cracking was observed on the inside of the outer hood cover plate. Several internal braces were detached and found on top of the steam separators. No damage was found on the inner banks of the dryer. Again, the failure was accompanied by a significant increase in moisture content. Of the other monitored reactor parameters, only the flow distribution between the individual steamlines was affected. The cause of this failure was attributed to high cycle fatigue resulting from low frequency oscillating pressure loads (<50 Hz) of higher amplitude at EPU operation and the local stress concentration introduced by the internal brackets that anchor the diagonal internal braces to the dryer hoods. Appendix B provides a more detailed description of this event.

The combined effect of these modifications was to increase the natural frequency of the outer hood, reduce the maximum stress by at least a factor of two, and reduce the pressure loading by reducing the magnitude of vortices in the steam flow near the MSLs.

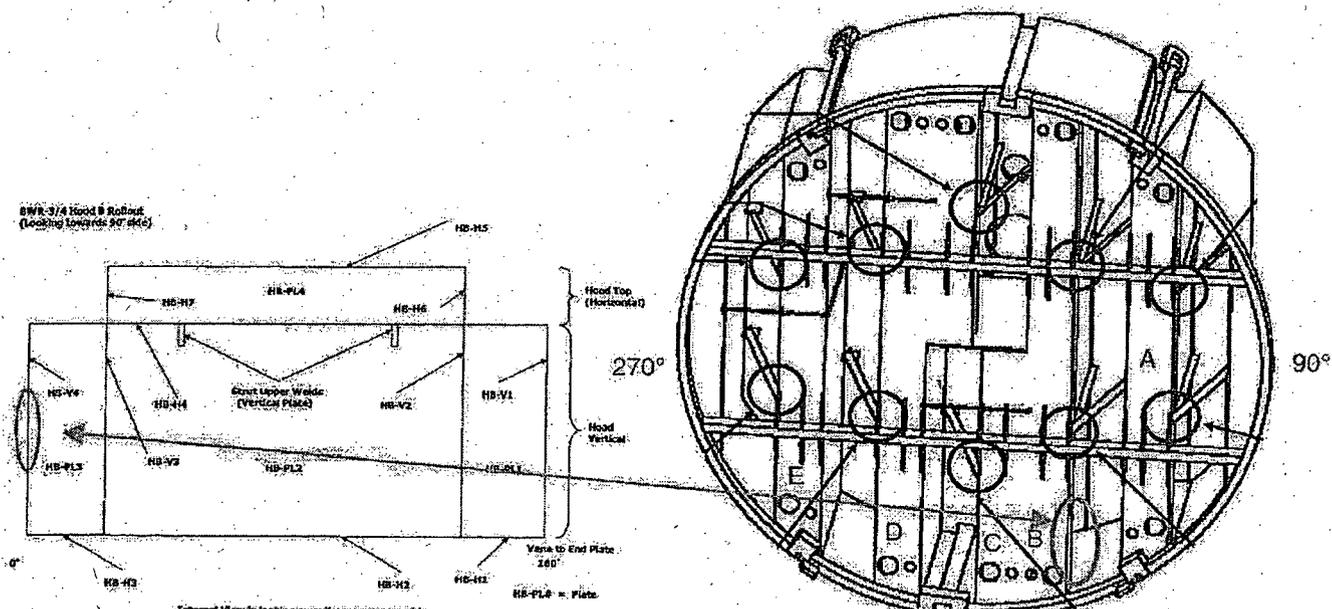
During the Vermont Yankee 2007 refueling outage, in accordance with the Vermont Yankee VT-VMY-204V10 Rev 2 Procedure, the Steam Dryer was inspected. The dryer inspection included inspection of the Steam Dryer interior welds and components. These inspections were done with GE's Fire-Fly ROV with color camera. During the inspection of the HB-V04 weld (Dryer Unit Hood End Panel to HB-PL3 Plate weld), relevant linear indications were observed in the heat-affected zone on the Dryer Unit side of the weld. Most of these linear indications were previously seen in RFO-25, Reference:INF # 002. When comparing this outage with last outage, one new relevant indication is seen (3rd indication) of similar appearance, orientation and size as those previously seen; one indication was not seen (RFO25: 3th indication). No discernible change was noted in those indications which correlates to those of RFO26. See attached 2007 photos and sketches.

Sketch on the left shows the weld map rollout. The sketch on the right shows a bottom view of the dryer.

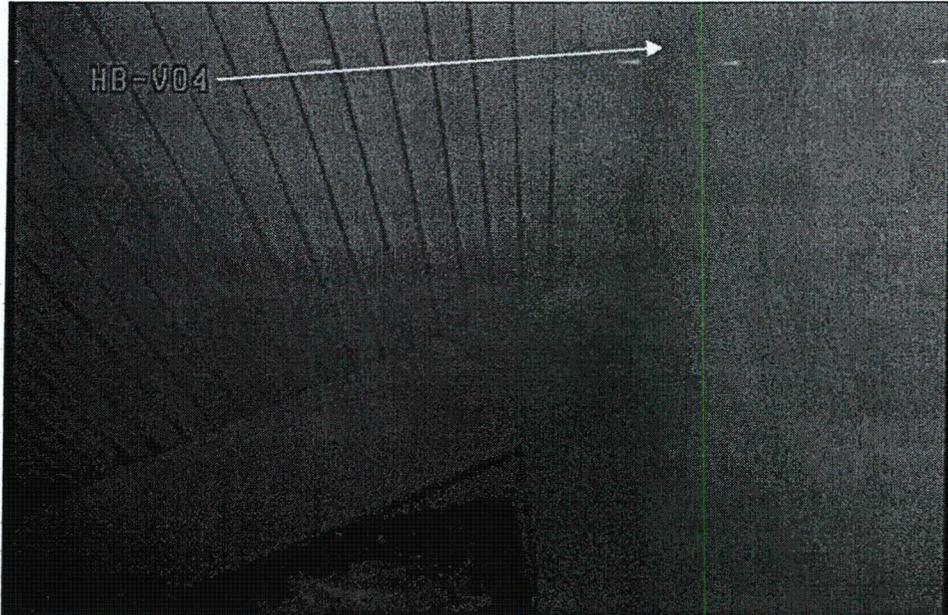
This 2007 photo shows the interior of the dryer and the location of HB-V04 vertical weld.

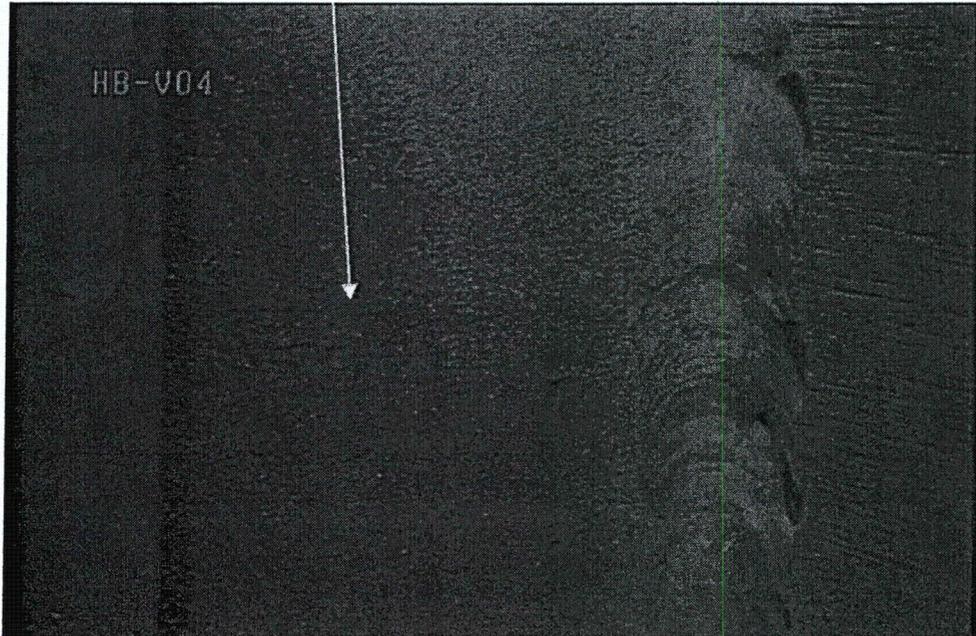
This 2007 photo is a close-up of the 1st indication (Correlates to RFO25: 1st indication).
